Prisma II Reverse Receiver Incorrect or Incomplete Data Display Technical Bulletin

The purpose of this document is to inform users of full-height Prisma II™ Reverse Receiver application modules of an issue regarding the display of incorrect or incomplete module status information.

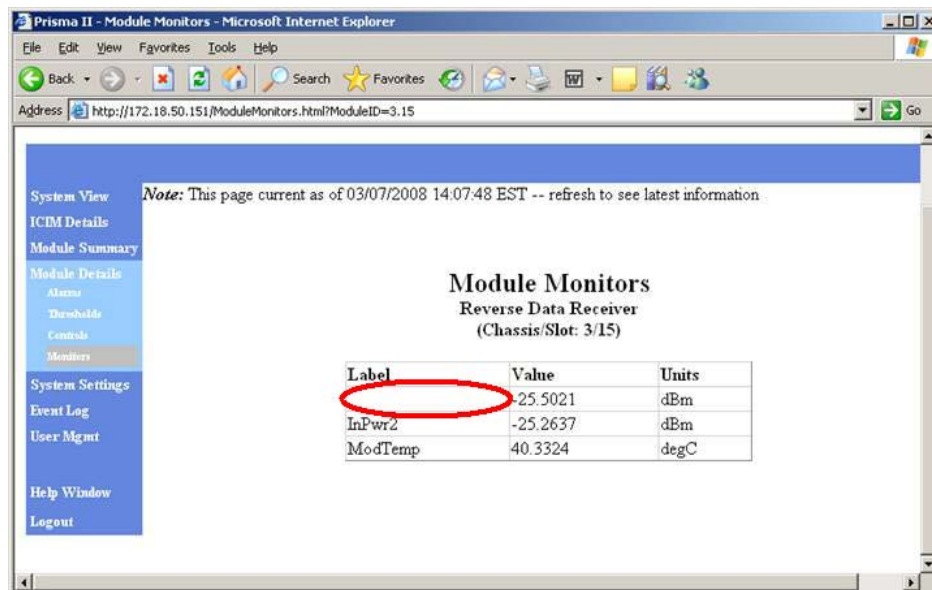
ICIM Web Interface Screen

The following illustration shows an ICIM Web Interface screen in which the label for InPwr1 is missing (see circled area).

Customers can correct affected units by running a custom Windows software program, as described in this section, during their normal service window. This program updates the module firmware, and is available from Cisco Services.

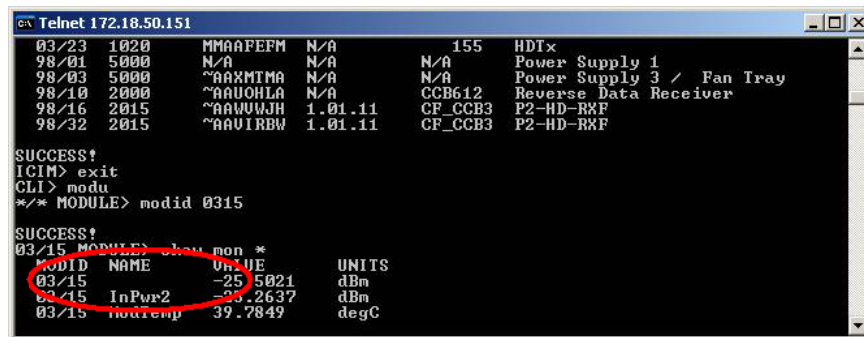
ICIM2 CLI Session

The following illustration shows a CLI session window in which the label for InPwr1 is missing (see circled area).

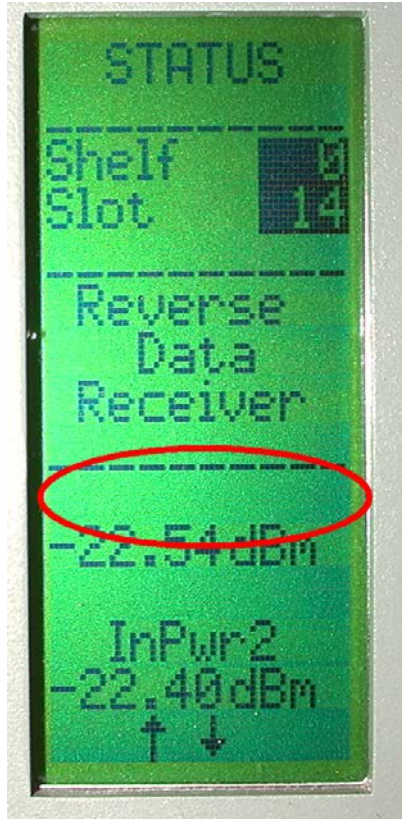
ICIM Front-Panel LCD Display

The following illustration shows an ICIM2 LCD Status display in which the label for InPwr1 is missing (see circled area).
