Troubleshoot LMP Communication Failure between NCS1004 and NCS2006

This document describes a specific combination of hardware and software that results in communication failure for LMP, which fails to build or restore WSON circuits.

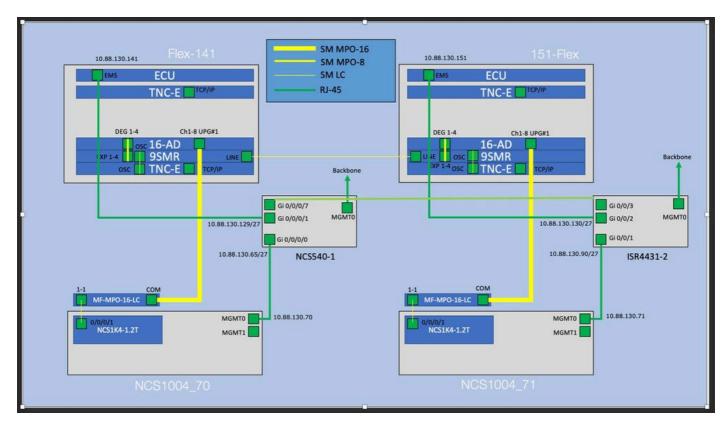
Figure shows lab topology to replicate field issue

When the customer attempts to build an LMP between the devices represented by NCS1004_70 and Flex-141, the GMPLS tunnel fails to establish. Attempts to build an LMP between NCS1004 and NCS2006 devices connected by the NCS540 and NCS55A2 fail, but other connection types succeed, including these flavors:

After you enable proxy ARP on the NCS540 management interface that faces the NCS1K, the GMPLS tunnel comes up.
