Attempt to Upgrade Firepower Devices Results in Failure "006_check_snort.sh"

This document describes a specific upgrade failure scenario seen on Firepower Threat Defense (FTD) when the upgrade procedure is not properly followed. It also covers the proposed solution.

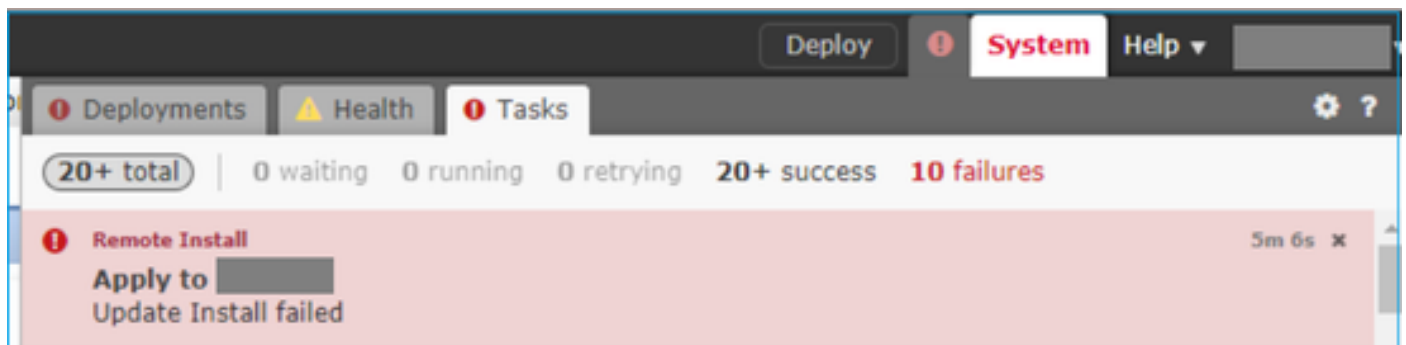
An attempt to perform an upgrade results in the Update Install failed error as shown in this screenshot:

```
ui:[14%] Running script 200_pre/003_check_health.sh...
ui:[15%] Running script 200_pre/006_check_snort.sh...
ui:[15%] Fatal error: Error running script 200_pre/006_check_snort.sh <-- the problem
Additionally, under this path there is a file named 006_check_snort.sh.log which further describes the
reason for the failure:
results-xx-xx-xxxx-xxxxxx\dir-archives\var-log\sf\Cisco_FTD_SSP_Upgrade-6.x.x\200_pre
```

```
Entering 200_pre/006_check_snort.sh...
Snort build is too old.
Please apply AC Policy from FMC before attempting upgrade.
There are a few reasons why this error can occur:
```

- Your Firepower Management Center was updated; however, the sensor which attempts to upgrade has not had a new policy deployment pushed out towards it.
- Your Firepower Management Center has updated its Snort Rule Update (SRU); however, the sensor which attempts to upgrade has not had a new policy deployment pushed out towards it

Once you have verified that the device encounters this issue, simply deploy a policy to the affected device in order to resolve the error. From Firepower Management Center, check the box next to the device to be upgraded and click **Deploy**.
