Screw Replacement Procedure of Itron RIVA CAM Module on IR8140 Router

Revised: August 29, 2023,

The procedure provided in this document is to establish the alternate procedure for replacing the alignment pin and lock washer with screw in Cisco IR8140 router.

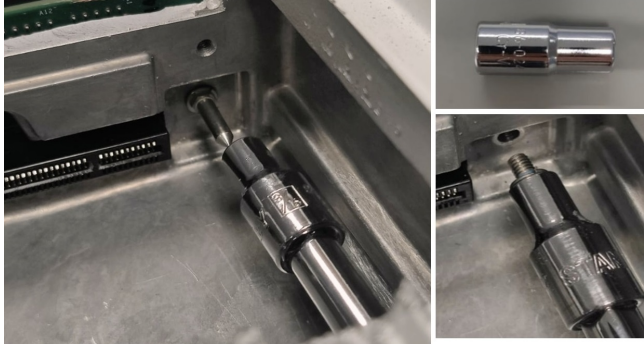
—	—
2	Use 3/16 socket driver as shown to remove the alignment pin and washer. The washer is intended to come off with the alignment pin.

The socket might hit the connector in the slot.	<ul style="list-style-type: none"> • Make sure alignment pin and washer is removed. • Do not disturb or hit any other components.
3	Check to see the washer is removed. If not, use a magnetic retriever to remove the washer.
