HX節點PCI地址重新排序故障排除

簡介

本檔案介紹各種第三代C系列虛擬介面卡(VIC)配接器上的網路介面卡(NIC)重新排序問題。在參考虛擬網路介面卡(vNIC)/虛擬主機匯流排介面卡(vHBA)的位置、裝置順序、外圍元件互聯(PCI)列舉時發現行為更改，並且導致從各種作業系統(OS)中看到PCI重新排序問題。

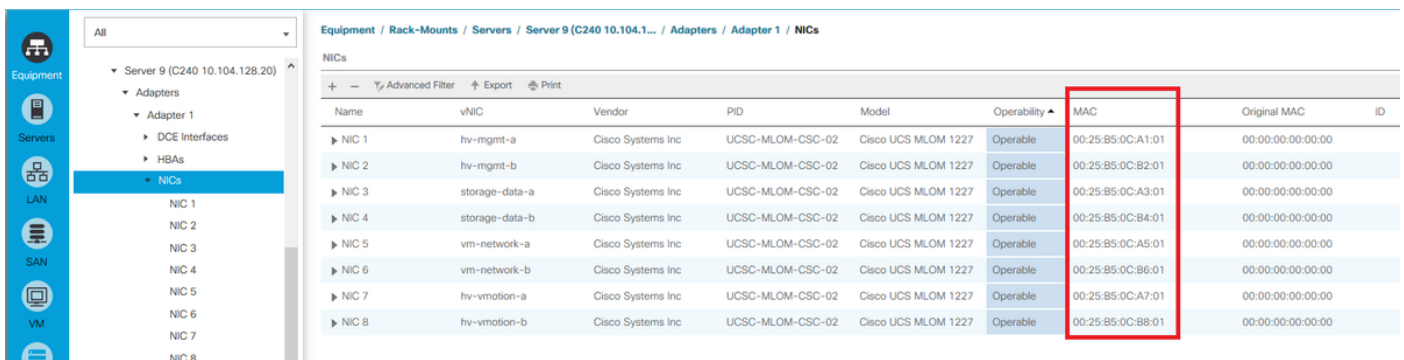
1.從伺服器的UCSM GUI獲取MAC地址對映，如下圖所示：

在此輸出中，MAC地址不匹配，vmnic2和vmnic4被交換。這是由PCI匯流排重新訂購問題引起的。
