# UCS M5刀片DIMM填充標籤與文檔不匹配

本文檔介紹舊UCS M5刀片DIMM填充標籤的問題，該標籤不能反映當前的聯機文檔。

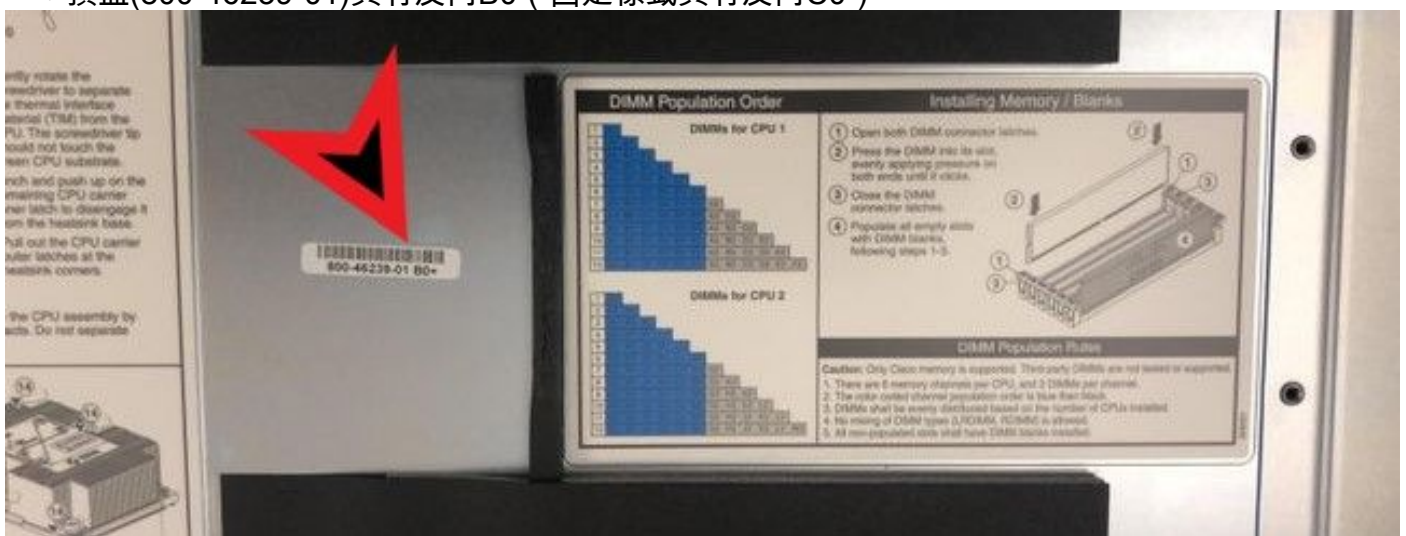
- UCS B200 M5
- UCS B480 M5
- 頂蓋(800-46239-01)具有反向B0 ( 固定標籤具有反向C0 )

原始DIMM填充標籤沒有錯誤，但應指導客戶閱讀有關最新和最佳化配置的線上文檔。

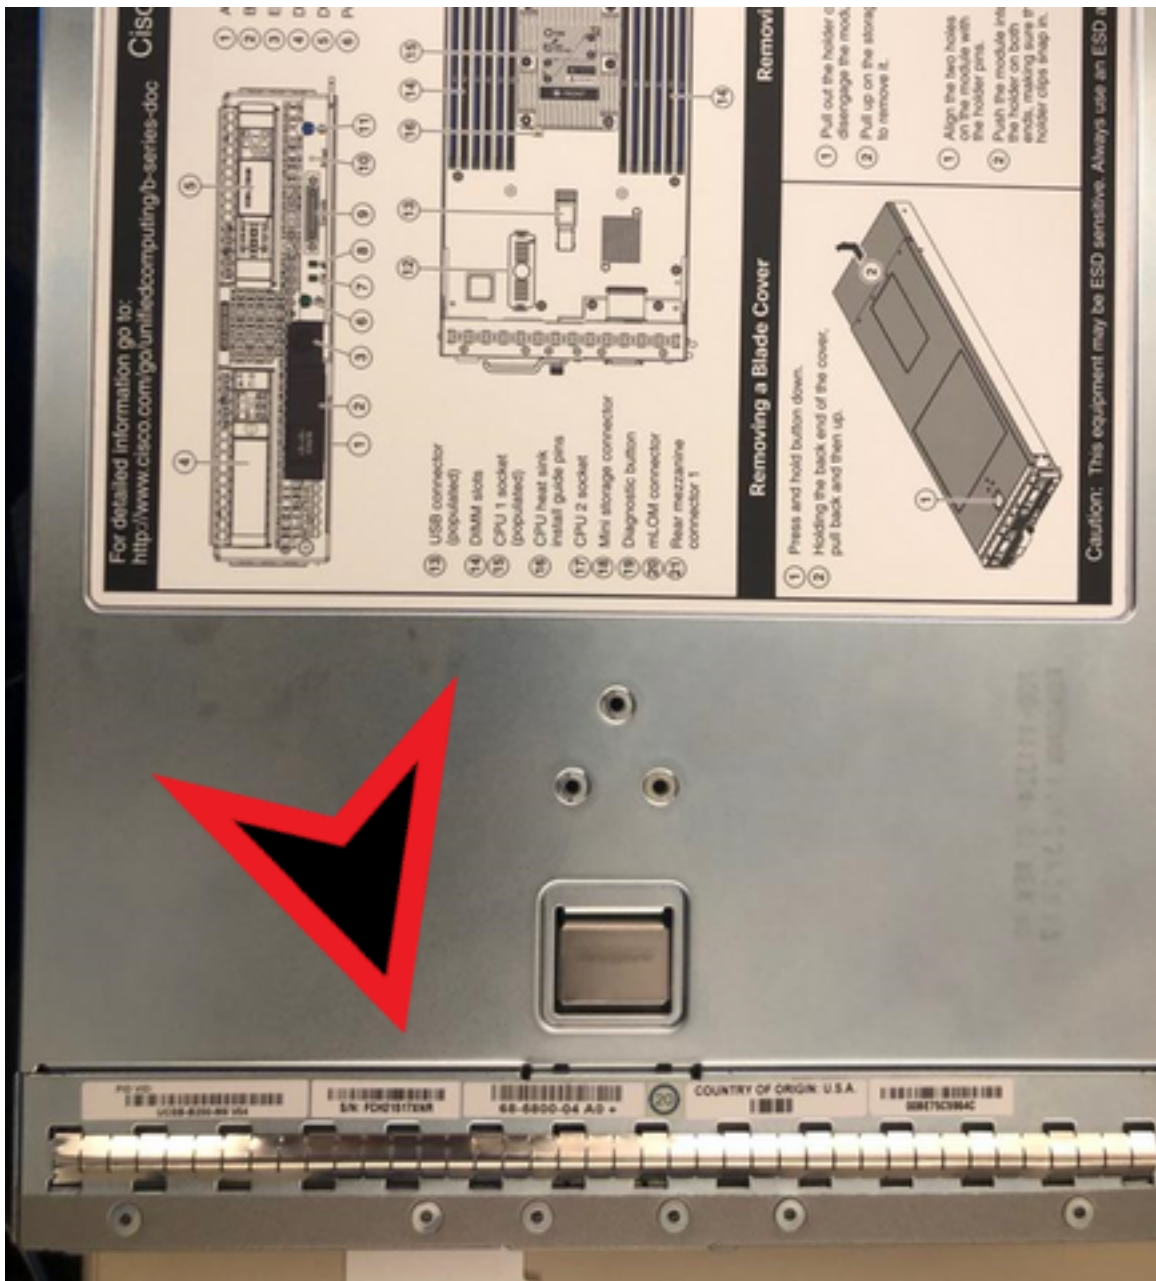
- 頂級程式集編號(68-5800-04)具有版本A0 ( 固定版本為B0 )

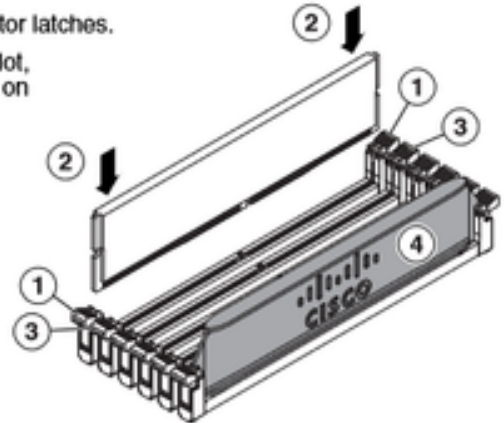
UCS M5刀片蓋子下的DIMM填充標籤與聯機UCS文檔中的資訊不匹配。

B200-M5的舊貼紙供參考：

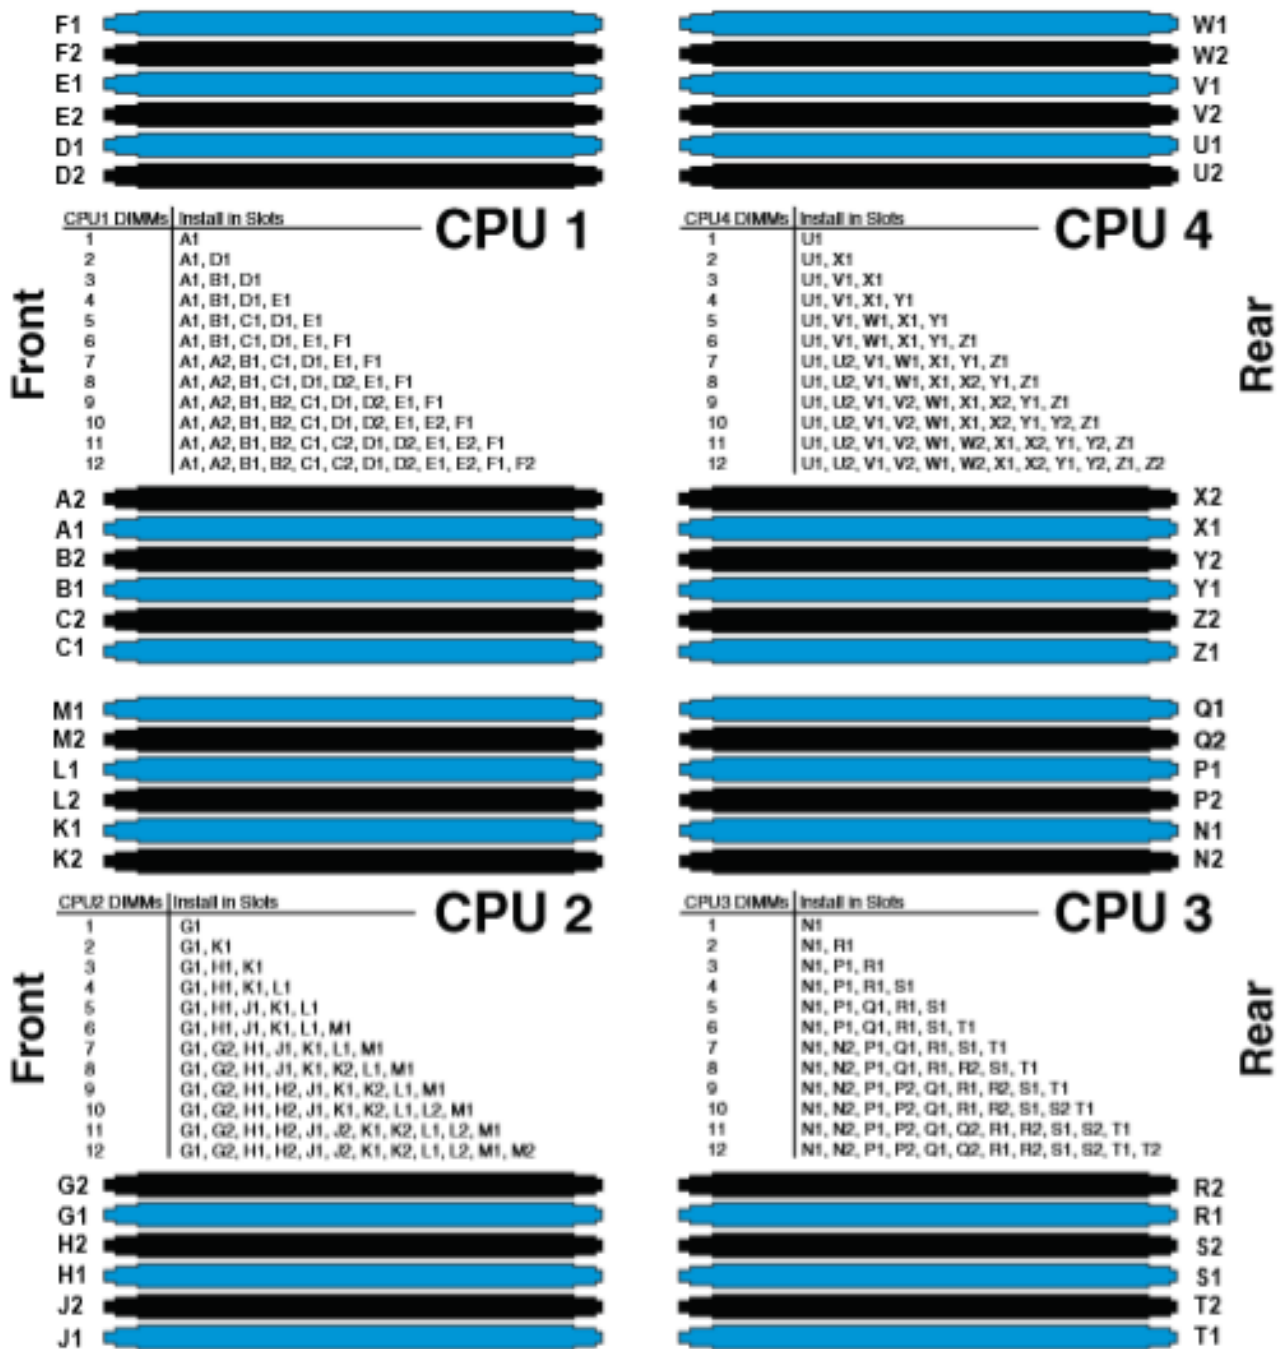
# Cisco UCS B480 M5 Memory Slot Locations

B480-M5的舊貼紙供參考：
