Cisco RF Gateway 1 Software Release Notes, Release 2.05.06

Overview

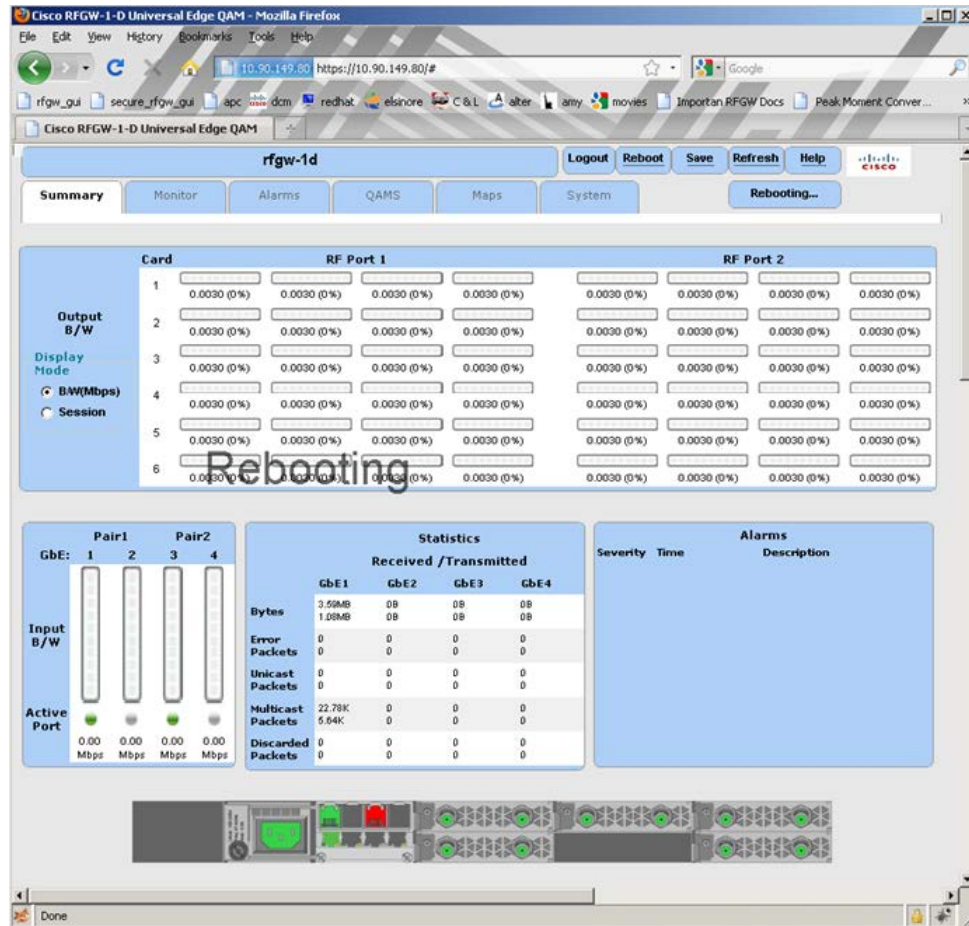
- The GUI times out after about 17 seconds of inactivity and no longer automatically reconnects to the RF Gateway 1. For example, if the RF Gateway 1 is rebooted from the GUI, the following page is displayed.

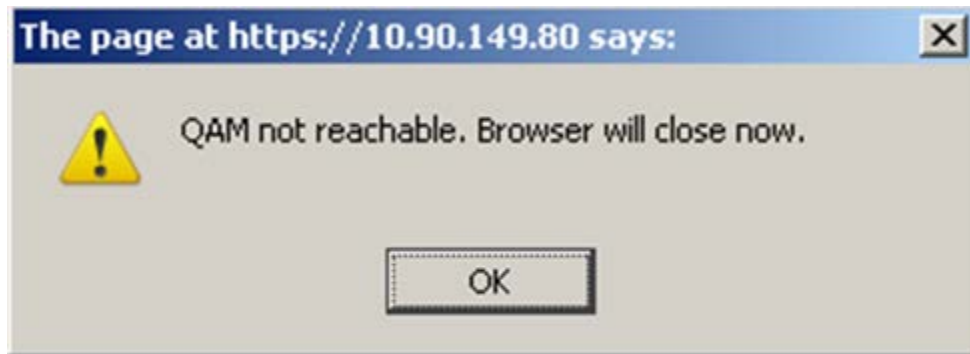
After 17 seconds, the screen below is displayed. Click **OK**. The browser closes. You will need to reopen the browser upon an RFGW reboot.
