Troubleshoot Duplicate IP Address 0.0.0.0 Error Messages

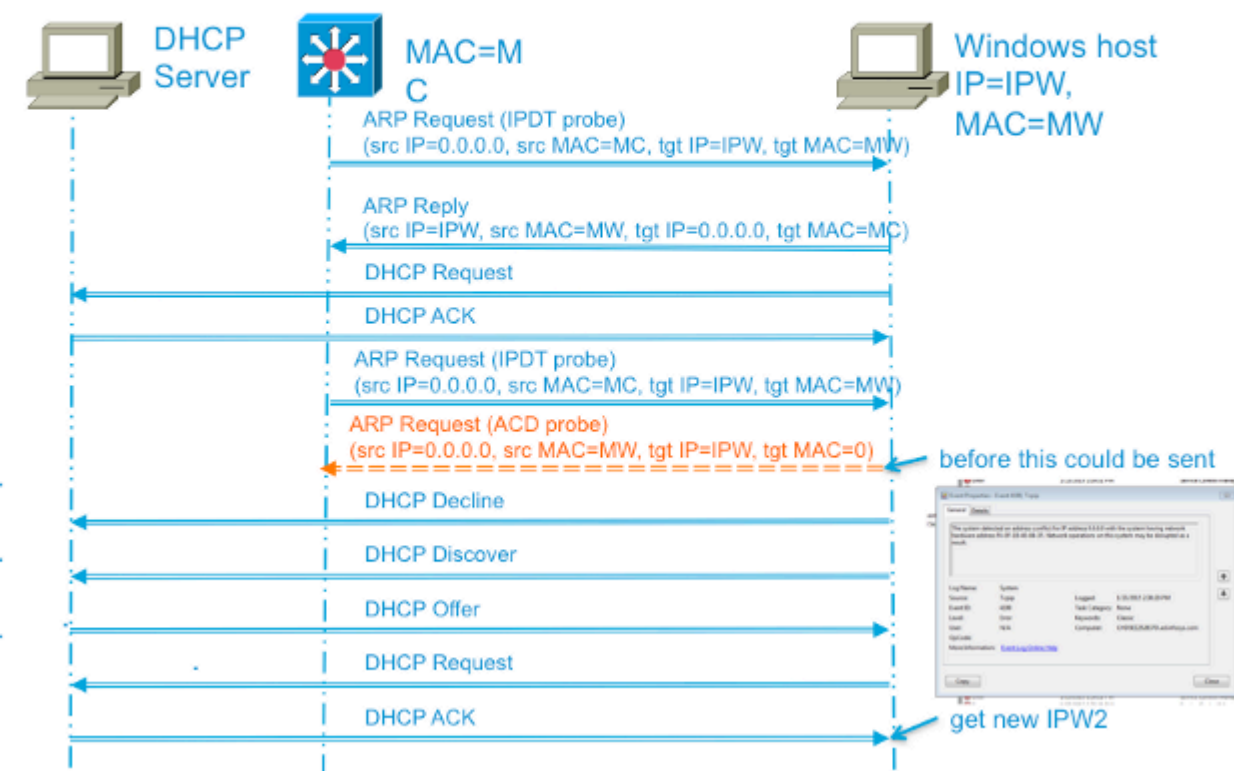
Failing Sequence Packet Flow

If the switch sends out an ARP Probe for the client while the Microsoft Windows PC is in its duplicate-address detection phase, then Microsoft Windows detects the probe as a duplicate IP address and presents a message that a duplicate IP address was found on the network for 0.0.0.0. The PC does not obtain an IP address, and the user must either manually release/renew the address, disconnect and reconnect to the network, or reboot the PC to gain network access.

This is an example of the failed packet sequence:

- The most effective method used to prevent this issue is to configure the switch so it sends a non-RFC compliant ARP Probe to source the probe from the Switch Virtual Interface (SVI) in the VLAN where

the PC resides. If an SVI is configured for the Virtual Local Area Network (VLAN) and either of the two commands that are next are used, then the sender IP address in the IP Device Tracking (IPDT) probes is never 0.0.0.0. Thus, it is certain the duplicate IP address error does not occur.

- The primary non-SVI alternative used to work around the issue is to delay the probe from the switch so Microsoft Windows has time to finish the duplicate IP address detection. This is effective only on access ports and link-up scenarios. Enter this command to delay the probe:
