Tech Notes

# Why Don't RIPv1 and IGRP Support Variable-Length Subnet Mask?

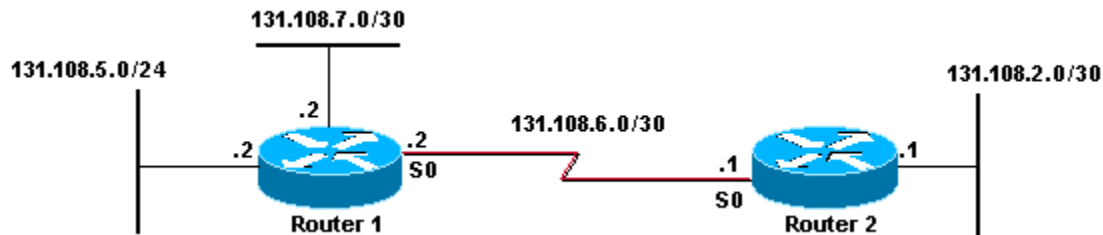
This section provides an example. In this figure, Router 1 has three subnets with two different masks (/24 and /30):

1. Router 1 checks to see whether 131.108.5.0/24 is part of the same major net as 131.108.6.0/30, which is the network assigned to the interface that will be sourcing the update.
2. It is, and now Router 1 checks whether 131.108.5.0 has the same subnet mask as 131.108.6.0/30.
3. Because it does not, Router 1 drops the network, and does not advertise the route.
4. Router 1 now checks whether 131.108.7.0/30 is part of the same major net as 131.108.6.0/30, which is the network assigned to the interface that will be sourcing the update.
5. It is, and now Router 1 checks whether 131.108.7.0/30 has the same subnet mask as 131.108.6.0/30.
6. Because it does, Router 1 advertises the network.

These checks determined that Router 1 only includes 131.108.7.0 in its update that is sent to Router 2. When the **debug ip rip** command is issued, you can actually see the update sent by Router 1. This is how it looks:

Notice that in the previous output only one subnet is included in the update. This results in this entry in Router 2's routing table, which is displayed using the **show ip route** command:

In order to avoid having subnets eliminated from routing updates, either use the same subnet mask over the entire RIPv1 network or use static routes for networks with different subnet masks.
