Why Doesn't OSPF Form Adjacency on a PRI, BRI, or Dialer Interface?

Document ID: 13691

This Tech Note explains an issue with the formation of OSPF adjacency when the dialer interfaces are configured as point-to-point links.

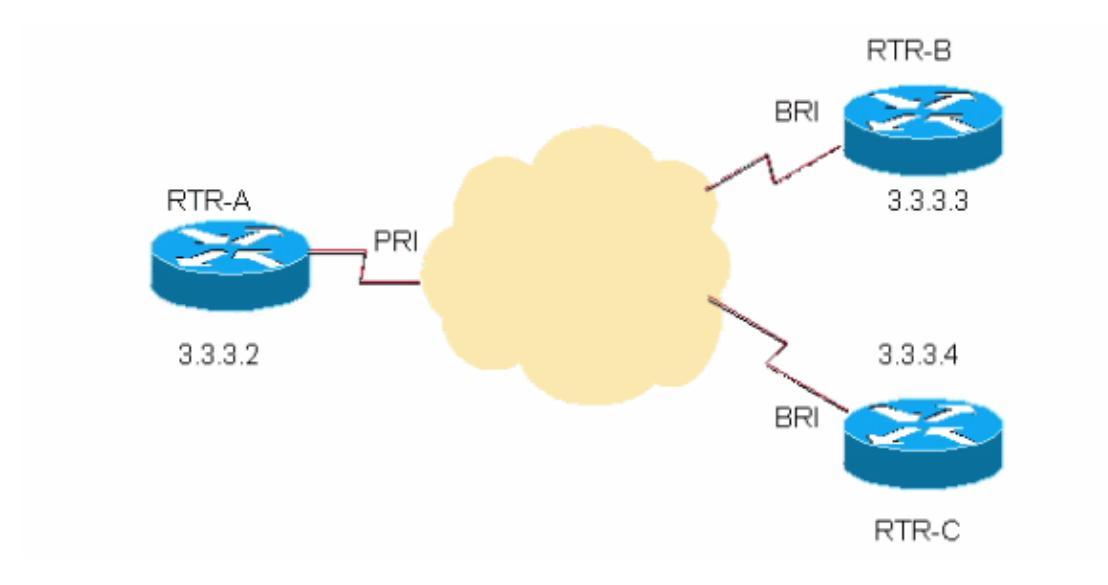
The OSPF network-type on Primary Rate Interface (PRI), Basic Rate Interface (BRI), and dialer interfaces is point-to-point, which means that an interface can't form adjacency with more than one neighbor. A common problem when a PRI, BRI, or dialer interfaces try to form an OSPF adjacency is the neighbor gets stuck in the exstart/exchange process. Let's look at an example.

We can debug this situation using the **debug ip ospf adj** command. Let's look at some sample output taken while running this command on RTR–B in the figure above:

Lines 9 – 11: RTR–B receives a reply from slave (RTR–A) with a completely different sequence number and a flag of 0x7, which is the init flag. This DBD was intended for another router (most likely RTR–C), but RTR–B incorrectly received it. RTR–B declares there is a discrepancy because a flag of 0x7 means the slave has changed its status to master by setting the MS (Master/Slave) bit during the adjacency exchange. RTR–B also complains about the sequence number because it's out of order. The slave should always follow the master's sequence number.

According to section 8.1 of RFC 2328 \Box , OSPF sends a multicast packet for a point-to-point network-type even after the interface achieves the 2-way state. Since RTR-A is trying to form adjacencies with both RTR-B and RTR-C, RTR-B receives DBD packets meant for RTR-C and RTR-C receives DBD packets meant for RTR-B.

To solve this problem, change the network type on all routers to point-to-multipoint. This changes the

behavior of OSPF to send unicast packets after the 2-way state. Now RTR-B receives only packets destined for itself and RTR-C receives packets destined for itself. Changing the network-type in this way ensures that the OSPF router will form adjacency on a PRI, BRI, or dialer interface.
