為什麼OSPF需求電路不斷開啟鏈路

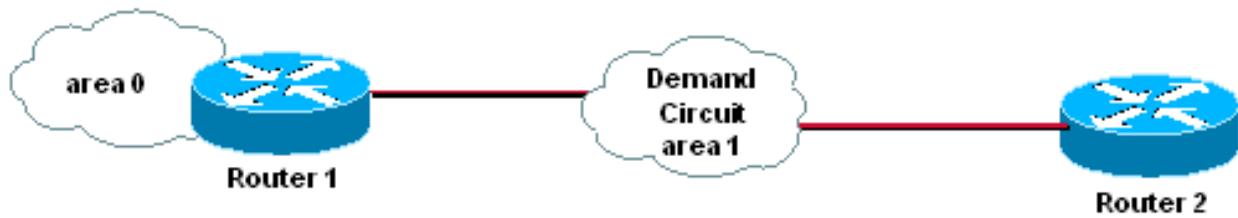
在上圖中，路由器1和2通過ISDN鏈路運行OSPF需求電路。路由器1和路由器2之間的鏈路不斷啟動，這破壞了OSPF需求電路的用途。show dialer命令的輸出顯示，鏈路是因為OSPF組播Hello資料包而啟動的。

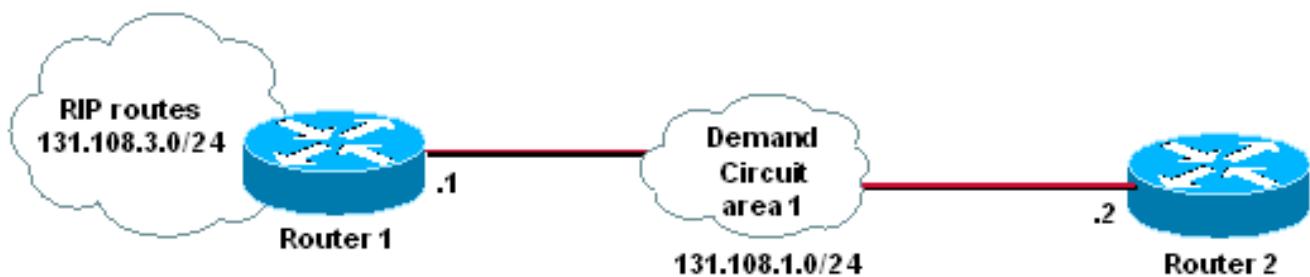
路由器1和路由器2之間的鏈路是131.108.1.0/24，路由器1和路由器2之間配置了請求電路。Router 1將路由資訊協定(RIP)路由重分發到OSPF。

當鏈路斷開時，/32消失，OSPF將此理解為拓撲的變化。需求電路再次啟動該連結，以向其鄰居傳播/32掩碼的MAXAGE版本。當連結啟動時，/32掩碼將再次有效，因此LSA期限將重置。然後，在鏈路的dead計時器啟動後，鏈路將再次關閉。此過程會不斷重複，並且需求電路鏈路不斷抖動。解決此問題的方法有三種，如下所示。

在運行需求電路的BRI介面下，配置no peer neighbor-route。這將阻止安裝/32掩碼。您只能在Router 1上使用如下所示的組態，但為了保持一致，我們建議您在兩端配置此命令。

從RIP重分發到OSPF時，請使用route-map命令和deny /32命令，這樣它就不會被注入到OSPF資料庫中。只有執行重分發的路由器需要此配置命令，在我們的示例中為Router 1。

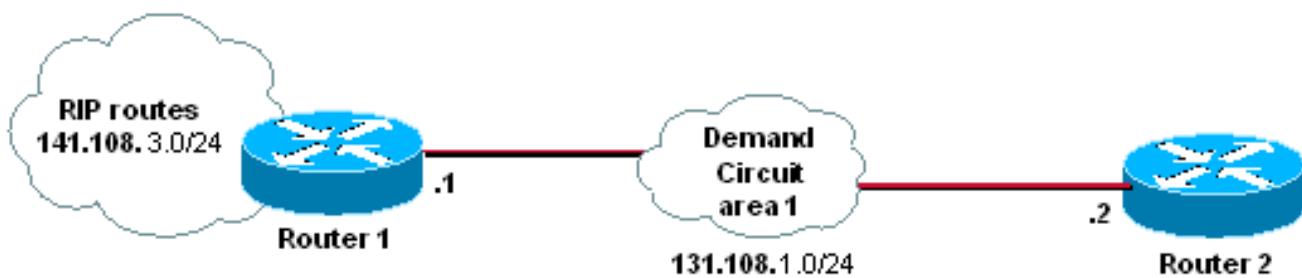
RIP域現在位於141.108.0.0網路之下，而OSPF域（和需求電路鏈路）位於131.108.0.0網路之下。

對RIP或OSPF域使用不同的主網。其思想是在需求電路鏈路上使用不同的主網，因此當鏈路在PPP封裝下啟動時，它會為鏈路的另一端安裝主機路由。如果主機路由與RIP中所使用的主機路由處於不同的主網中，則RIP並不擁有此安裝了PPP的主機路由，因為它沒有主網的network語句。以

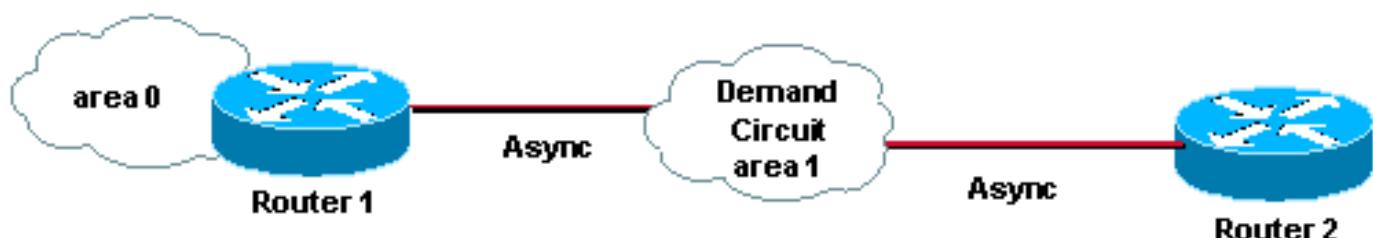
在非同步（非同步）介面上配置需求電路時，當第2層關閉時，實際物理介面將關閉。這將觸發OSPF資料庫發生更改，非同步介面將再次恢復以交換資料庫。第2層再次關閉，這將再次觸發資料庫中的更改，因此此過程不斷重複。

非同步介面上的OSPF預設網路型別為點對點，但需求電路仍會不斷開啟鏈路。

要求電路不斷開啟連結的原因在於，當閒置逾時到期後第2層關閉時，整個介面就會關閉。但是在BRI或PRI的情況下，當其中一個通道關閉時，介面仍保持開啟狀態（處於欺騙模式）。要解決此問題，您必須配置撥號器介面，因為它從不關閉。撥號器介面會一直運作（處於欺騙模式）。

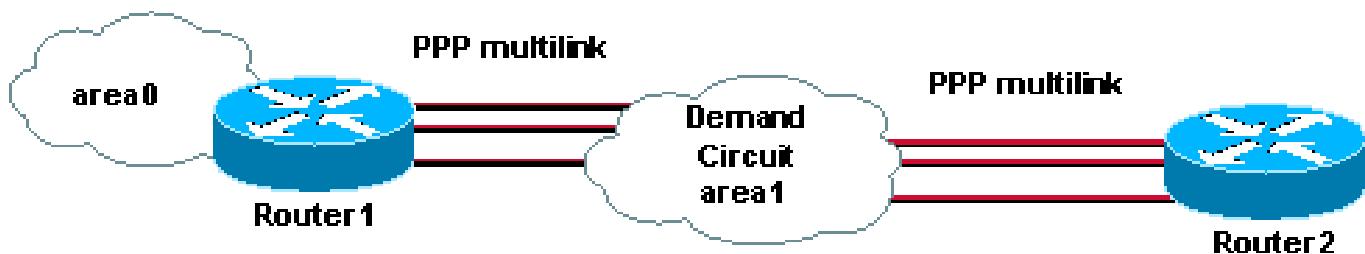
當存在多個WAN鏈路時，可使用多鏈路PPP功能進行負載均衡。在OSPF方面，需要記住的一個重要因素是多鏈路PPP的頻寬。當合併多條鏈路時，多鏈路介面的頻寬將發生變化。

這將觸發SPF計算，並且OSPF將啟動需求電路。如果鏈路不斷擺動，我們可能會看到需求電路不斷擺動，因為每次鏈路增加或從多鏈路PPP捆綁中刪除鏈路時，開銷都會更改。

OSPF支援PPP多鏈路，但只要捆綁中的所有鏈路保持運行，需求電路就會保持穩定。一旦鏈路斷開，即使沒有關聯的IP地址，也會影響OSPF開銷計算，因此，OSPF將運行SPF來重新計算最佳路徑。要解決此問題，唯一的解決方法是使用以下命令手動配置OSPF開銷。

此命令將確保每當多鏈路PPP捆綁包中新增或刪除一條鏈路時，OSPF開銷不會受到影響。這將穩定PPP多鏈路上的OSPF需求電路。
