疑難排解開放最短路徑優先路由資料庫相關問題

本文說明當資料庫中的路由不在路由資訊庫 (RIB) 或路由表中時，如何修復 OSPF 問題。

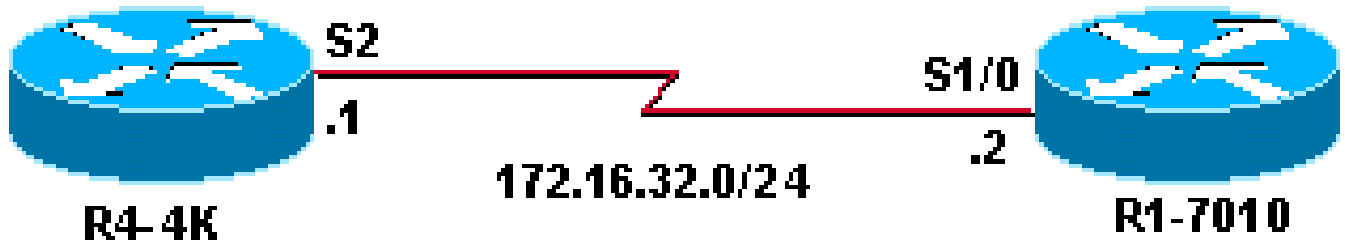
如前面的輸出所示，路由器R4-4K配置為廣播，路由器R1-7010配置為點對點。這種網路型別不相符會導致廣告路由器無法連線。

您可以看到，對於子網172.16.32.0/24，路由器R1-7010生成一條點對點鏈路，路由器R4-4K生成一條傳輸鏈路。這會導致鏈路狀態資料庫中存在不一致，這意味著路由表中未安裝任何路由。

要解決此問題，請將兩台路由器配置為同一網路型別。您可以將路由器R1-7010的網路型別更改為廣播，或者將路由器R4-4K串列介面更改為點對點。

在本示例中，我們刪除了R4-4K上的network-type broadcast語句，因為兩端都是點對點高級資料鏈路控制(HDLC)封裝的介面。

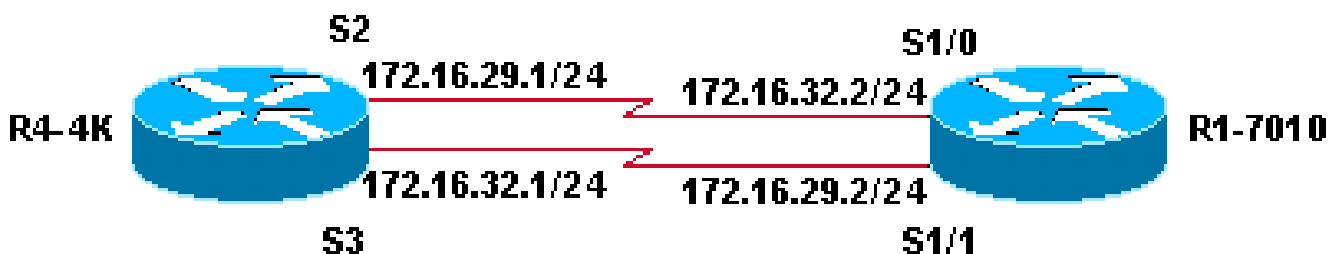
您可以看到，IP地址在以前的配置中發生翻轉，導致OSPF資料庫中存在差異。但是，這些路由器仍然在Cisco IOS版本12.1之前形成鄰居，因為在點對點鏈路上，OSPF路由器不會驗證相鄰路由器是否位於同一子網中。

從上面的輸出中，您可以看到Serial2用於形成IP地址為172.16.32.2的鄰居，該鄰居不在同一個子網中。雖然形成了鄰居，但路由表中未安裝任何路由：

要解決此問題，請正確分配IP地址或交換串列電纜。我們已更正以下IP地址：

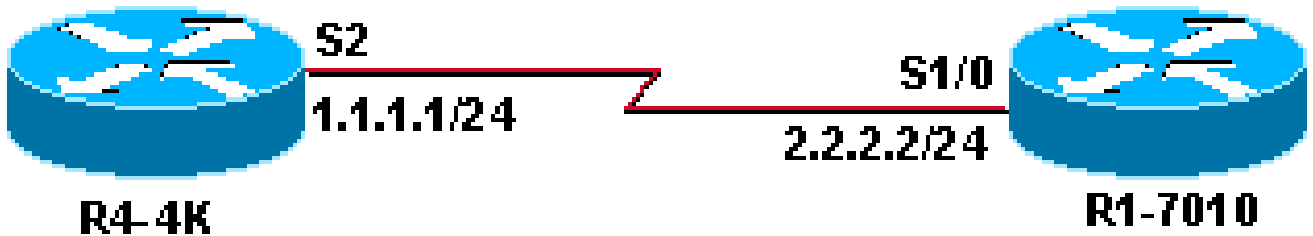
這種情況產生的行為與雙串列鏈路設定中的[錯誤地址分配完全相同](#)。要解決此問題，請在兩台路由器上分配同一子網中的IP地址。

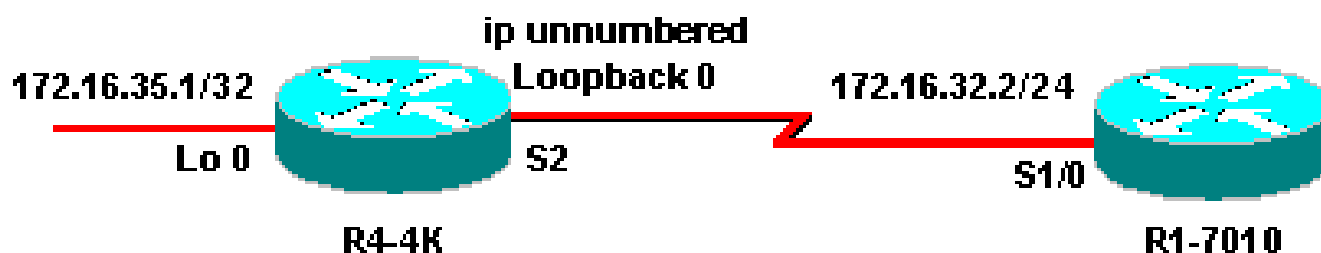
正如前面所看到的，這兩種情況中的network-type都是點對點的。問題是一端未編號，而另一端未編號，這樣會在資料庫中產生差異，如下所示。

您可以看到，R1-7010使用包含其介面地址的Link Data欄位為此點對點鏈路生成LSA，而R4-4K使用包含MIB-II IfIndex值的Link Data欄位為同一鏈路生成LSA([RFC 2328](#))。這會導致鏈路狀態資料庫中存在不一致，這意味著路由表中未安裝任何路由。

要解決此問題，請將兩台路由器的串列介面配置為已編號或未編號。在本例中，我們對路由器R4-4K的串列2介面進行了編號。

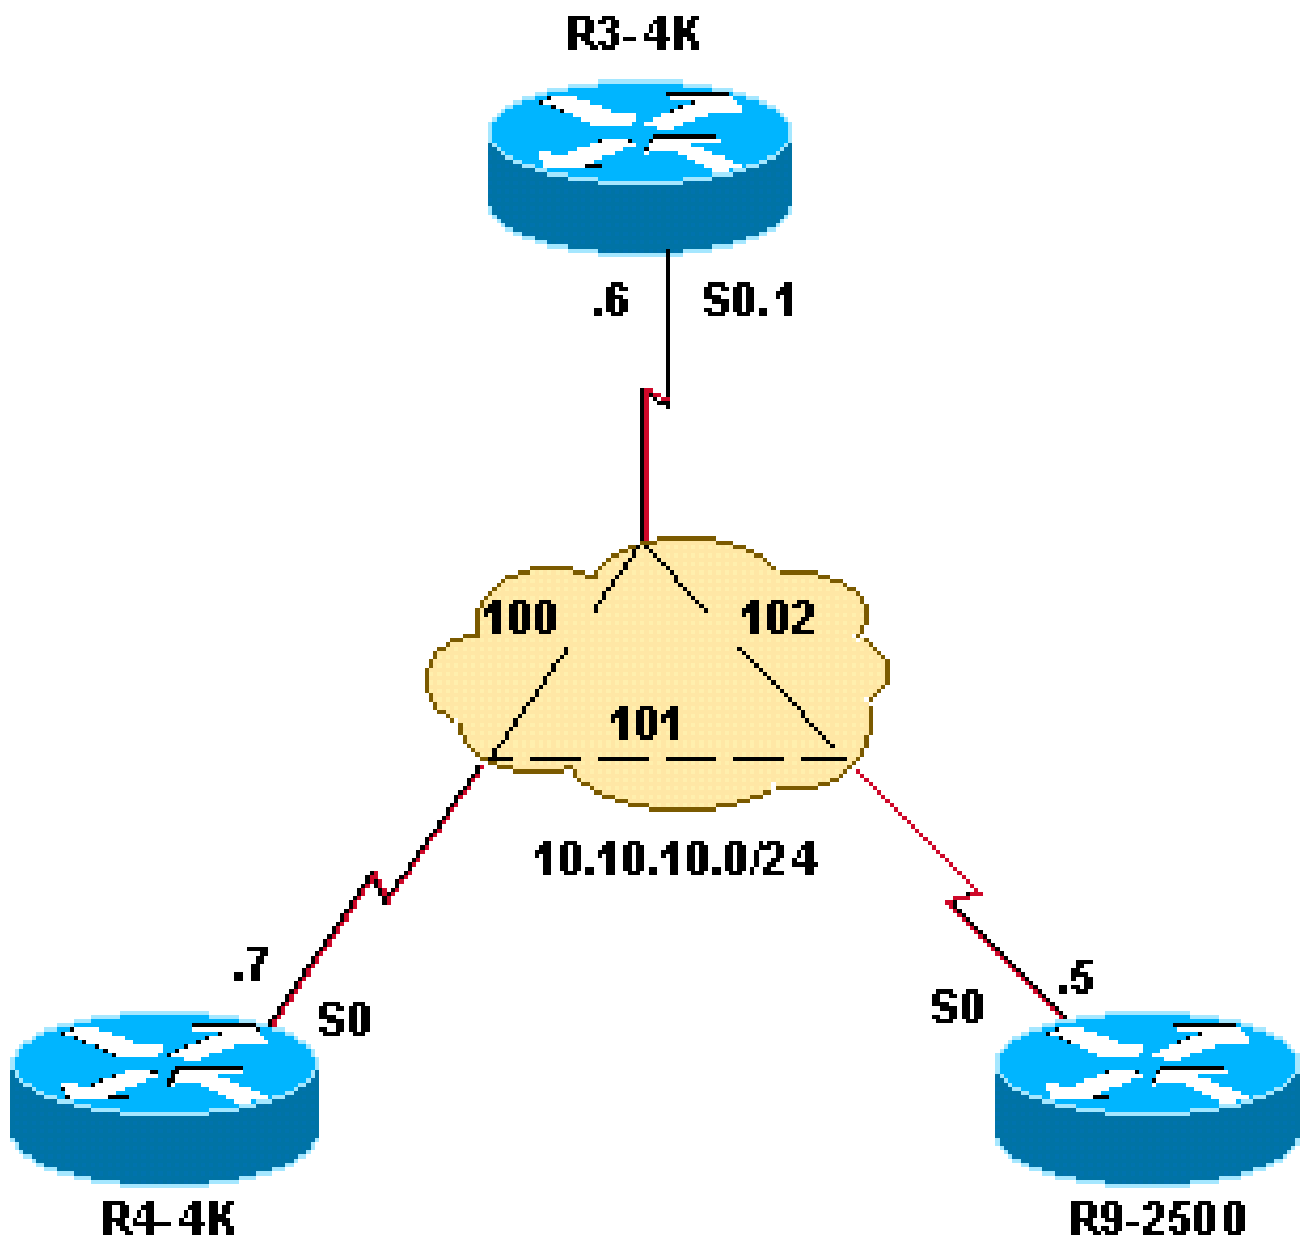
只要幀中繼網雲是全網狀的，幀中繼上的廣播模型就可以正常工作。如果任何永久虛擬電路(PVC)損壞，它可能會在OSPF資料庫中出現問題，從而產生Adv路由器無法訪問消息。

在本示例中，R9-2500和R4-4K之間的PVC斷開，通往指定路由器(DR)的R9-2500鏈路斷開。因此，R9-2500宣告來自R3-4K (不是DR) 的所有LSA不可達。您可以看到，R9-2500不會為連線到R3-4K的串列介面生成傳輸鏈路；而是生成末節鏈路，因為對於R9-2500而言，此鏈路上沒有DR。

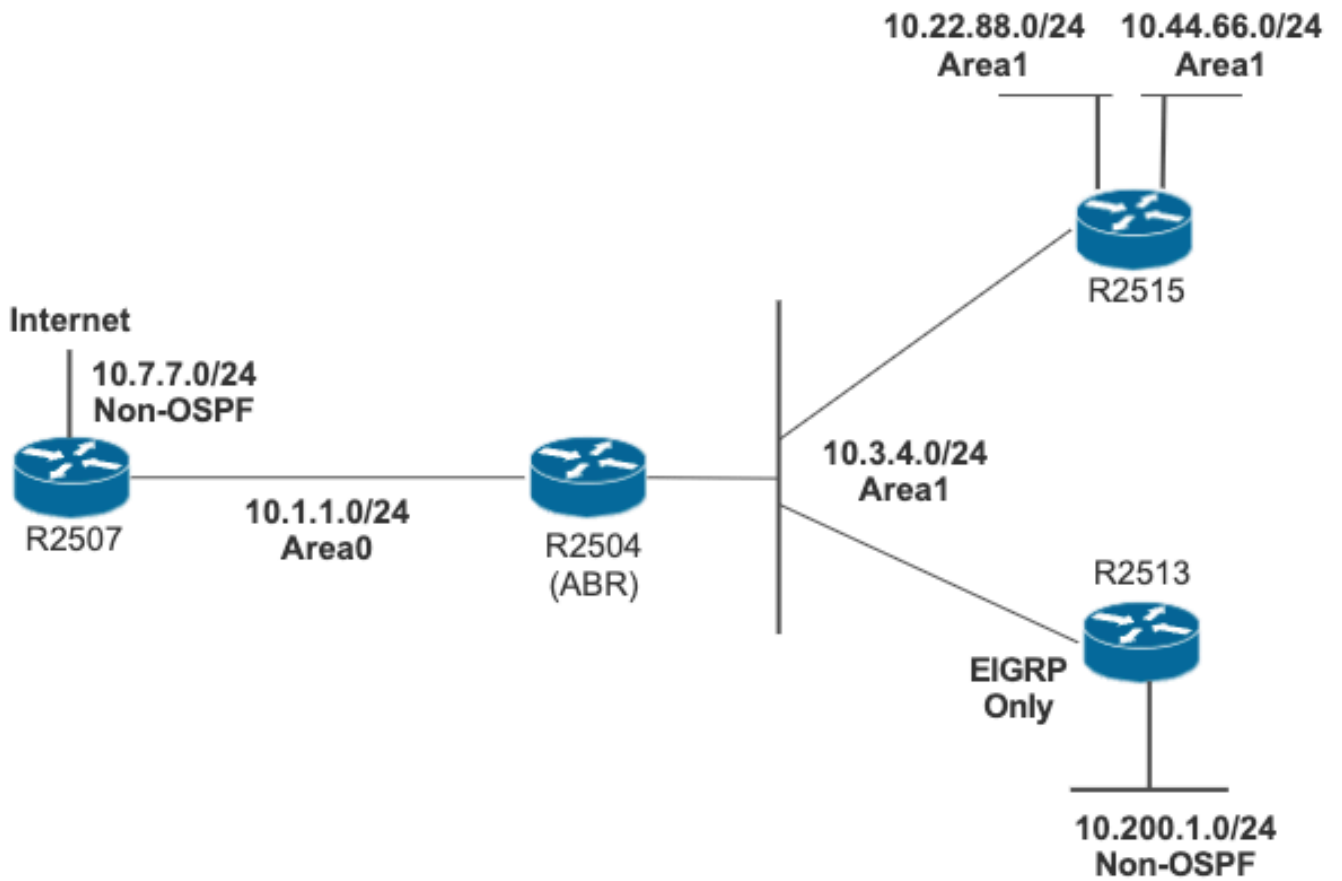
R2507的資料庫中包含10.200.1.0/24，但它尚未將其安裝在路由表中，因為通過OSPF外部路由獲知10.3.4.4。

注意：在此案例中，通過外部路由獲知轉發地址的原因在於下一個警告。在修復「Cisco bug ID [CSCdp72526](#)」(僅限註冊客戶) 後，OSPF不會生成重疊外部網路的5類鏈路狀態通告 (LSA)；因此，R2507僅顯示10.0.0.0/8的區域間總結路由。然後，R2507會安裝帶有轉發地址的10.200.1.0/24，並且可以通過區域間路由10.0.0.0/8到達，因此符合RFC 2328。

如果轉發地址也通過外部路由得知，OSPF不會將該路由安裝到路由表中。有關此問題的更多詳細資訊，請參閱[OSPF轉發地址的常見路由問題](#)。

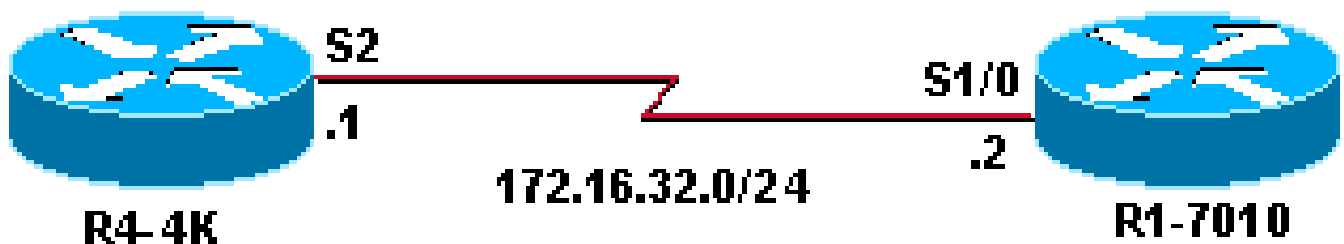
如前所述，R1-7010配置了distribute-list命令，它僅允許在路由表中安裝172.16.32.0/24地址範圍。在鏈路狀態協定中，您實際上無法使用distribute-list命令篩選LSA。LSA仍存在於資料庫中；但是LSA未安裝在路由表中。

R1-7010上的distribute-list配置命令過濾172.16.33.1/32網路並阻止將子網安裝到路由表中。

要解決此問題，請在訪問控制清單(ACL)中配置R1-7010並允許172.16.33.0/24，以便將此網路安裝到路由表中。
