Screw Replacement Procedure of Itron RIVA CAM Module on IR8140 Router

Revised: August 29, 2023,

The procedure provided in this document is to establish the alternate procedure for replacing the alignment pin and lock washer with screw in Cisco IR8140 router.

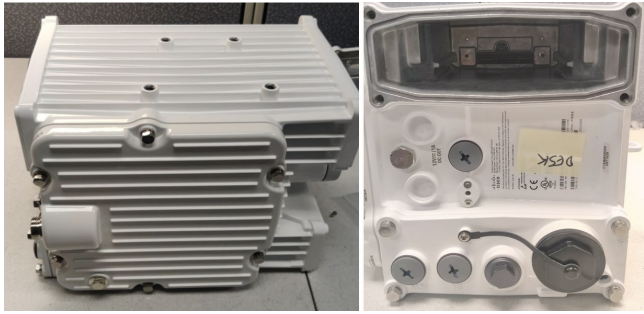
Step No.	Step Description	Failure Mode	Remarks
1	Place the IR8140 in the fixture. (In horizontal orientation)

—	—
2	Use 3/16 socket driver as shown to remove the alignment pin and washer. The washer is intended to come off with the alignment pin.
