Cisco RF Gateway 1 Software Release Notes, Release 2.01.09

Software Release 2.01.09 includes DVB Simulcrypt Scrambling capability for the RF Gateway 1 platform. It will support license upgradeable encryption and data features. A user authentication feature is also available for security of the RF Gateway 1 management interface and platform access.

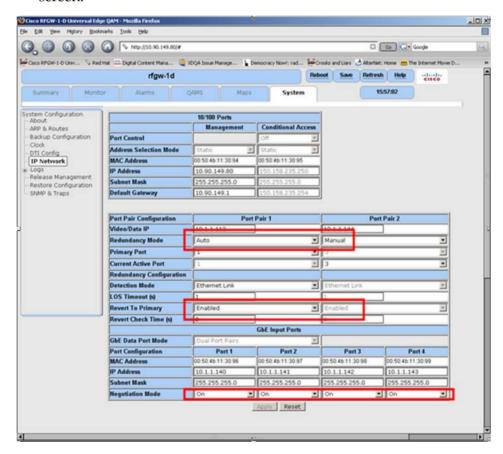
- 1 Launch your web browser.
- 2 In the IP Address field, enter the RF Gateway 1 IP address.
- 3 Click Enter.
- 4 Click the *System/IP Network* tab and review the IP settings. Refer to the following screen.
