TelePresence MCU Hardware Troubleshoot Guide

This document describes the procedures used in order to troubleshoot Cisco TelePresence Multipoint Control Unit (MCU) products. The document is written for Video System Administrators and for Cisco Partners whose customers are Video System Administrators.

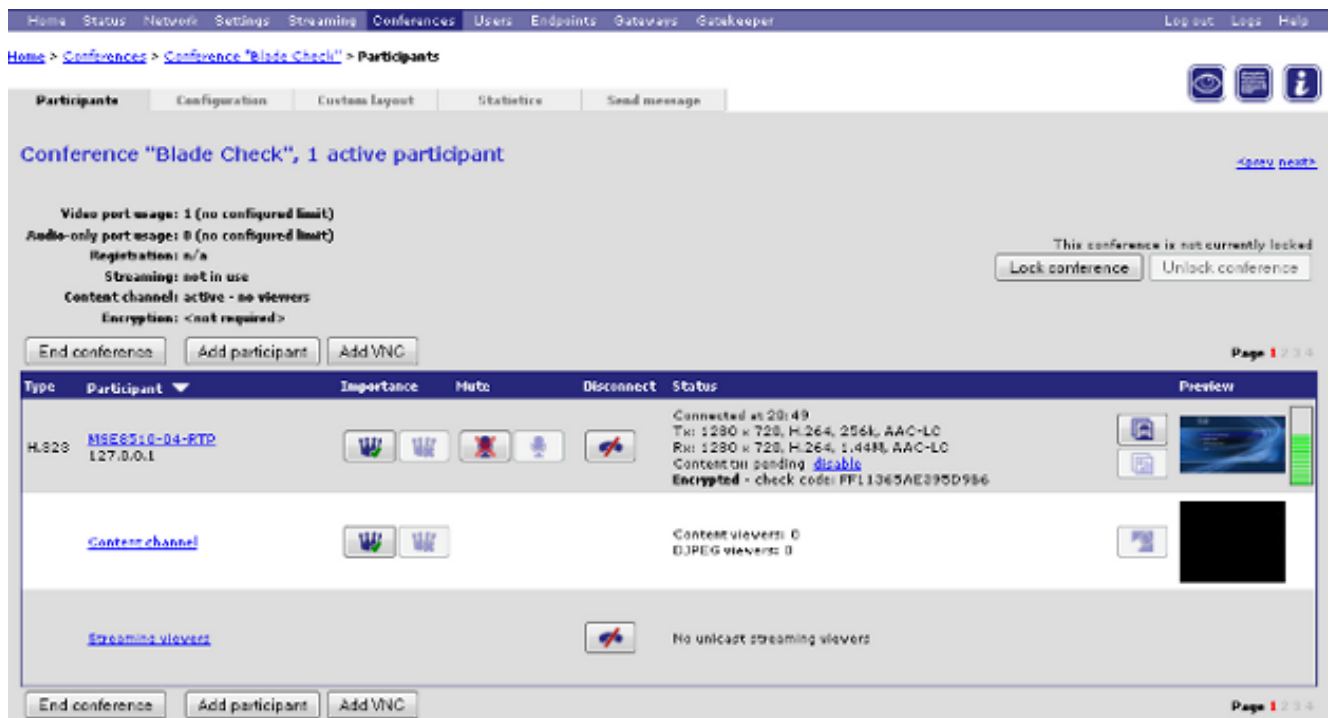
Here is an example of the MCU MSE 8510 screen when the MCU can successfully call itself:

Create a new conference, and add an H.323 participant with an IP address of **127.0.0.1**. This causes the MCU to dial back to its own Auto Attendant (AA). The AA screen displays in the preview thumbnail, and both audio and video codecs are negotiated in each direction.

If this works, and a connected participant is seen (similar to the previous image), most likely there is a gatekeeper, network, or endpoint interoperability problem. Dial a real endpoint, and troubleshoot from there with the event log and H323/Session Initiation Protocol (SIP) log. If the connection fails immediately, but the web interface still works, continue with this procedure.

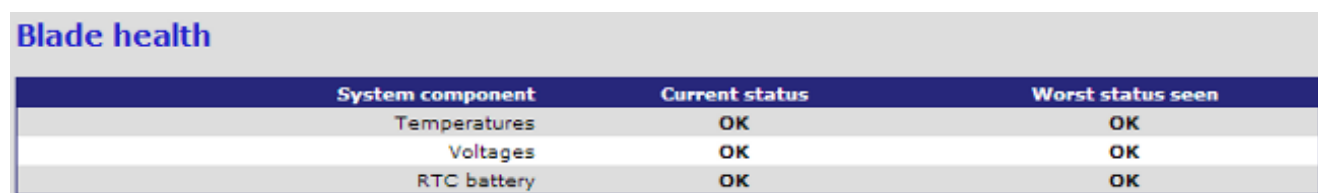
This image shows the **Blade health** section:

System component	Current status	Worst status seen
Temperatures	OK	OK
Voltages	OK	OK
RTC battery	OK	OK

2. If any Voltage status (current or worse) does not appear **OK**, then ensure that enough rectifiers are installed in the power shelves that power the chassis. Also, check that the power source meets the current requirements of the chassis, as detailed in the [Calculating power and current requirements for an MSE 8000](#) Cisco article.
3. If the Power Supply provision does not show **OK**, contact Cisco Technical Support.

4. If any of the other Current statuses in the **Blade health** section do not show as **OK**, contact Cisco Technical Support.
5. If all of the Current statuses show **OK**, but one or more of the **Worst status seen** does not show **OK**, obtain the event log and alarm logs from the Supervisor, and contact Cisco Technical Support.
6. Check the uptime. If the uptime is unexpectedly short (less than 30 minutes), and there is no known reason (if it was not power-cycled or the blade has not reseated, for example), then the blade might have recently rebooted. The cause of the reboot might be a software defect or a hardware problem. This depends on whether it is a one-time reboot, or cyclical.

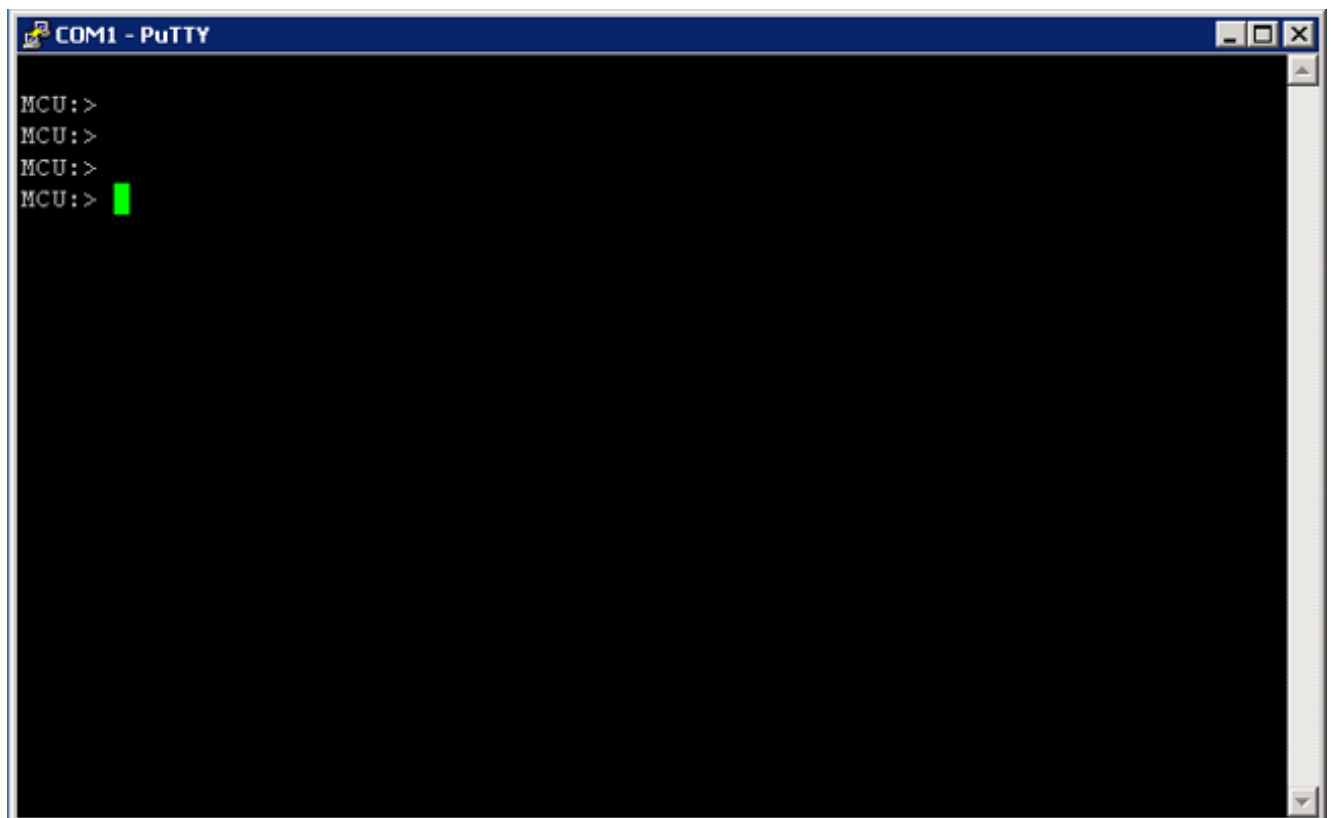
3. In order to verify that the terminal session connected is actually connected, press the **Enter** key a few times and the prompt appears. The prompt that displays shows your device (IPGW:>, ISDNGW:>, or **MCU:>**, for example):

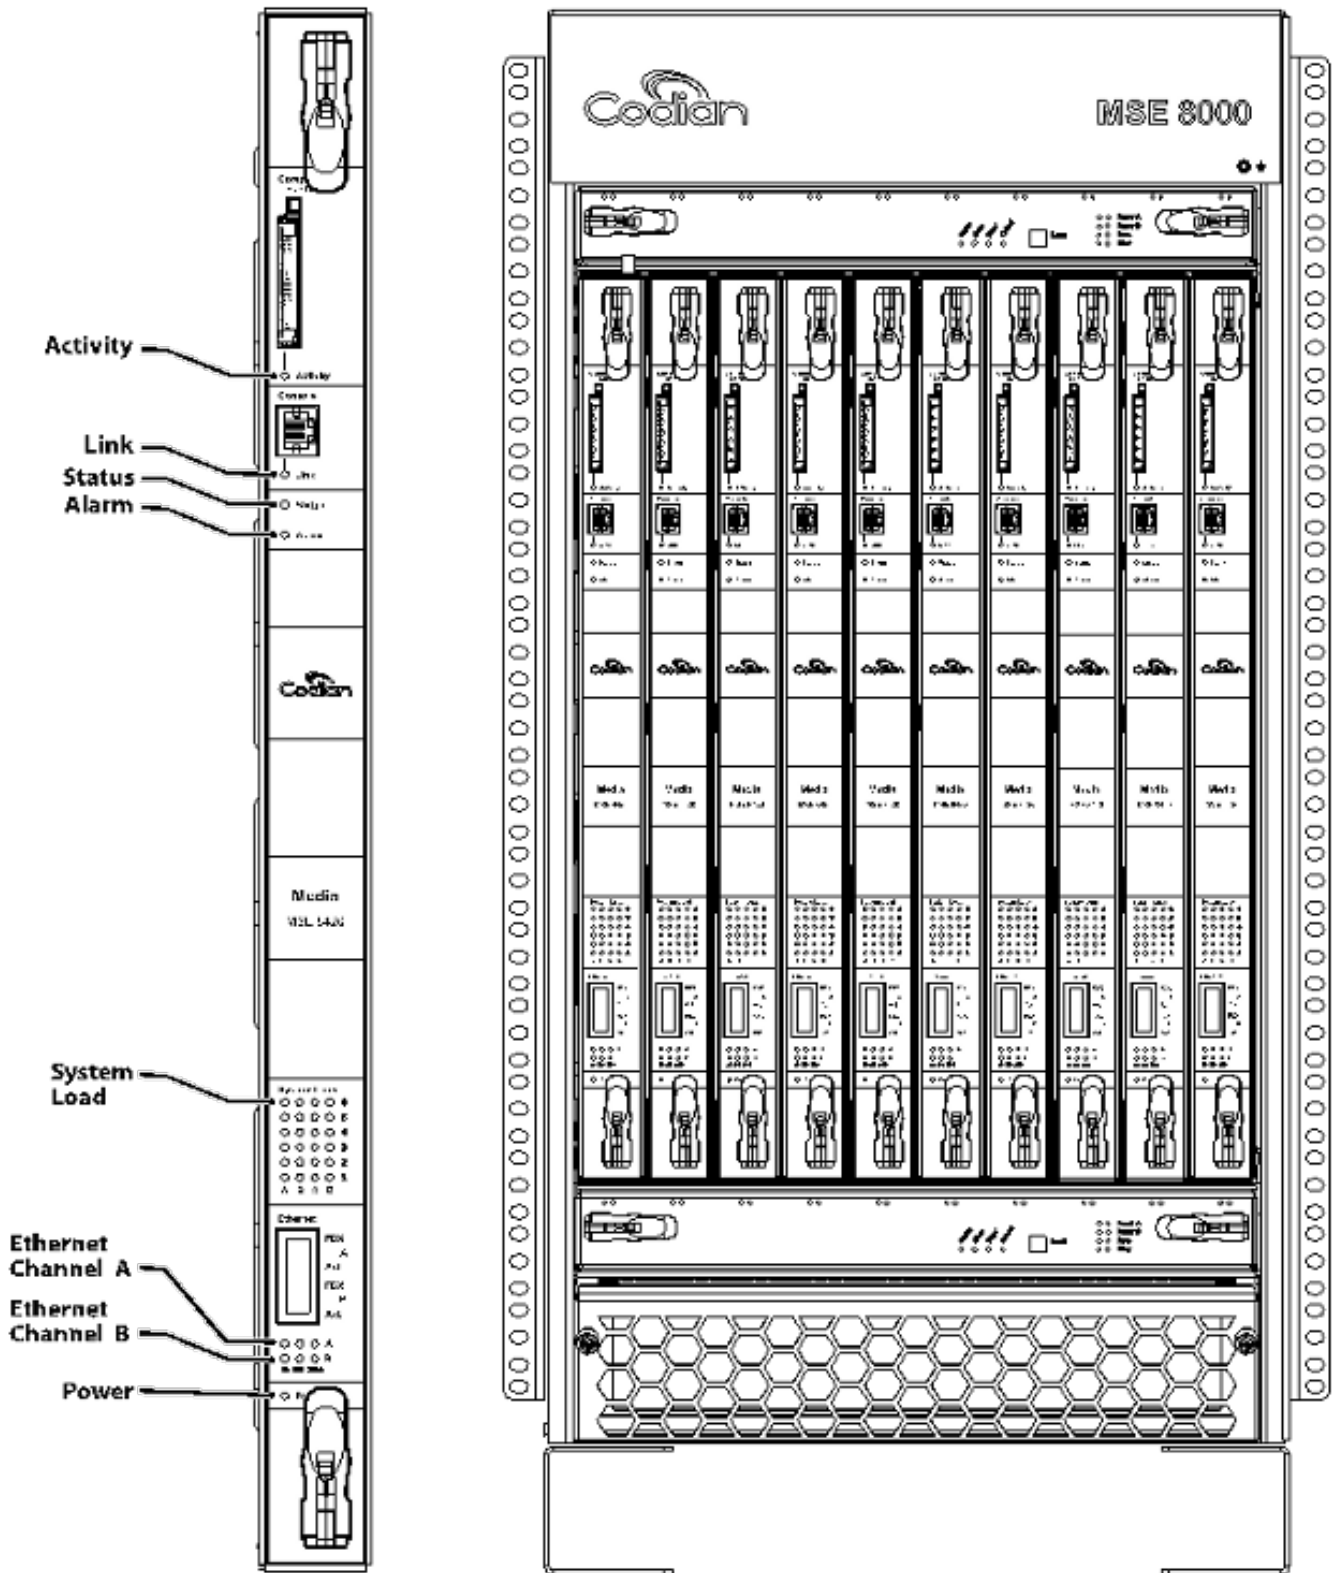
Here is an image that shows the full MSE 8000 Series chassis:

Note in the previous image:

- The upper and lower fan trays
- The inserted blades
- The close-up of an individual blade
- The rack mounts

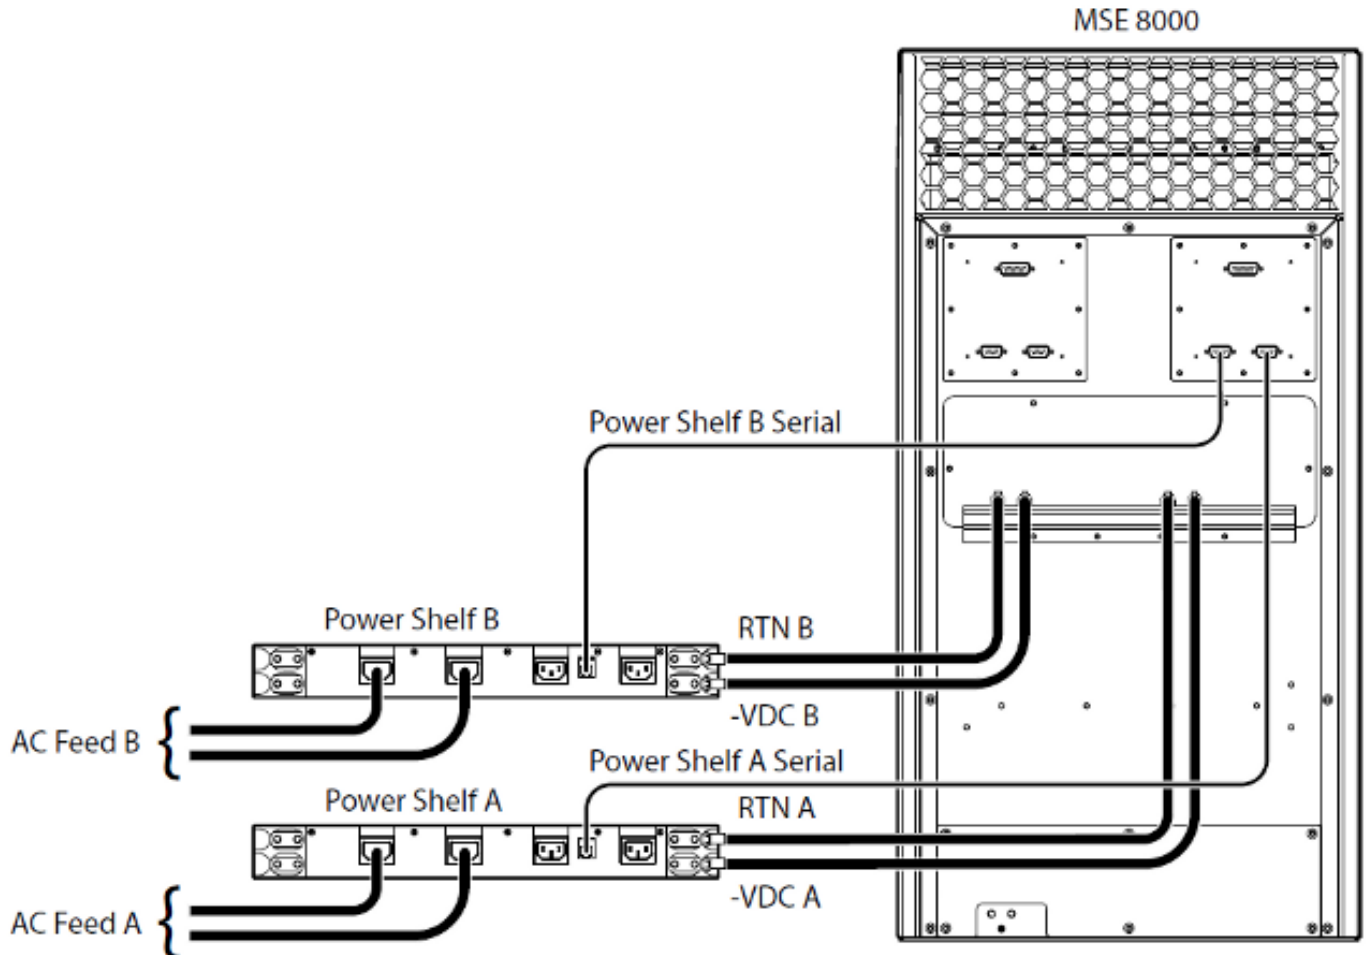
This image shows the MSE 8000 Series DC power shelf:

Within the MSE 8000 Series chassis, there are two independent DC power inputs that you can either connect directly to two DC power supplies, or to two Valere shelves that convert AC to DC. The MSE 8000 Series chassis can be operated with one or two power shelves - A and B. These feed power independently to every fan tray and blade. The unit can be fully-powered from either supply A or supply B. In the event that either of the power supplies fail, the unit continues to

- **Lost Contact with Power Shelf** - When you navigate to **Hardware > Power Supplies**, **Supply A** shows **Lost Contact with Power Shelf**. This means that the Supervisor MSE 8050 Series is unable to communicate with the power shelf.
- **10/External supply out of range SET** - This means that the input voltages to the chassis are out of specification. Verify that the correct power and current is provided to the chassis via the [Calculating power and current requirements for an MSE 8000](#) online tool.

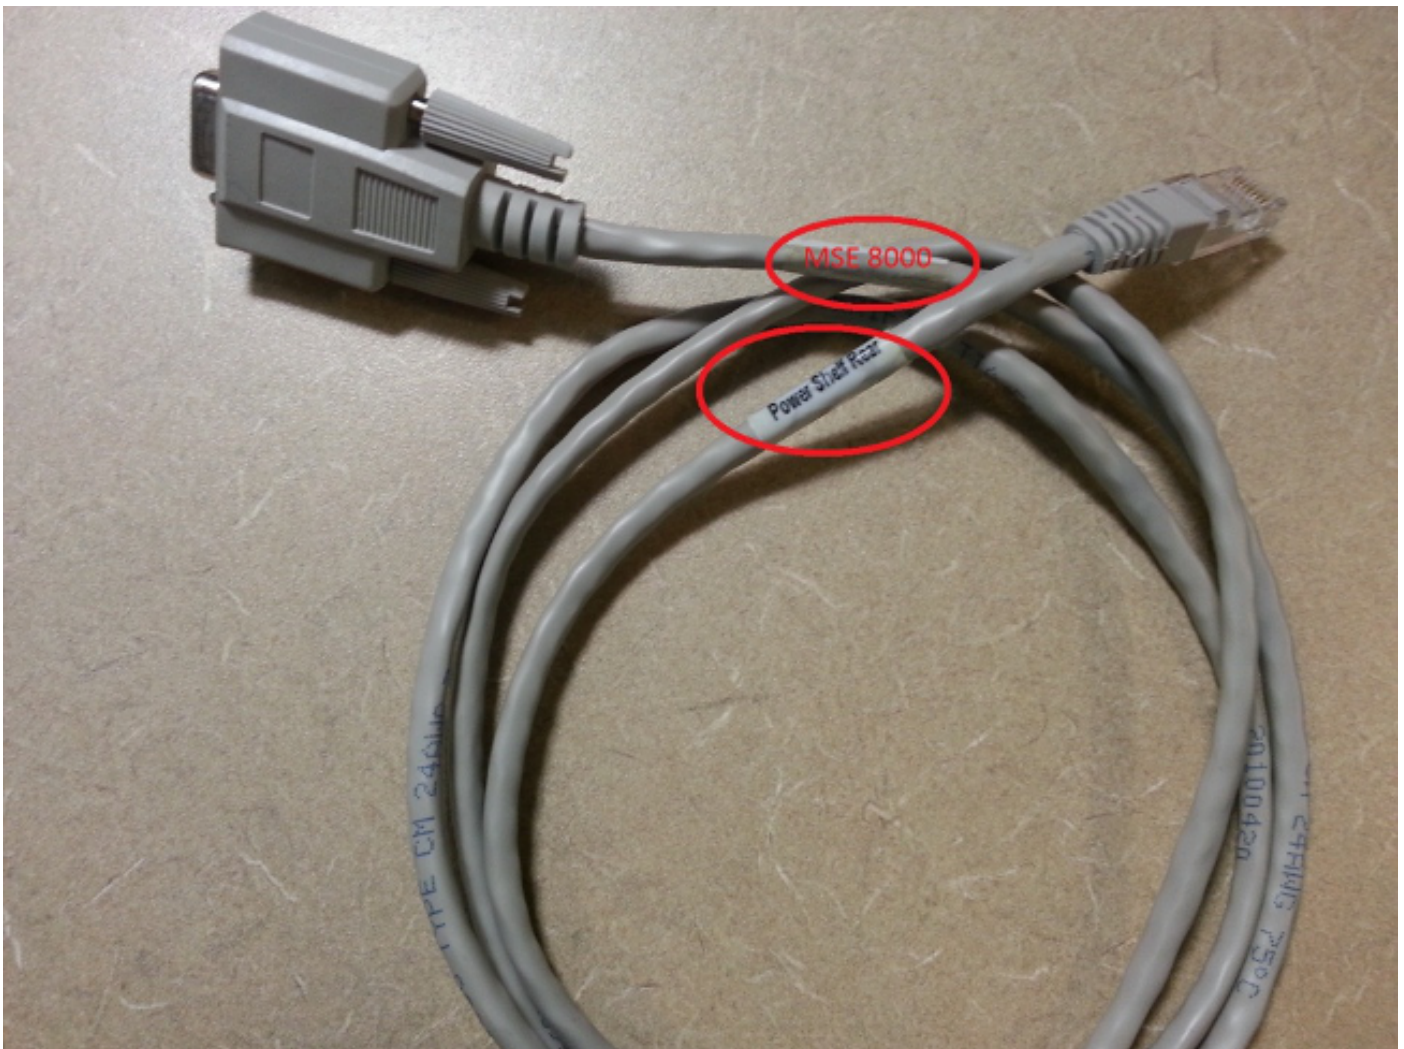
Check the power shelf monitoring cable that runs from the back of the power shelf to the chassis. This is a special cable that is used for power shelf monitoring. Take care when you check the cable, as it can be easily confused with a regular DB9-RJ45 console cable. The power shelf monitoring cable is labelled with a sticker that says **Power Shelf Rear**:

There are two pairs of connectors located at the back of the MSE 8000 Series chassis: the pair on the left is labelled **Slot 10**, and the pair on the right is labelled **Slot 1**. Ensure that the monitoring cables are connected to **Slot 1**, which are the connectors that represent the MSE 8050 Series Supervisor slot.

1. Swap the power shelf monitoring cable from **Shelf A** to **Shelf B** in order to determine if the issue follows the cable. If the problem follows the cable, contact Cisco Technical Support.
2. Swap the NIC cards around from **Power Shelf A** and **Power Shelf B** in order to determine if the NIC cards are the cause of the issue. If the alarms return, and the issue follows the NIC card, contact Cisco Technical Support.
