DSP on NM-HDV2 Functionality Verification for 2600XM/2691/2800/3700/3800 Platforms

This document discusses techniques used to verify the basic functionality of the digital signal processors (DSPs) on the NM-HDV2 IP Communications High-Density Digital Voice or Fax Network Modules for the Cisco 2600XM/2691/2800/3700/3800 router platforms. The DSPs are necessary for packet Telephony technologies such as Voice over IP (VoIP), Voice over Frame-Relay (VoFR), and Voice over ATM (VoATM). The DSPs are responsible for the conversion of voice from analog to digital forms and the other way around, to set the signal gain and attenuation parameters, for the operation of Voice Activity Detection (VAD), and more. Proper hardware and software operation of the DSPs is necessary to ensure that calls are established and maintained correctly.

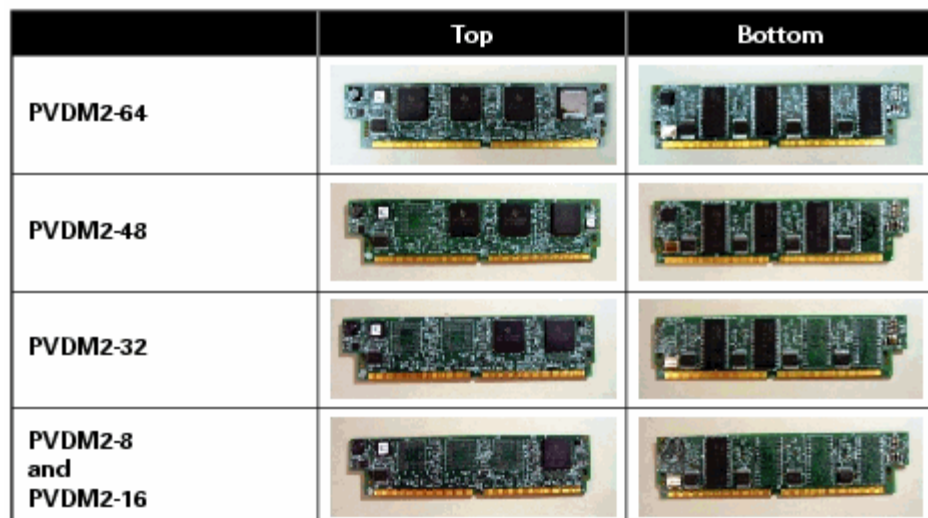
PVDM2 Top and Bottom Views

The NM-HDV2 has four SIMM sockets (called Banks) that hold the PVDM2 DSP cards. Each Bank has an LED on the front face of the NM-HDV2. When a PVDM2 card is installed in the SIMM, the LED shines solid green.
