MSTP System APC-OUT-OF-RANGE Alarm Troubleshoot

Document ID: 117630

Contributed by Sunil Poonia, Cisco TAC Engineer.
Apr 21, 2014

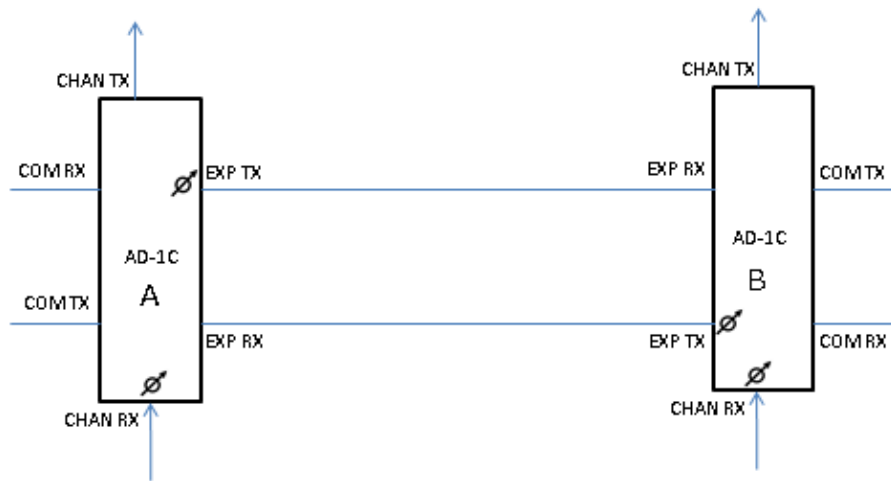
In the block diagram of the AD card, you can see that there is a VOA on EXP TX. If you look into the ANS parameter, there are set points for COM-RX and COM-TX ports. It is important to understand why it is like that.

From the diagram, you can understand that you have VOAs on EXP-TX and CHAN-RX ports, and the same applies to all other types of cards. In the ANS parameter, you have a set point of COM-RX and COM-TX.

The set point is achieved when you set the VOA or GAIN. In this case, it is VOA. So the set point of the COM TX of card **B** as shown in the diagram can be achieved if you regulate the VOA of the EXP-TX port of card **A** and the VOA of the CHAN RX port of card **B**.

The set point of COM RX is achieved by the GAIN of a connected amplifier. If there is no amplifier connected, then it is the amplifier of a neighboring node.

Therefore, if there is an APC-OUT-OF-RANGE alarm on the EXP-TX port, then it means the VOA of the EXP-TX is not able to regulate itself to achieve the COM-TX set point of the next card. It can be because of an increase/decrease in the optical power levels at the COM-RX port or because the appropriate optical power levels at the CHAN-RX of card B that is shown in the diagram.
