Fibre Channel Traffic Issues with MXP-MR-10DME-C Linecards

Document ID: 117543

Contributed by Sunil Poonia, Cisco TAC Engineer.

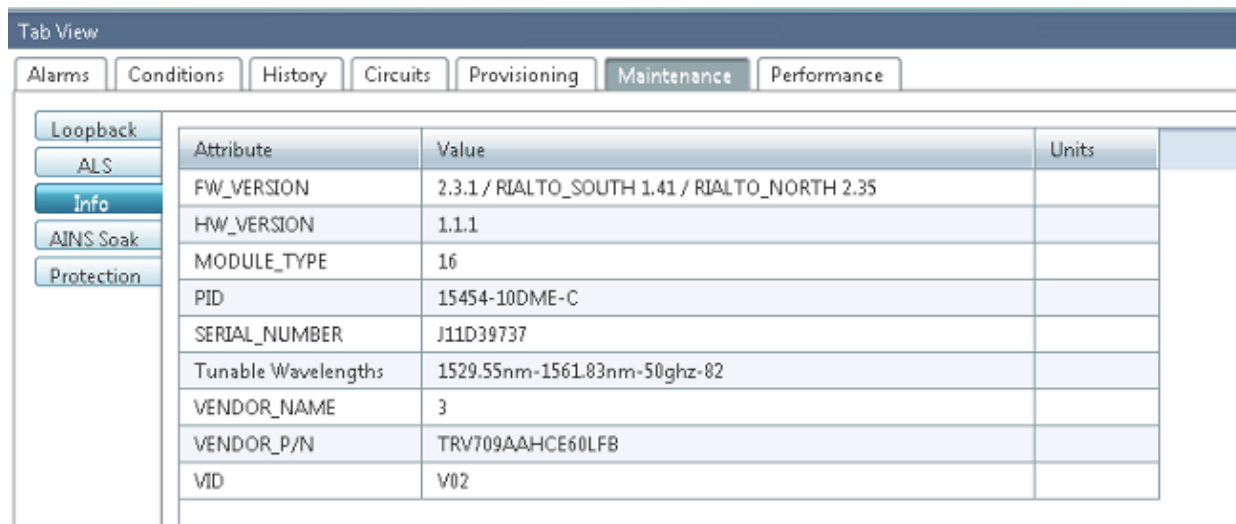
Attribute	Value	Units
FW_VERSION	2.3.1 / RIALTO_SOUTH 1.41 / RIALTO_NORTH 2.35	
HW_VERSION	1.1.1	
MODULE_TYPE	16	
PID	15454-10DME-C	
SERIAL_NUMBER	J11D39737	
Tunable Wavelengths	1529.55nm-1561.83nm-50ghz-82	
VENDOR_NAME	3	
VENDOR_P/N	TRV709AAHCE60LFB	
VID	V02

FPGA information can be obtained from CTC. In order to obtain this information while in Card view, click **Maintenance** and then **Info**. Under the **Info** tab, the **FW_VERSION** (Firmware Version) contains information about both FPGA versions. Ports **1** to **4** and ports **5** to **8** are configurable for 1-G FC or 4-G FC traffic.

There are two FPGAs on each MXP-MR-10DME-C linecard:

- **RIALTO_NORTH** for ports **1** to **4**.
- **RIALTO_SOUTH** for ports **5** to **8**.
