How Async Lines are Numbered in Cisco 3600 Series Routers

Document ID: 14947

This document discusses how async lines are numbered in Cisco 3600 Series Routers.

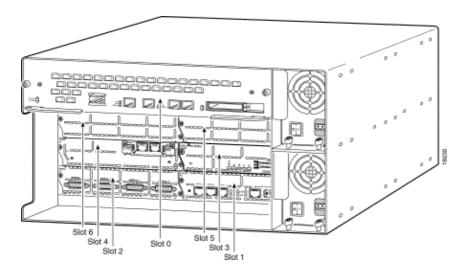
Cisco 3660

Async lines are not numbered in a linear fashion on the Cisco 3600 platform. Due to the modular design of these routers, there are fixed line ranges for each slot and each slot is allocated 32 line numbers. This means that the configuration does not change when you add or remove async lines from other slots. The following table shows the reserved line numbering per slot on Cisco 3600 router platforms.

Slot	Platform	Reserved line numbering
0	3620/3640	1 = 32

Modules with async ports have different densities (for example, 4, 16, 24, and so on). It is possible to have a combination of network modules with several line ranges that have gaps in their numbering. If the same functionality is desired for all async lines, you have to replicate the configuration in all line ranges. Be careful when using line range commands such as the **group–range** command under Group–Async interfaces. This command does not allow discontiguous range configuration; therefore, you need separate Group–Async interfaces so that each of them references a separate line range.
