# Upgrade Infrastructure and Server Firmware in Intersight Managed Mode

This document describes the process to perform firmware upgrades in all the fabric components in a Cisco UCS Domain. This includes the two Fabric Interconnects (FIs), I/O modules (IOM), and blade servers through Intersight Managed Mode (IMM).

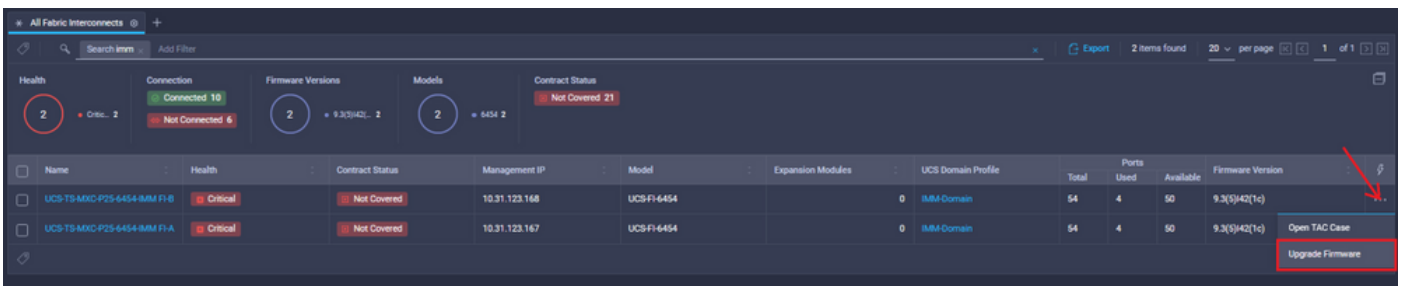
In order to start with the infrastructure firmware upgrade, you can choose any of the two FIs and click **Upgrade firmware**.

Name	Health	Contract Status	Management IP	Model	Expansion Modules	UCS Domain Profile	Total	Ports Used	Available	Firmware Version	
UCS-TS-MXC-P23-6454-BM-FI-B	Critical	Not Covered	10.31.123.168	UCS-FI-6454		0	54	4	50	9.3(5)42(1c)	Open TAC Case Upgrade Firmware
UCS-TS-MXC-P23-6454-BM-FI-A	Critical	Not Covered	10.31.123.167	UCS-FI-6454		0	54	4	50	9.3(5)42(1c)

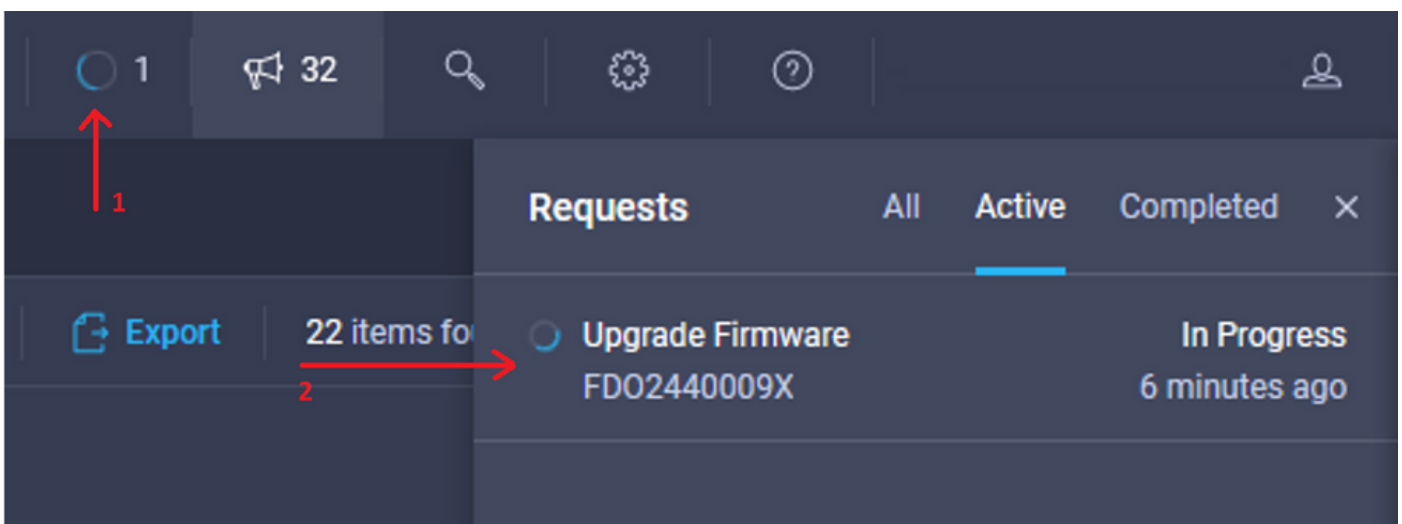
In order to monitor the upgrade, navigate to **Requests** and click **Active**. Click the activity's name to see the complete workflow tasks.

Workflow tasks are as follows:

- Download intersight FI bundle from Intersight software repository
- Upgrade IOMs
- Evacuate data traffic on FI B
- Activate FI B
- Wait for User Ack : for FI reboot
- Wait for activate to complete
- Evacuate data traffic on the FI A
- Activate FI A
- Wait for User Ack : for FI reboot
- Wait for activate to complete

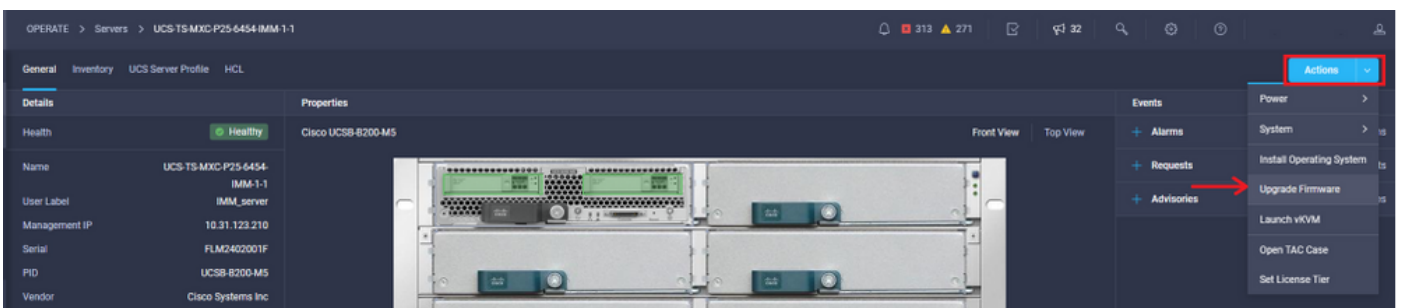
Choose the server you want to upgrade and from the **Actions** drop-down list, choose **Upgrade Firmware**.

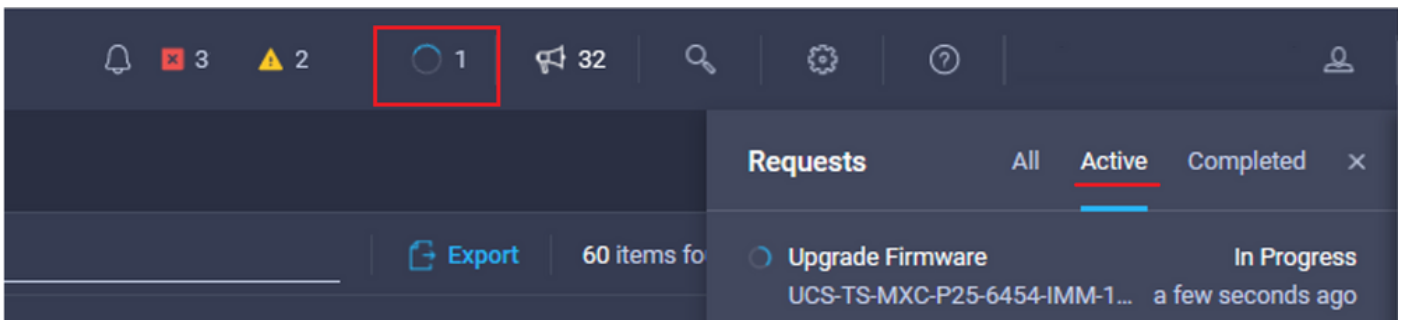
In order to monitor the upgrade, navigate to **Requests** and click **Active**.

The screenshot shows the top navigation bar with a notification icon (3), a warning icon (2), a request icon (1, highlighted with a red box), a megaphone icon (32), a search icon, a settings icon, a help icon, and a user profile icon. Below the navigation bar, the 'Requests' section is visible with tabs for 'All', 'Active' (selected), and 'Completed'. An 'Export' button is present, and a table shows 60 items for 'Upgrade Firmware' in progress, with the last entry 'UCS-TS-MXC-P25-6454-IMM-1...' updated 'a few seconds ago'.

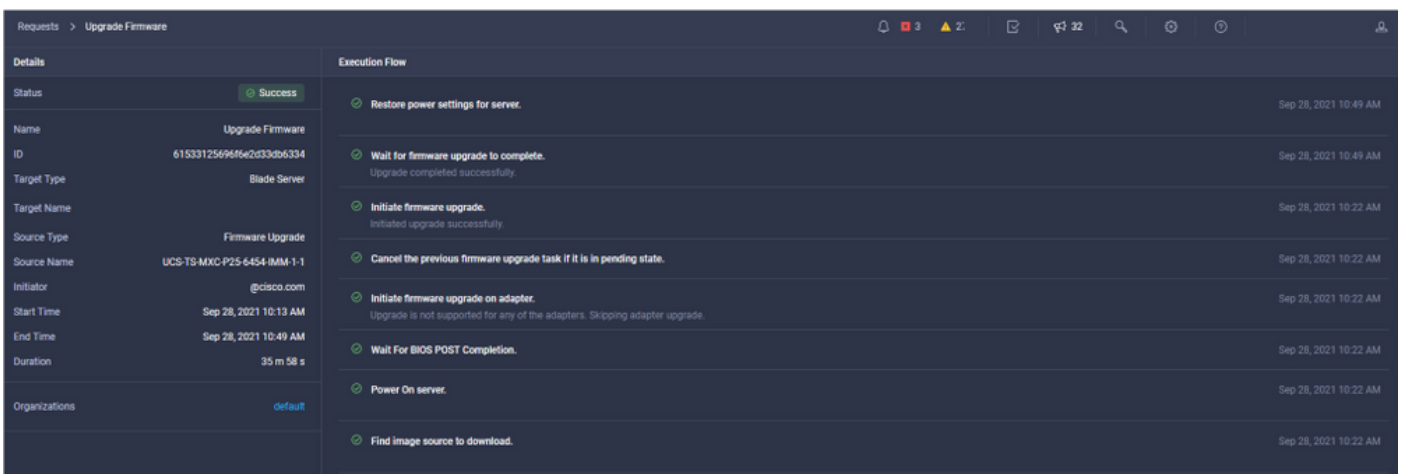
Click the activity's name to see the complete workflow tasks.

The screenshot shows the 'Upgrade Firmware' activity details page. The left sidebar contains 'Details' for the activity, including Status (Success), Name (Upgrade Firmware), ID (615331256966e2d330d6334), Target Type (Blade Server), Target Name, Source Type (Firmware Upgrade), Source Name (UCS-TS-MXC-P25-6454-IMM-1-1), Initiator (@cisco.com), Start Time (Sep 28, 2021 10:13 AM), End Time (Sep 28, 2021 10:49 AM), Duration (35 m 58 s), and Organizations (default). The main area shows the 'Execution Flow' with a list of tasks:

- Restore power settings for server. (Sep 28, 2021 10:49 AM)
- Wait for firmware upgrade to complete. (Sep 28, 2021 10:49 AM)  
Upgrade completed successfully.
- Initiate firmware upgrade. (Sep 28, 2021 10:22 AM)  
Initiated upgrade successfully.
- Cancel the previous firmware upgrade task if it is in pending state. (Sep 28, 2021 10:22 AM)
- Initiate firmware upgrade on adapter. (Sep 28, 2021 10:22 AM)  
Upgrade is not supported for any of the adapters. Skipping adapter upgrade.
- Wait For BIOS POST Completion. (Sep 28, 2021 10:22 AM)
- Power On server. (Sep 28, 2021 10:22 AM)
- Find image source to download. (Sep 28, 2021 10:22 AM)

The workflow tasks are as follows:

- Download Intersight server bundle from Intersight software repository
- Upgrade the adapters (for blade)
- Upgrade the server
- Wait for the server to reboot
- Wait for the completion of the upgrade
