Troubleshoot SVL on Catalyst 9000 Switches

This document describes how to identify, collect useful logs, and solve problems that occur with StackWise-virtual (SVL) on Catalyst 9000 switches.

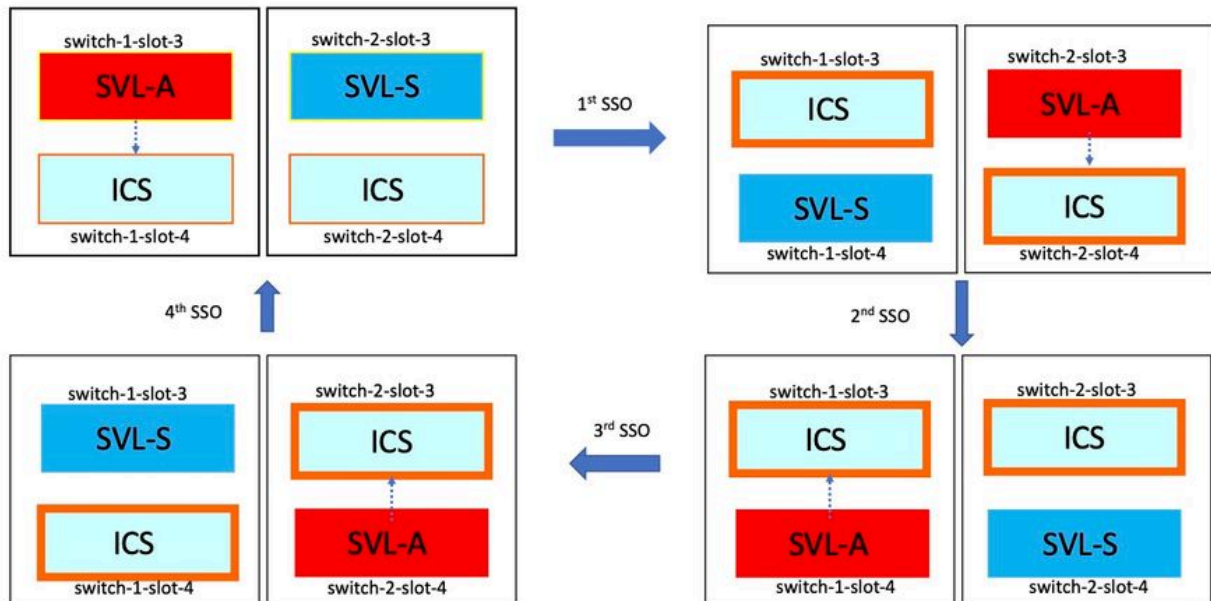
RPR Quad Sup - Z switchover

Quad SUP with all the four SUP populated in a system failure of Active SUP tracks a Z model for transition to New Active Supposition.

This image depicts the New Active SUP transition on the failure of the current Active SUP.

Use CLI mentioned as part of Section 9 to check for the current SUP status and health of each sup at any point of Switchover. In addition **show redundancy** CLI can be used to track the Global Active / Standby redundancy transition details along with the history of switchover.

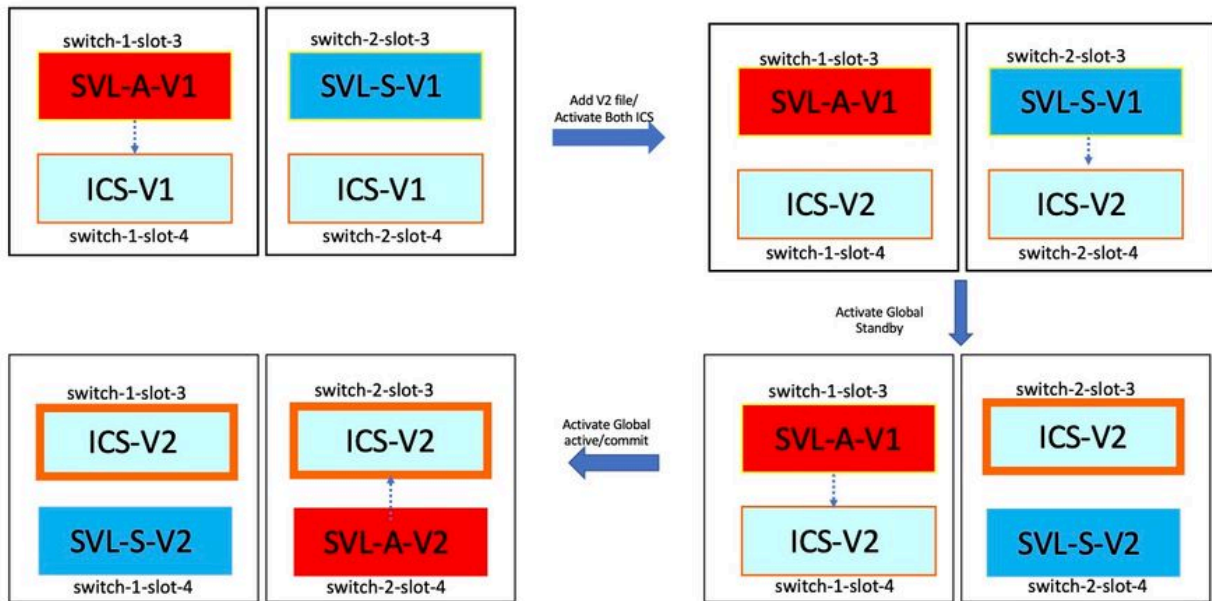
RPR Quad Sup – One Shot ISSU

Quad SUP with all the four Sup populated in a system, ISSU to new V2 image tracks a minimal data path impact model.

One shot ISSU progression is captured in this image which starts with:

1. Copy the new V2 image to all 4 SUP and activate both the ICS with New V2 image. This results in a reload of both the ICS to boot up with New V2 image.
2. Activate the Global Standby with V2, which results in the switchover to In-chassis Standby Sup associated with the Global standby followed by Old Global standby come up as ICS with V2.
3. Activate the Global Active with V2 image which results in Switchover to In-chassis Standby associated with the Global Active. On successful boot up of Old Global Active as ICS with V2, completes the commit operation.
