Troubleshooting No Ringback Tone on ISDN–VoIP (H.323) Calls

Document ID: 22983

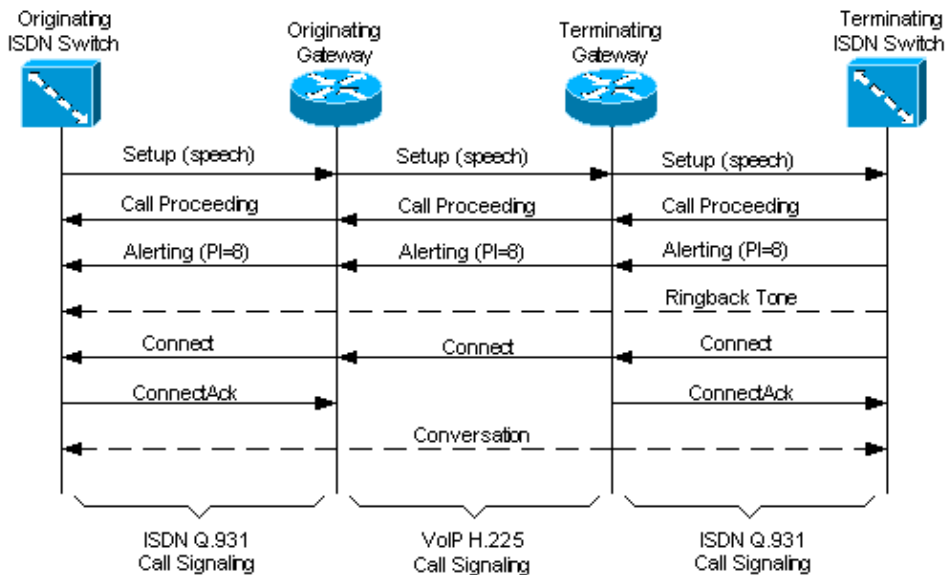
Call Setup Q.931-H.225 Messages

Note: H.225 is a protocol specified by H.323 for call signaling and call setup. H.225 specifies the use and support of Q.931. Refer to the H.323 Tutorial [\[4\]](#) for more information on H.323.
