Upgrade Cisco IOS on an Autonomous Access Point

This document describes how to upgrade a Cisco IOS® image on an autonomous Access Point through the GUI or CLI.

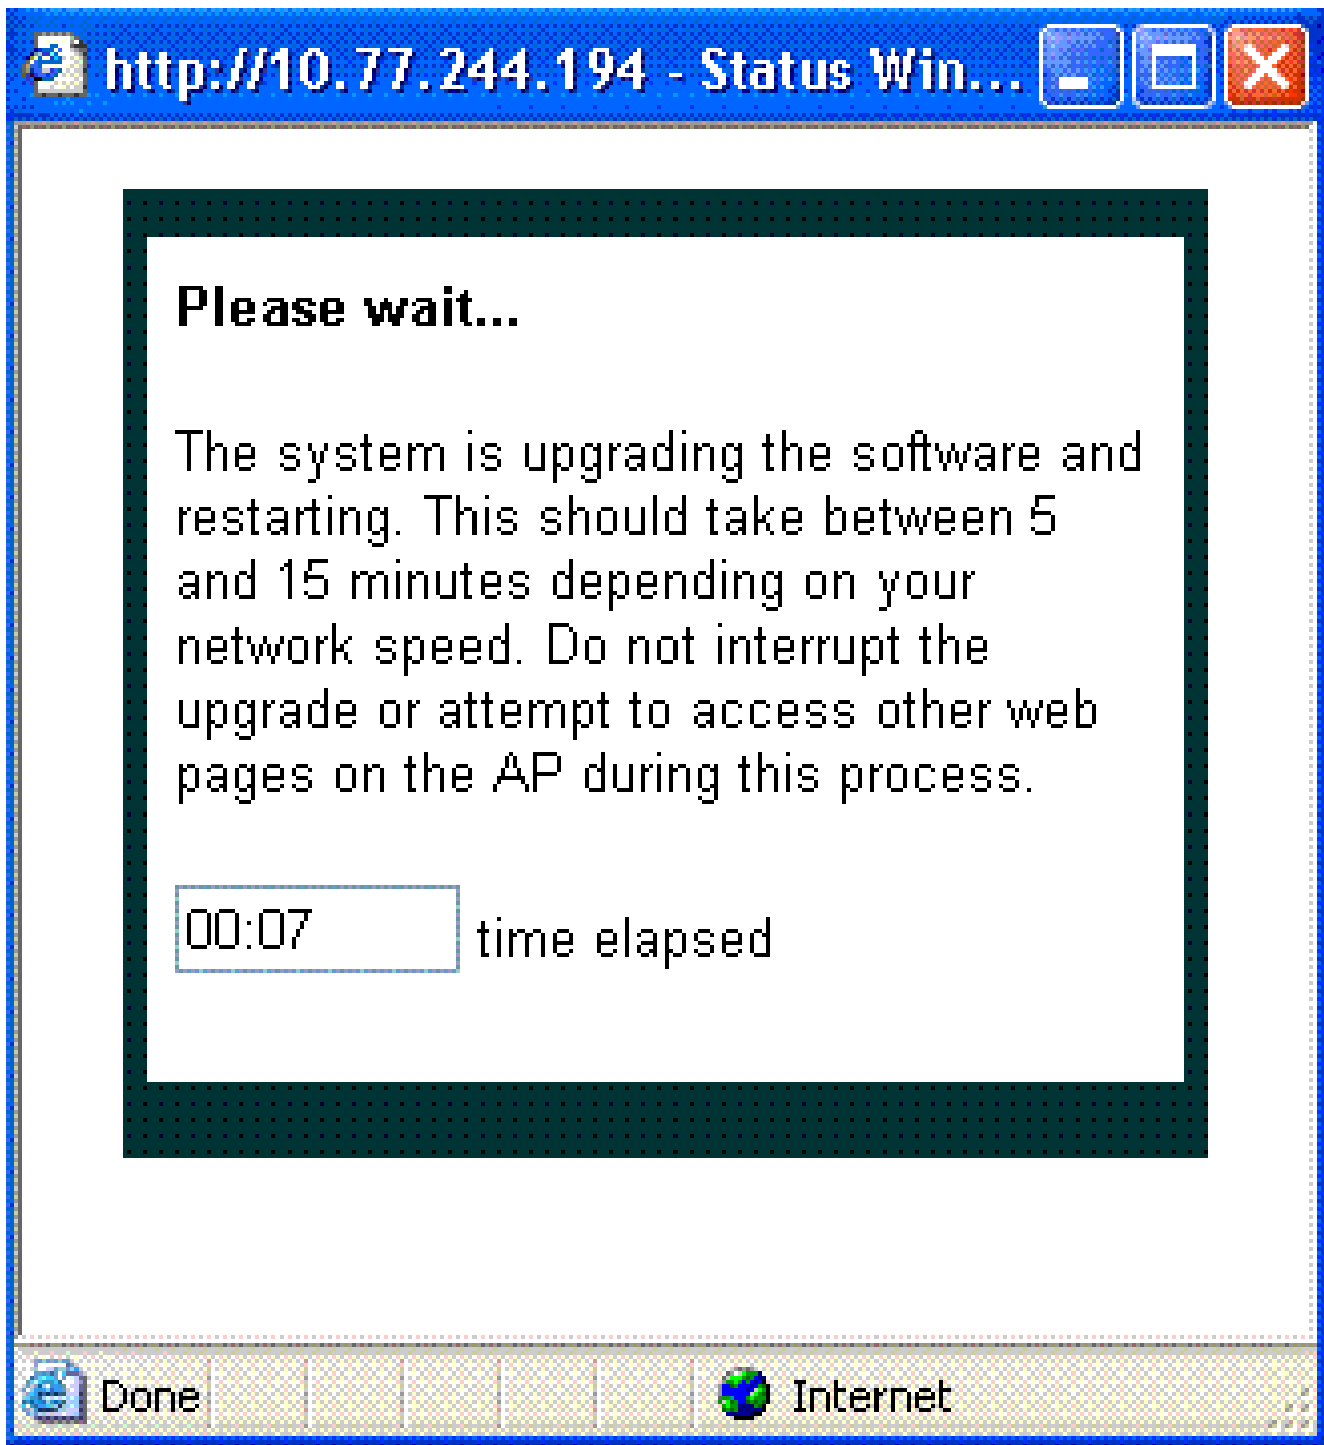
Status Window

5. Click **Upgrade**. A status window similar to the one shown in Figure 2 appears.

This takes few minutes, and then the AP reboots once the upgrade is complete.
