# Recover a Catalyst 9800 Controller from ROMMON Mode

This document describes how to recover a Catalyst 9800 controller based on ROMMON mode and no image in the flash.

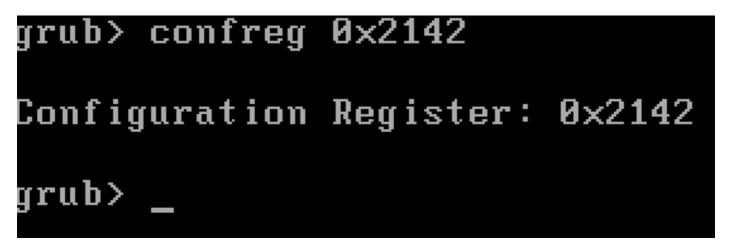
- Step 2. Press **C** on this screen to get the grub prompt.
- Step 3. You can change the config register in that prompt with the config 0x2142 command.
