Alarm Troubleshooting

This chapter gives a description, severity, and troubleshooting procedure for each commonly encountered Cisco ONS 15454 alarm and condition. Tables 2-1 through 2-5 provide lists of ONS 15454 alarms organized by severity. Table 2-6 on page 2-6 provides a list of alarms organized alphabetically. Table 2-8 gives definitions of all ONS 15454 alarm logical objects, which are the basis of the alarm profile list in Table 2-8 on page 2-12.

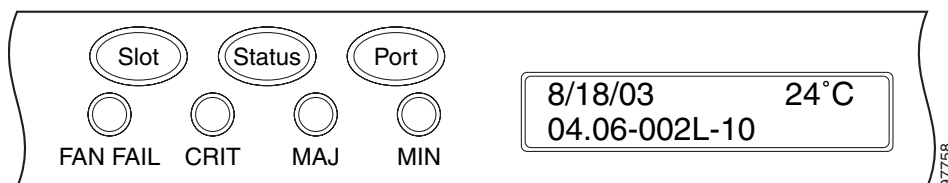
Figure 2-1 Shelf LCD Panel

- Step 1** View the temperature displayed on the ONS 15454 LCD front panel ([Figure 2-2](#)).

- Step 2** If the temperature of the shelf exceeds 194 degrees F (90 degrees C), the alarm should clear if you solve the ONS 15454 temperature problem. Complete the [“Clear the HITEMP Alarm” procedure on page 2-115](#).

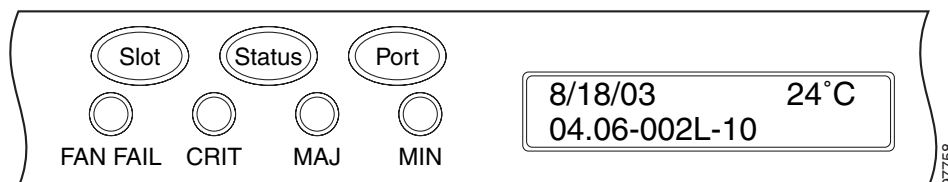
Figure 2-2 Shelf LCD Panel

Step 1 View the temperature displayed on the ONS 15454 LCD front panel ([Figure 2-2](#)).

- Step 1** Check for any outstanding alarms that were raised against the active and standby TCC2 and resolve them.
- Step 2** If the alarm does not clear, determine whether the LCD display on the fan tray ([Figure 2-2 on page 2-115](#)) is blank or if the text is garbled. If so, proceed to [Step 8](#). If not, continue with [Step 3](#).
- Step 3** At the earliest maintenance window, reset the standby TCC2:
