General Troubleshooting

This chapter provides procedures for troubleshooting the most common problems encountered when operating a Cisco ONS 15454. To troubleshoot specific ONS 15454 alarms, see [Chapter 2, "Alarm Troubleshooting."](#) If you cannot find what you are looking for, contact the Cisco Technical Assistance Center (1 800 553-2447).

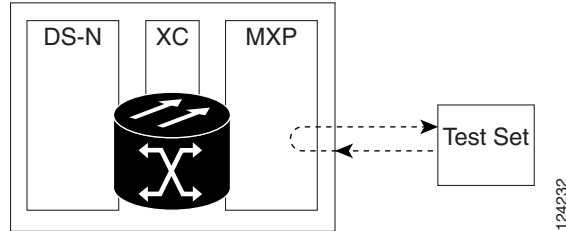
A facility (line) loopback tests the line interface unit (LIU) of a card, the EIA (electrical interface assembly), and related cabling. After applying a facility loopback on a port, use a test set to run traffic over the loopback. A successful facility loopback isolates the LIU, the EIA, or the cabling plant as the potential cause of a network problem.

To test an MXP card LIU, connect an optical test set to the MXP port and perform a facility (line) loopback. Or use a loopback on a card that is farther along the circuit path. [Figure 1-1](#) shows a facility loopback on an MXP card.

Figure 1-1 Facility (Line) Loopback Path on a Near-End MXP Card

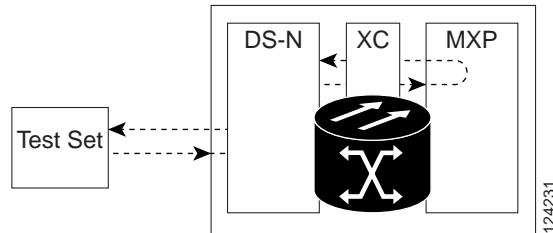
A terminal loopback tests a circuit path as it passes through the cross-connect card (XC10G) and loops back from the card with the loopback. [Figure 1-2](#) shows a terminal loopback on an MXP card. The test-set traffic comes into the electrical port and travels through the cross-connect card to the optical card. The terminal loopback on the optical card turns the signal around before it reaches the LIU and sends it back through the cross-connect card to the electrical card. This test verifies that the cross-connect card and terminal circuit paths are valid, but does not test the LIU on the optical card.

Figure 1-2 Terminal Loopback Path on an MXP Card

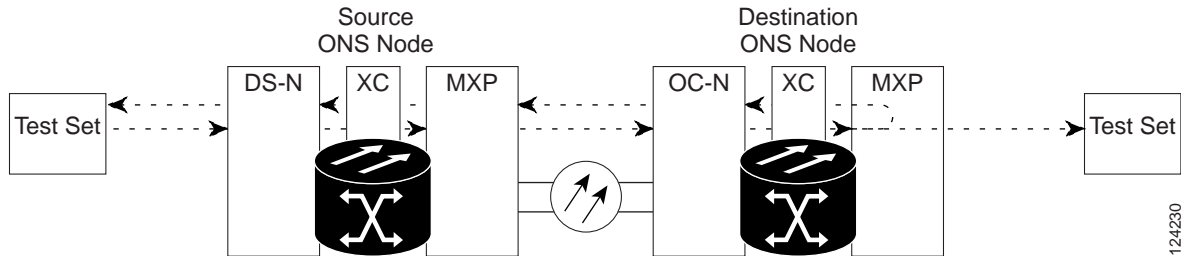
A bridged terminal loopback signal is shown in [Figure 1-3](#).

Figure 1-3 Terminal Loopback on an MXP Card with Bridged Signal

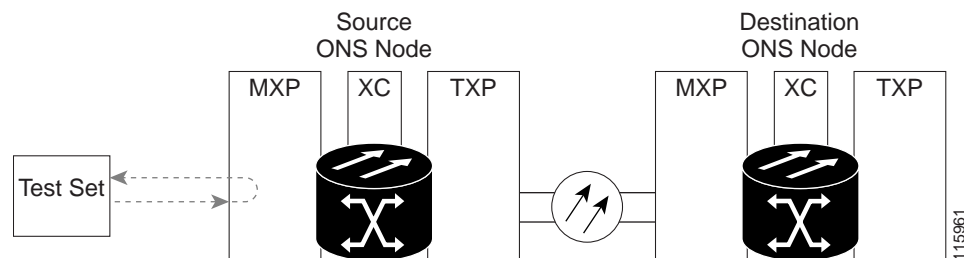
The facility (line) loopback test is performed on the node source port in the network circuit. In the testing situation used in this example, the loopback is performed on the source-node muxponder or transponder port. Completing a successful facility (line) loopback on this port isolates the port as a possible failure point. [Figure 1-4](#) shows an example of a facility loopback on a circuit source port.

Figure 1-4 Facility (Line) Loopback on a Circuit Source MXP or TXP Port

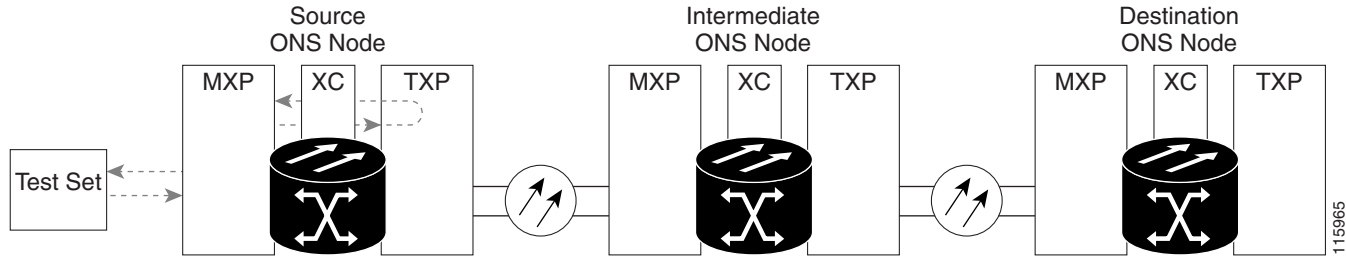
The terminal (inward) loopback test is performed on the node source MXP, TXP, or FC_MR port. For the circuit in this example, it is the source-node MXP port. You first create a bidirectional circuit that starts on the node destination MXP or TXP port and loops back on the node source port. You then proceed with the terminal loopback test. Completing a successful terminal loopback to a node source port verifies that the circuit is good to the source port. [Figure 1-5](#) shows an example of a terminal loopback on a source port.

Figure 1-5 Terminal (Inward) Loopback on a Source-Node MXP or TXP Port

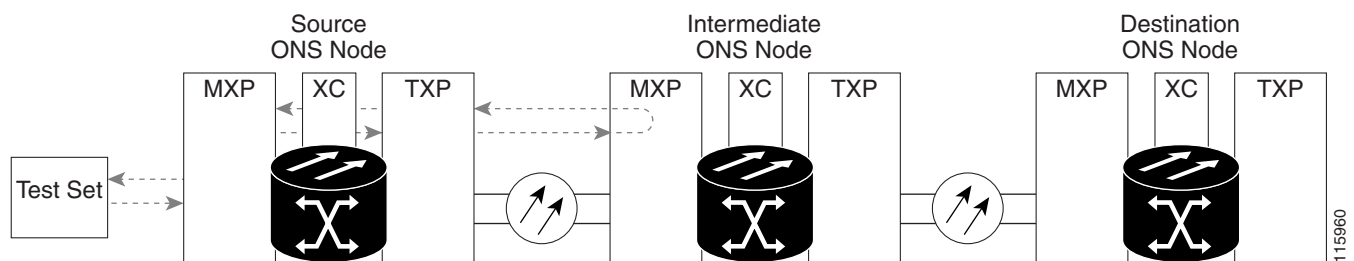
Performing the facility (line) loopback test on an intermediate port isolates whether this node is causing circuit failure. In the situation shown in [Figure 1-6](#), the test is being performed on an intermediate MXP or TXP port.

Figure 1-6 Facility (Line) Loopback on an Intermediate-Node MXP or TXP Port

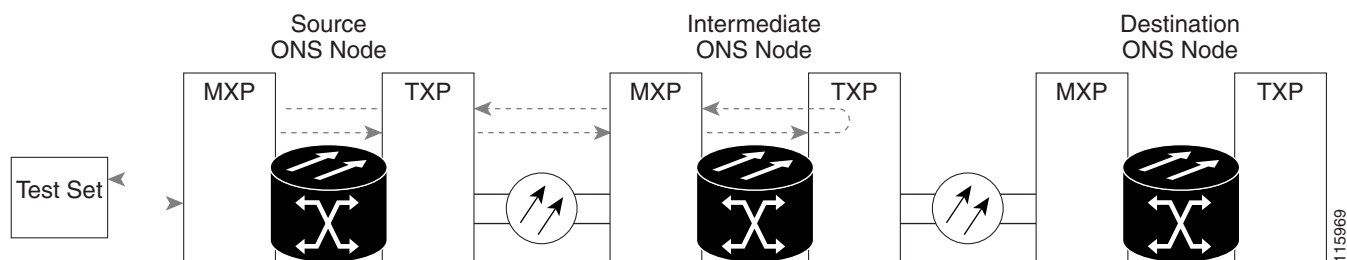
In the next troubleshooting test, you perform a terminal loopback on the intermediate-node port to isolate whether the destination port is causing circuit trouble. In the example situation in [Figure 1-7](#), the terminal loopback is performed on an intermediate MXP or TXP port in the circuit. You first create a bidirectional circuit that originates on the source-node MXP or TXP port and loops back on the intermediate-node port. You then proceed with the terminal loopback test. If you successfully complete a terminal loopback on the node, this node is excluded from possible sources of circuit trouble.

Figure 1-7 Terminal Loopback on an Intermediate-Node MXP or TXP Port

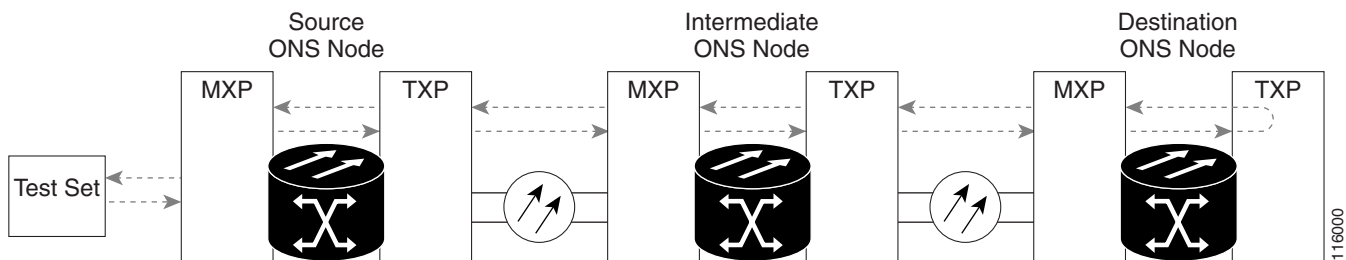
The terminal loopback at the destination-node port is the final local hardware error elimination in the circuit troubleshooting process. If this test is completed successfully, you have verified that the circuit is good up to the destination port. The example in [Figure 1-9](#) shows a terminal loopback on an intermediate-node destination MXP or TXP port.

Figure 1-9 Terminal Loopback on a Destination-Node MXP or TXP port

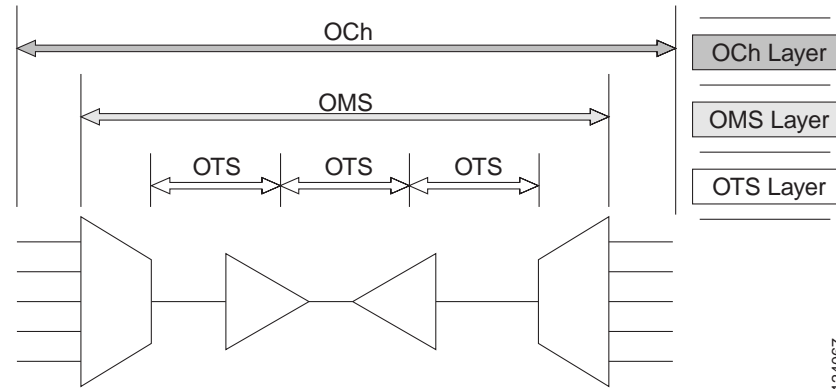
Like traditional SONET networks, G.709 optical networks have a layered design (Figure 1-10). This structure enables localized monitoring that helps you isolate and troubleshoot network problems.

Figure 1-10 Optical Transport Network Layers

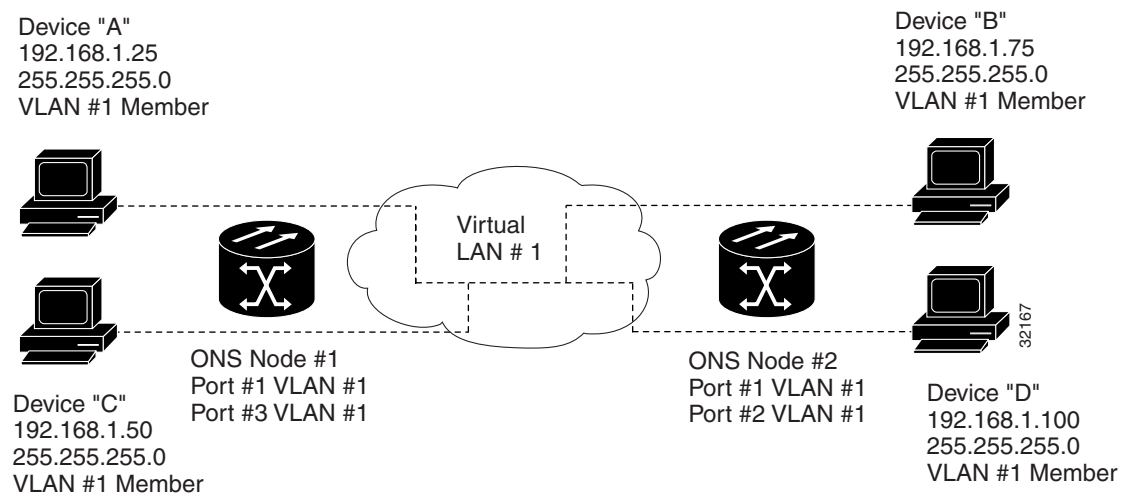
Recommended Action You can fix most connectivity problems in an Ethernet network by following a few guidelines. See [Figure 1-22](#) when using the steps in the “[Verify Ethernet Connections](#)” procedure on page 1-55.

Figure 1-22 Ethernet Connectivity Reference

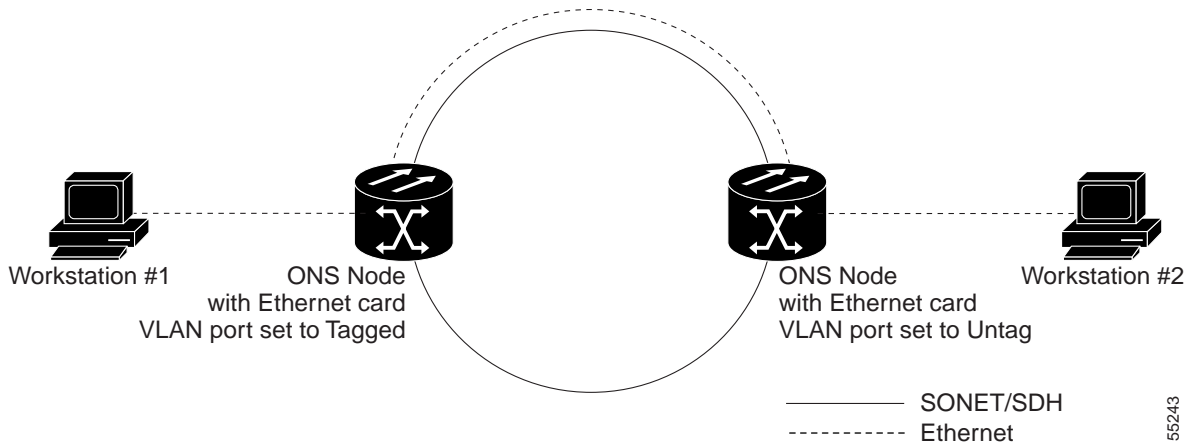
Symptom Networks that have a VLAN with one ONS 15454 Ethernet card port set to Tagged and one ONS 15454 Ethernet card set to Untag might have difficulty implementing Address Resolution Protocol (ARP) for a network device attached to the Untag port ([Figure 1-23](#)). They might also see a higher than normal runt packets count at the network device attached to the Untag port. This symptom/limitation also exists when ports within the same card or ports within the same chassis are put on the same VLAN, with a mix of tagged and untagged.

Recommended Action The solution is to set both ports in the VLAN to Tagged to stop the stripping of the 4 bytes from the data packet and prevent the NIC card in the network access device from recognizing the packet as a runt and dropping it. Network devices with IEEE 802.1Q-compliant NIC cards accept the tagged packets. Network devices with non IEEE 802.1Q compliant NIC cards still drop these tagged packets. The solution might require upgrading network devices with non-IEEE 802.1Q compliant NIC cards to IEEE 802.1Q compliant NIC cards. You can also set both ports in the VLAN to Untag, but you will lose IEEE 802.1Q compliance.

Figure 1-23 VLAN with Ethernet Ports at Tagged and Untag

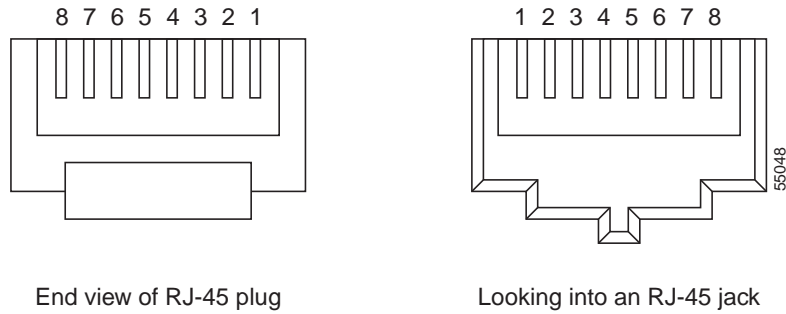
You can crimp your own LAN cables for use with the ONS 15454. Use a cross-over cable when connecting an ONS 15454 to a hub, LAN modem, or switch, and use a LAN cable when connecting an ONS 15454 to a router or workstation. Use CAT-5 cable RJ-45 T-568B, Color Code (100 Mbps), and a crimping tool. [Figure 1-25](#) shows the wiring of an RJ-45 connector. [Figure 1-26](#) shows a LAN cable layout, and [Table 1-4](#) shows the cable pinouts. [Figure 1-27](#) shows a cross-over cable layout, and [Table 1-5](#) shows the cross-over pinouts.

Figure 1-25 RJ-45 Pin Numbers

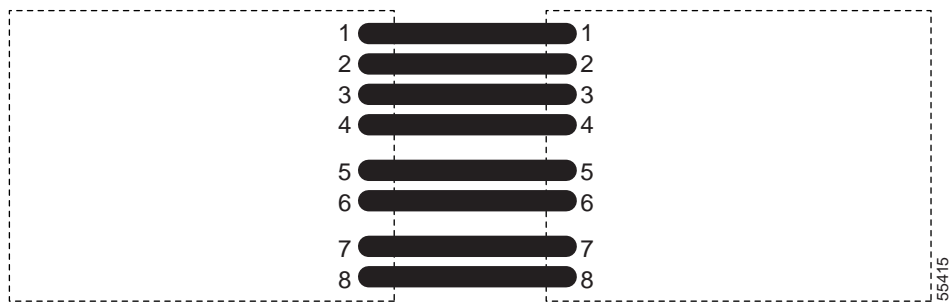
Figure 1-26 LAN Cable Layout

Pin	Color	Pair	Name	Pin
1	white/orange	2	Transmit Data +	1
2	orange	2	Transmit Data —	2
3	white/green	3	Receive Data +	3
4	blue	1	—	4
5	white/blue	1	—	5
6	green	3	Receive Data —	6
7	white/brown	4	—	7
8	brown	4	—	8

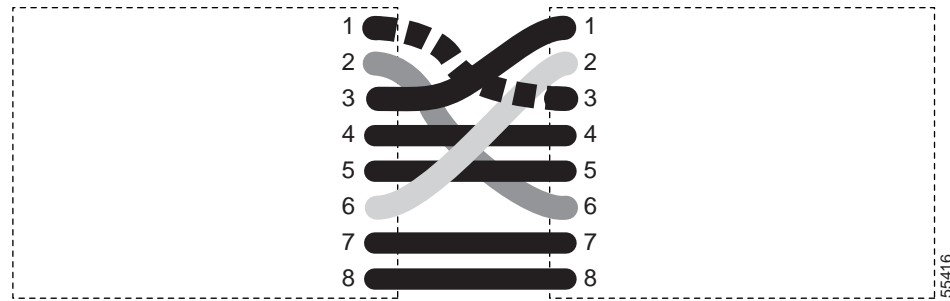
Figure 1-27 Cross-Over Cable Layout

Pin	Color	Pair	Name	Pin
1	white/orange	2	Transmit Data +	3
2	orange	2	Transmit Data —	6
3	white/green	3	Receive Data +	1
4	blue	1	—	4
5	white/blue	1	—	5
6	green	3	Receive Data —	2
7	white/brown	4	—	7
8	brown	4	—	8

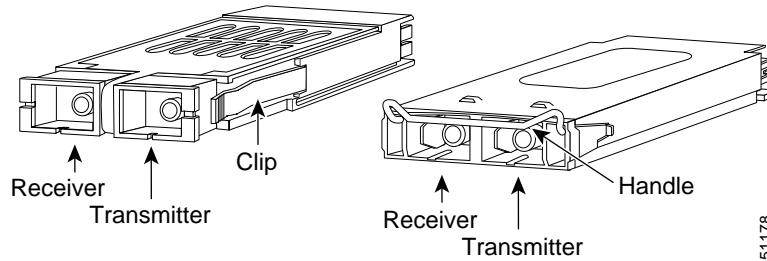
Figure 1-28 GBICs

GBICs are available in two different models. One GBIC model has two clips (one on each side of the GBIC) that secure the GBIC in the slot on the E1000-2-G, G-Series, or G1K-4 card. The other model has a locking handle. Both models are shown in [Figure 1-28](#).

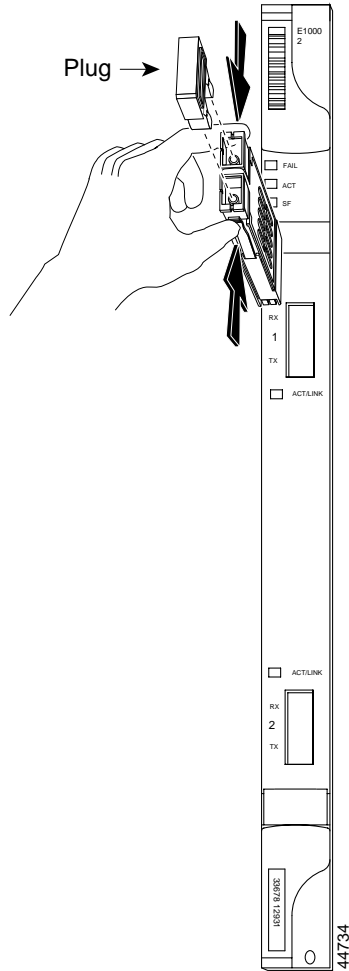
Figure 1-29 GBIC Installation (with Clips)

-
- Step 1** Remove the GBIC from its protective packaging.
- Step 2** Check the label to verify that the GBIC is the correct type (SX, LX, or ZX) for your network.
- Step 3** Verify that you are installing compatible GBICs; for example, SX to SX, LX to LX, or ZX to ZX.
- Step 4** Grip the sides of the GBIC with your thumb and forefinger and insert the GBIC into the slot on the E1000-2, E1000-2-G, or G-Series card ([Figure 1-29](#)).

GBICs are keyed to prevent incorrect installation.

- Step 5** Slide the GBIC through the flap that covers the opening until you hear a click. The click indicates the GBIC is locked into the slot.
- Step 6** When you are ready to attach the network fiber-optic cable, remove the protective plug from the GBIC and save the plug for future use.
- Step 7** Return to your originating procedure (NTP).
