# General Troubleshooting

This chapter provides procedures for troubleshooting the most common problems encountered when operating a Cisco ONS 15454 DWDM shelf in ANSI or ETSI platforms. To troubleshoot specific alarms, see [Chapter 2, “Alarm Troubleshooting.”](#) If you cannot find what you are looking for, contact Cisco Technical Support (1-800-553-2447).

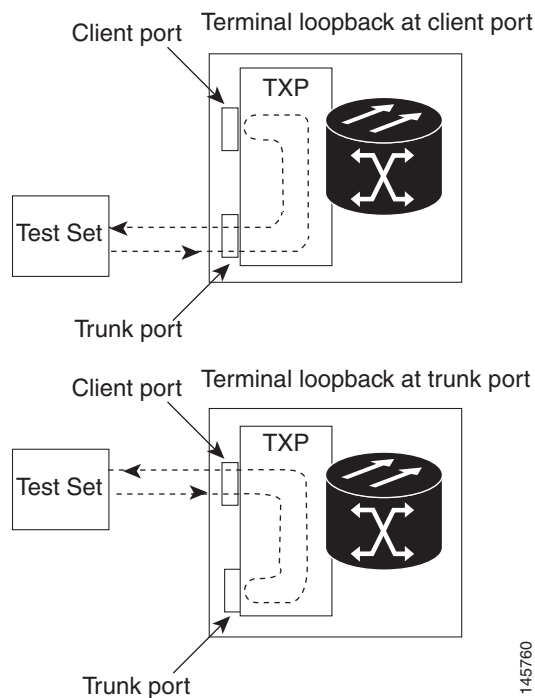
**Figure 1-2 Terminal Loopback on a TXP Card**

A terminal loopback tests a circuit path as it passes through a TXP or MXP card and loops back. For example, as shown in [Figure 1-2](#), there are two types of terminal loopbacks shown for a TXP card.

This test verifies that the terminal circuit paths are valid, but does not test the LIU on the TXP card.

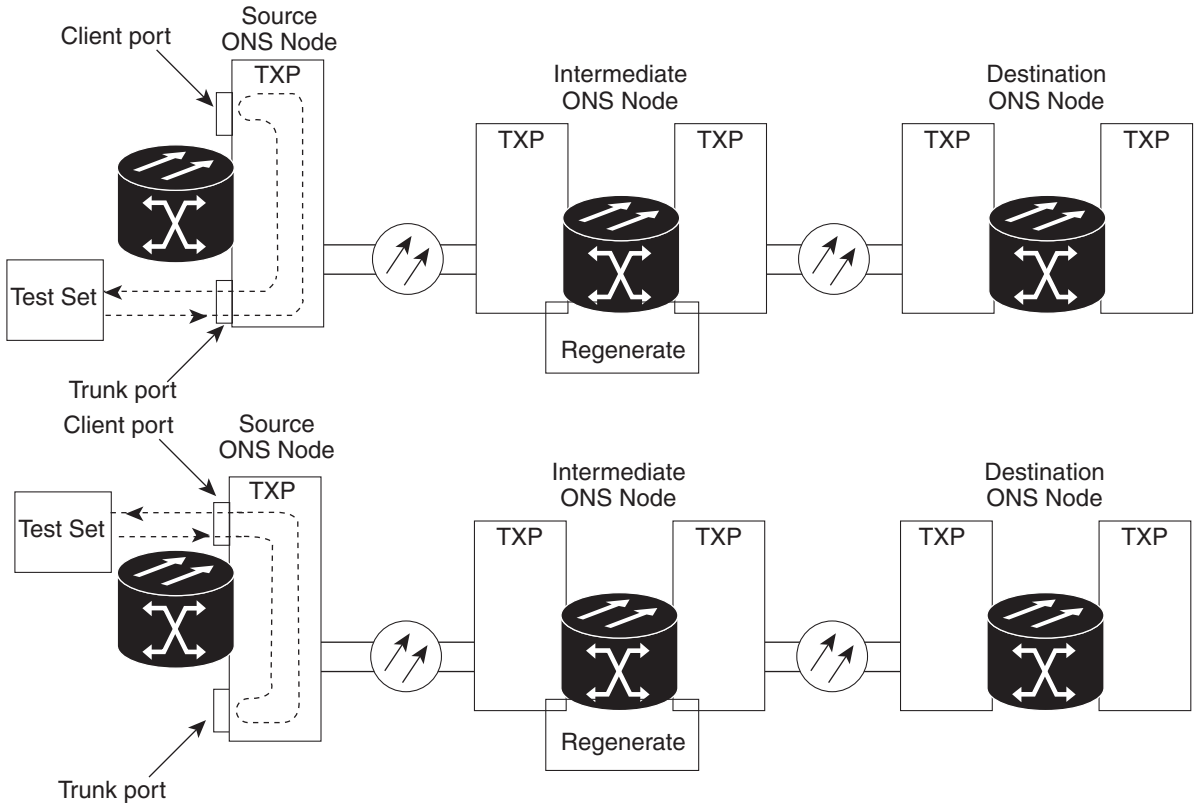
Figure 1-4 Terminal Loopback on a Source-Node MXP or TXP Port

The terminal loopback test is performed on the node source MXP or TXP muxponder or transponder port. For the circuit in this example, it is the source TXP trunk port or a client port in the source node. Completing a successful terminal loopback to a node source port verifies that the circuit is through the source port. [Figure 1-4](#) shows an example of a terminal loopback on a source TXP port and a client TXP port.

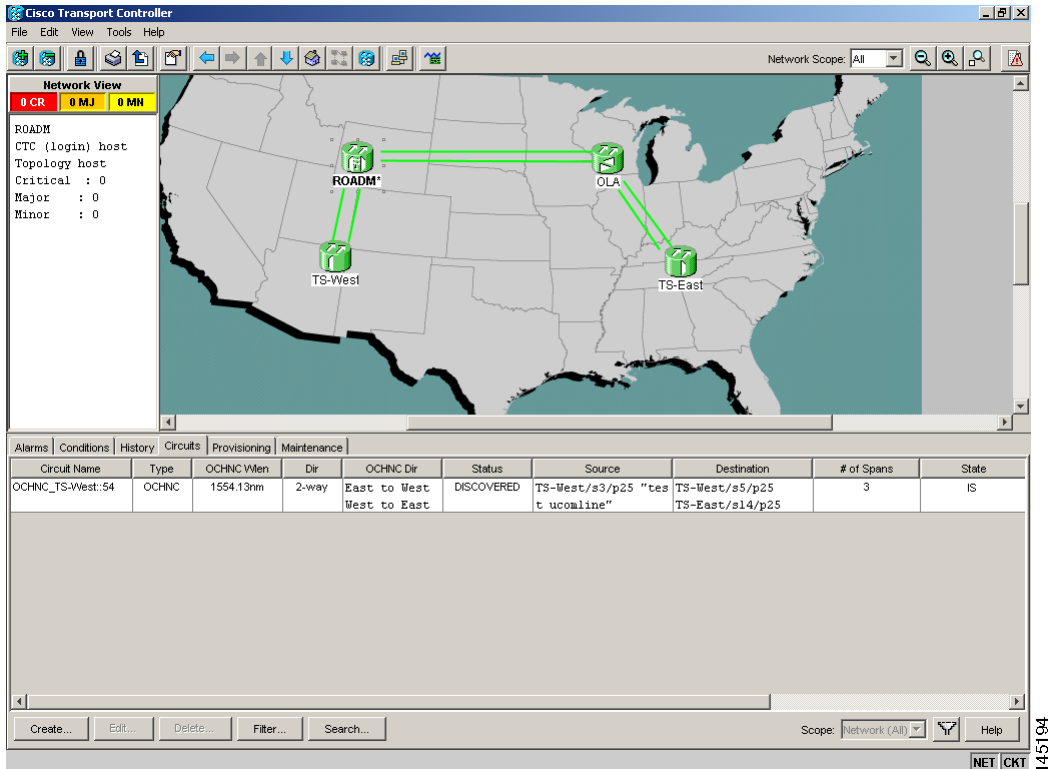
Figure 1-29 OCHNC Circuit Successfully Completed

OCHNC circuit creation is successfully completed when the CTC circuit table reports the situation shown in [Figure 1-29](#).

- The Circuit Status has turned to DISCOVERED.
- The # of spans field shows the correct number of hops among different nodes that the OCHNC circuit passes through to reach the final destination.
- Circuit State reports IS (or unlocked).

The screenshot shows the Cisco Transport Controller interface. The network view displays a map of the United States with nodes ROADM, OLA, TS-West, and TS-East connected by green lines. The circuit table below shows the details of the OCHNC\_TS-West:54 circuit.

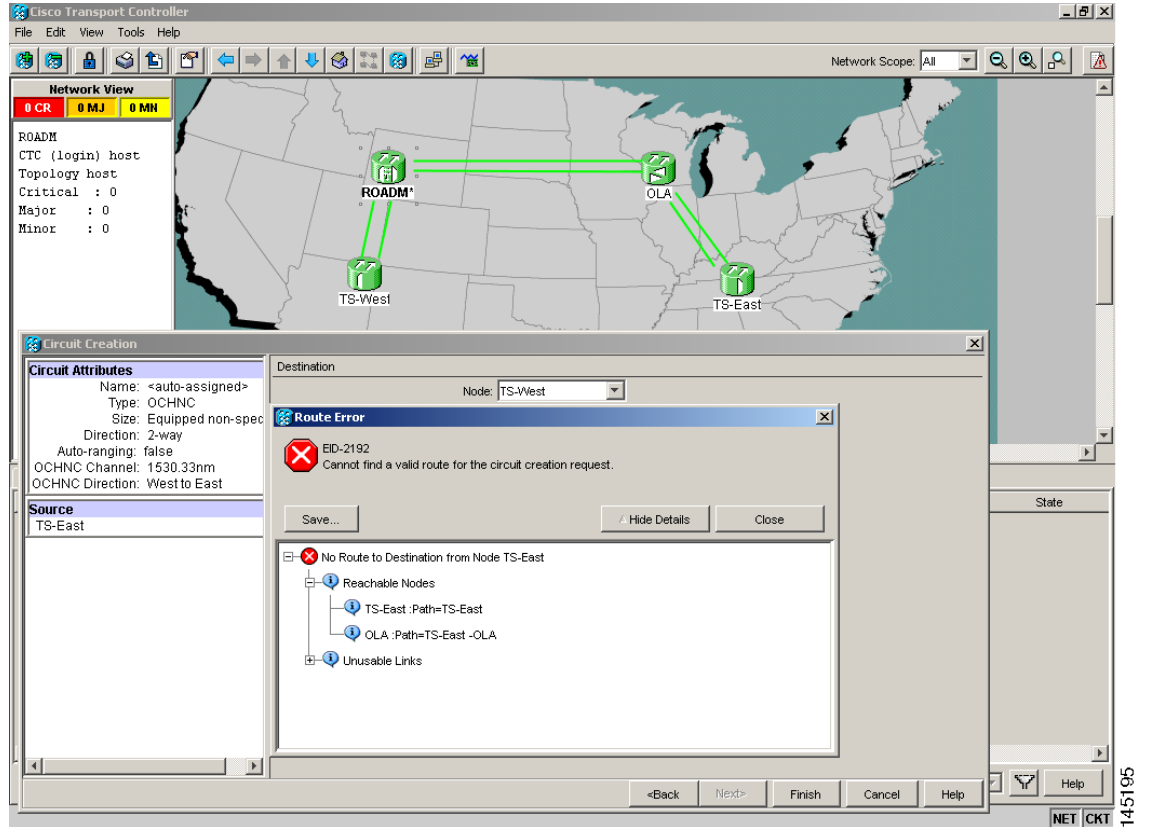
Figure 1-30 Partial Circuit

- If the WPP wizard cannot complete the circuit creation procedure, CTC displays the error message shown in [Figure 1-30](#). In the message, click **Details** to see the partial connections that WPP can set up. Start troubleshooting the problem in the first node that is unreachable along the path.

To troubleshoot and eventually fix issues related to the faulty OCHNC circuit creation shown in [Figure 1-30 on page 1-81](#), the following procedure must be performed.
