Cisco ONS 15454 Troubleshooting Guide

Product and Documentation Release 8.5
September 2010

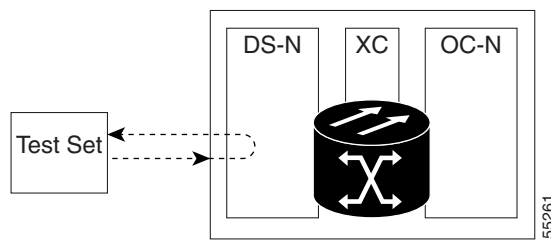
Figure 1-1 Facility Loopback Path on a Near-End DS-N Card

A facility loopback tests the line interface unit (LIU) of a card, the electrical interface assembly (EIA), and related cabling. After applying a facility loopback on a port, use a test set to run traffic over the loopback. A successful facility loopback isolates the LIU, the EIA, or the cabling plant as the potential cause of a network problem. [Figure 1-1](#) shows a facility loopback on a DS-N electrical card.

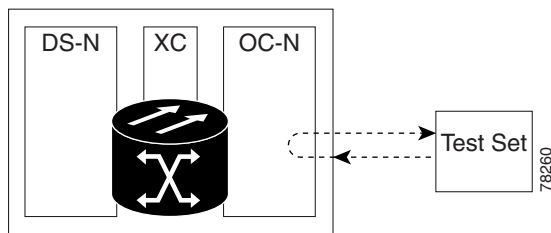
Figure 1-2 Facility Loopback Path on a Near-End OC-N Card

To test an OC-N card LIU, connect an optical test set to the OC-N port and perform a facility loopback. Alternately, use a loopback or hairpin circuit on a card that is farther along the circuit path. [Figure 1-2](#) shows a facility loopback on an OC-N card.

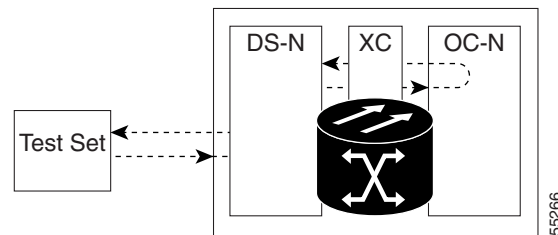
Figure 1-4 Terminal Loopback Path on an OC-N Card

A terminal loopback tests a circuit path as it passes through the cross-connect card and loops back from the card with the loopback. [Figure 1-4](#) shows a terminal loopback on an OC-N card. The test-set traffic comes into the electrical port and travels through the cross-connect card to the optical card. The terminal loopback on the optical card turns the signal around before it reaches the LIU and sends it back through the cross-connect card to the electrical card. This test verifies that the cross-connect card and terminal circuit paths are valid, but does not test the LIU on the optical card.

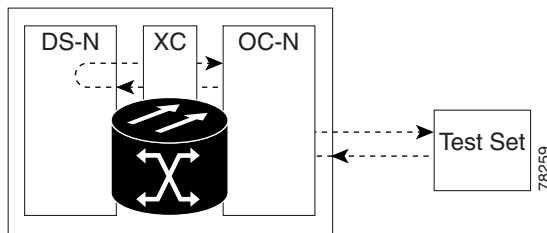
Figure 1-6 Terminal Loopback Path on a DS-N Card

Figure 1-6 shows a terminal loopback on a DS-N electrical card. The test-set traffic comes in on the optical card and travels through the cross-connect card to the electrical card. The terminal loopback on the electrical card turns the signal around before it reaches the LIU and sends it back through the cross-connect card to the optical card. This test verifies that the cross-connect card and terminal circuit paths are valid, but does not test the LIU on the electrical card.

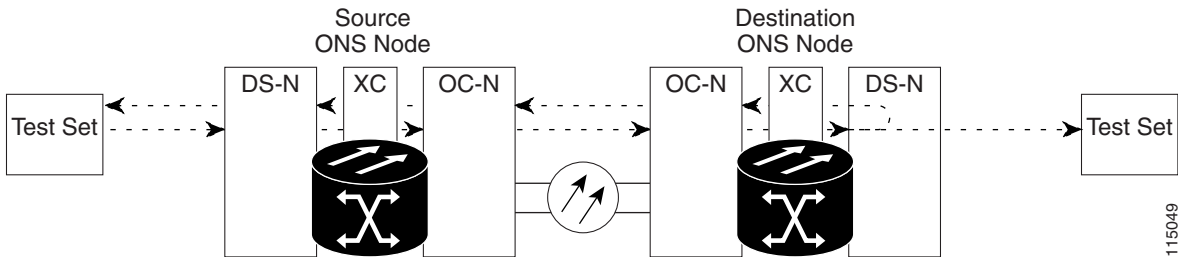
Figure 1-7 Terminal Loopback on a DS-N Card with a Bridged Signal

Bridged DS-N and OC-N terminal loopback examples are shown in [Figure 1-7](#) and [Figure 1-8](#).

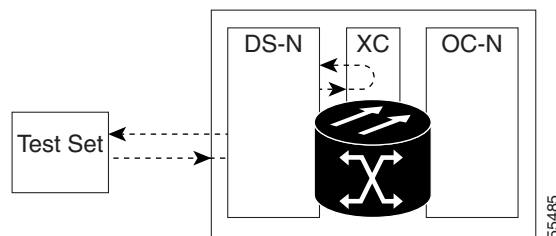
Figure 1-9 Hairpin Circuit Path on a DS-N Card

Figure 1-9 shows the hairpin circuit path on a DS-N card.

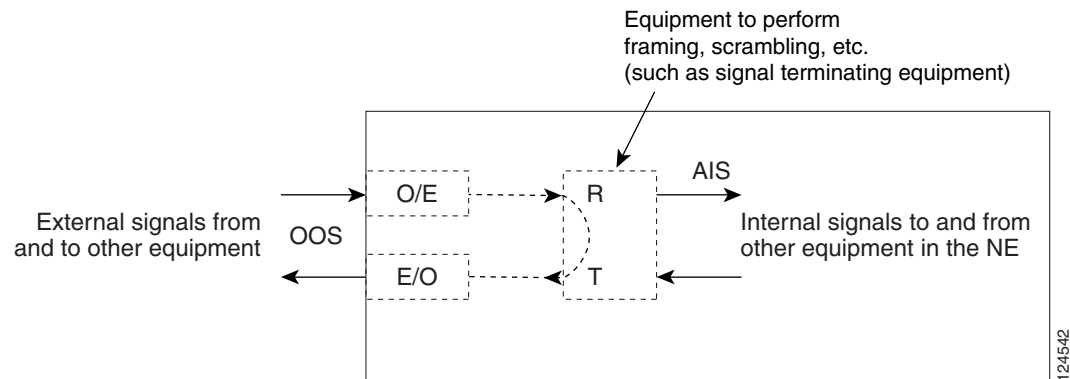
Figure 1-10 Network Element with SONET Cross-Connect Loopback Function

The XC loopback breaks down the existing path and creates a new cross-connect—a hairpin—while the source of the original path is set to inject a line-side AIS-P. The loopback signal path and AIS injection are shown in Figure 1-10.

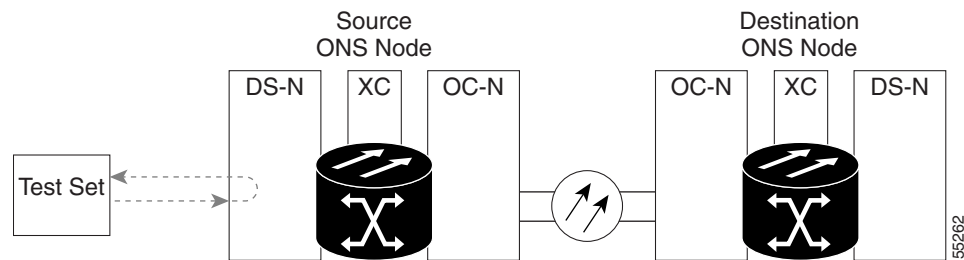
Figure 1-11 Facility Loopback on a Circuit Source DS-N Port

The facility loopback test is performed on the node's source electrical port in the network circuit; in this example, the DS-N port in the source node. Completing a successful facility loopback on this port isolates the cabling, the electrical card, and the EIA as possible failure points. [Figure 1-11](#) shows an example of a facility loopback on a source DS-N port.

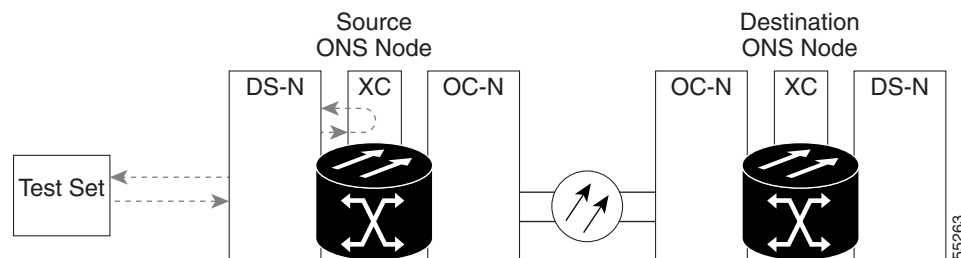
Figure 1-12 Hairpin on a Source-Node Port

The hairpin test is performed on the cross-connect card in the network circuit. A hairpin circuit uses the same port for both source and destination. Completing a successful hairpin through the port isolates the possibility that the cross-connect card is the cause of the faulty circuit. [Figure 1-12](#) shows an example of a hairpin loopback on a source-node port.

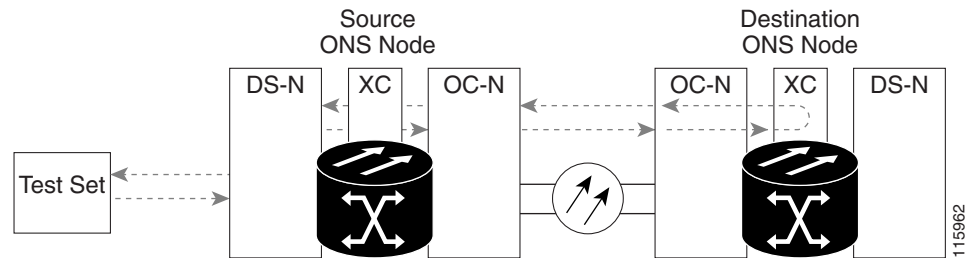
Figure 1-13 XC Loopback on a Destination OC-N Port

The XC loopback tests whether any problem exists on the circuit’s OC-N span, isolating this span from others present on the card. The loopback occurs on the cross-connect card in a network circuit. [Figure 1-13](#) shows an example of an XC loopback on a destination OC-N port. The traffic pattern looks similar to a terminal loopback but traffic is only carried on one STS instead of affecting the entire port.

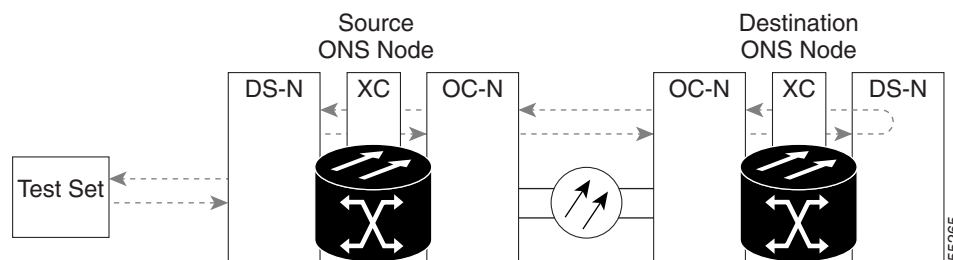
Figure 1-14 Terminal Loopback to a Destination DS-N Port

The terminal loopback test is performed on the destination-node electrical port in the circuit, such as a destination-node electrical port. You create a bidirectional circuit that starts on the source-node electrical port and loops back on the destination-node electrical port. Then you proceed with the terminal loopback test. Completing a successful terminal loopback to a destination-node electrical port verifies that the circuit is good to the destination electrical port. [Figure 1-14](#) shows an example of a terminal loopback on a destination DS-N port.

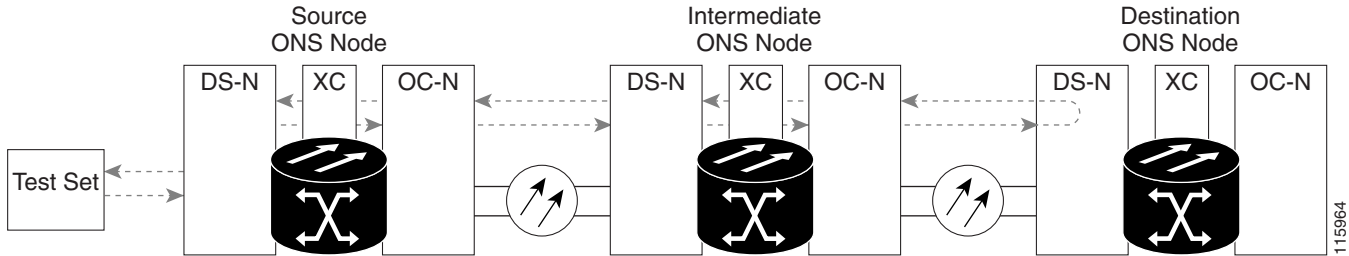
Figure 1-15 Facility Loopback on a Circuit Destination DS-N Port

The facility loopback test is performed on the destination-node electrical port in the network circuit. Completing a successful facility loopback on this port isolates the cabling, the electrical card, and the EIA as possible failure points. [Figure 1-15](#) shows an example of a facility loopback on a destination DS-N port.

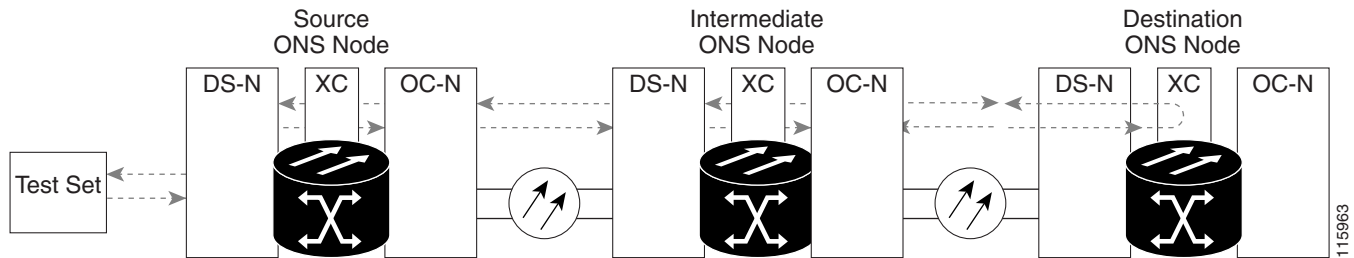
Figure 1-16 Hairpin on a Destination-Node DS-N Port

The hairpin test is performed on the cross-connect card in the network circuit and uses the same port as source as well as destination. Completing a successful hairpin through the card isolates the possibility that the cross-connect card is the cause of the faulty circuit. [Figure 1-16](#) shows an example of a hairpin loopback on a destination-node port.

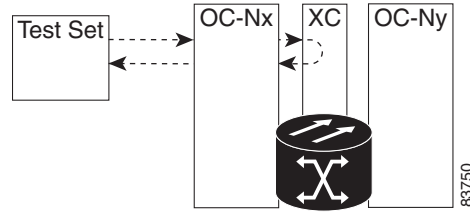
Figure 1-17 XC Loopback on a Source OC-N Port

The XC loopback tests whether problem exists on the circuit’s OC-N span by isolating this span from others on the card. The loopback also eliminates the cross-connect card as the source of trouble for a faulty circuit. The loopback occurs on the cross-connect card in a network circuit. [Figure 1-17](#) shows an example of an XC loopback on a source OC-N port.

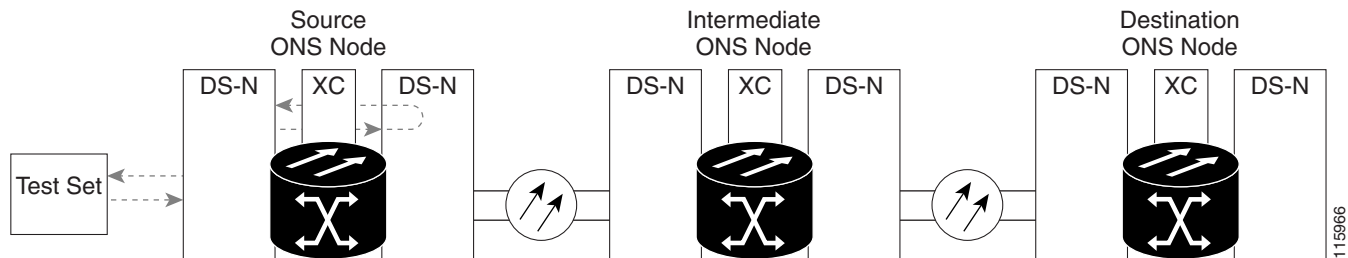
Figure 1-18 Terminal Loopback on a Source DS-N Port

The terminal loopback test is performed on the source-node electrical port in the circuit, such as a source-node electrical port. You first create a bidirectional circuit that starts on the destination-node electrical port and loops back on the source-node electrical port. Then you proceed with the terminal loopback test. Completing a successful terminal loopback to a source-node electrical port verifies that the circuit is good to the source electrical port. Figure 1-18 shows an example of a terminal loopback on a source DS-N port.

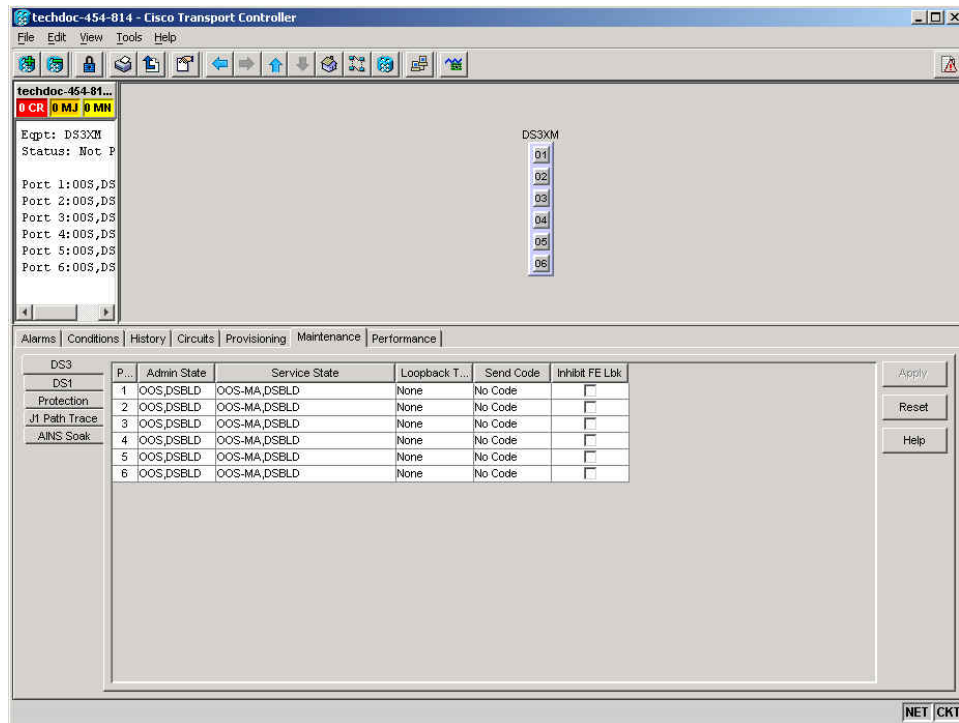
Figure 1-19 Accessing FEAC Functions on the DS3XM-6 Card

The DS3XM-6 card and DS3XM-12 cards support FEAC functions that are not available on basic DS-3 cards. Click the DS3XM-6 or DS3XM-12 **Maintenance > DS1** tabs at the card view to reveal the two additional function columns. [Figure 1-19](#) shows the DS3 subtab and the additional Send Code and Inhibit FE Lbk function columns.

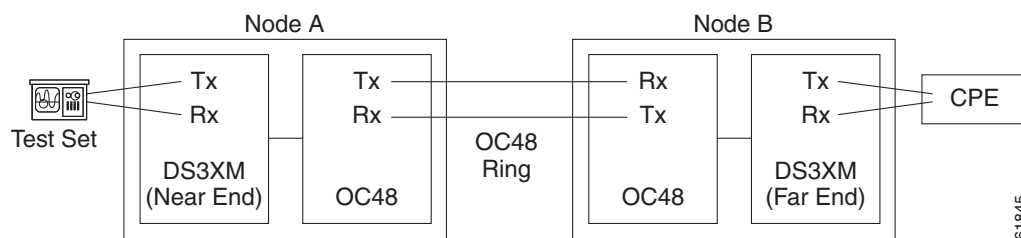
Figure 1-20 Diagram of FEAC Circuit

The “far end” in FEAC refers to the equipment connected to the DS3XM card and not to the far end of a circuit. In Figure 1-20, if a DS3XM-6 (near-end) port is configured to send a line loop code, the code will be sent to the connected test set, not the DS3XM-6 (far-end) port.

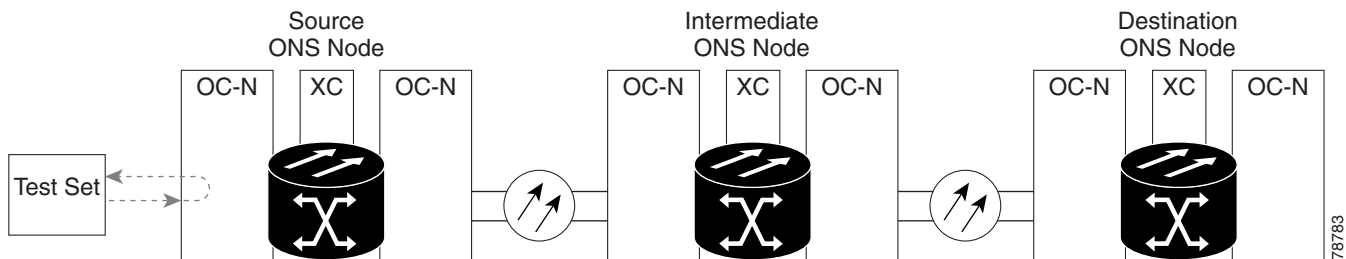
Figure 1-21 Facility Loopback on a Circuit Source OC-N Port

The facility loopback test is performed on the node source port in the network circuit. In the testing situation used in this example, the source OC-N port in the source node. Completing a successful facility loopback on this port isolates the OC-N port as a possible failure point. [Figure 1-21](#) shows an example of a facility loopback on a circuit source OC-N port.

The facility loopback test is performed on the node source port in the network circuit. In the testing situation used in this example, the source G-Series port in the source node. Completing a successful facility loopback on this port isolates the G-Series port as a possible failure point. [Figure 1-21](#) shows an example of a facility loopback on a circuit source Ethernet port.

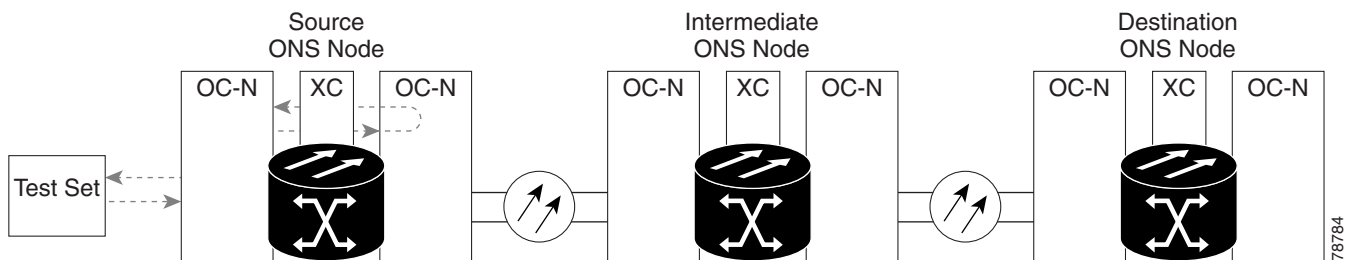
Figure 1-22 Terminal Loopback on a Source-Node OC-N Port

The terminal loopback test is performed on the source-node optical port. For the circuit in this example, it is the source OC-N port in the source node. You first create a bidirectional circuit that starts on the node destination optical port and loops back on the node source optical port. You then proceed with the terminal loopback test. Completing a successful terminal loopback to a node source port verifies that the circuit is good to the source port. Figure 1-22 shows an example of a terminal loopback on a source OC-N port.

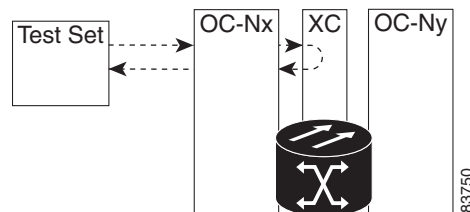
Figure 1-24 XC Loopback on a Source OC-N Port

The XC loopback test occurs on the cross-connect card in a network circuit. Completing a successful XC loopback from an OC-N card through the cross-connect card eliminates the cross-connect card as the source of trouble for a faulty circuit. [Figure 1-24](#) shows an example of an XC loopback path on a source OC-N port.

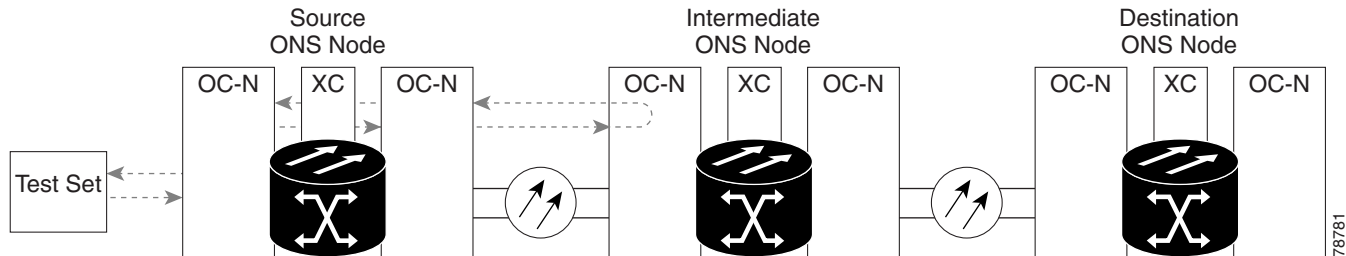
Figure 1-25 Facility Loopback Path to an Intermediate-Node OC-N Port

Performing the facility loopback test on an intermediate port isolates whether this node is causing circuit failure. In the situation shown in [Figure 1-25](#), the test is being performed on an intermediate OC-N port.

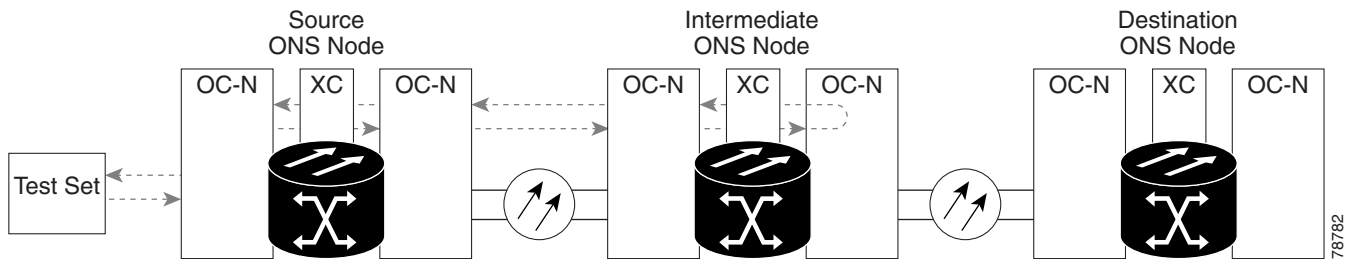
Figure 1-26 Terminal Loopback Path to an Intermediate-Node OC-N Port

In the next troubleshooting test, you perform a terminal loopback on the intermediate-node port to isolate whether the destination port is causing circuit trouble. In the example situation in [Figure 1-26](#), the terminal loopback is performed on an intermediate optical port in the circuit. You first create a

bidirectional circuit that originates on the source-node optical port and loops back on the intermediate-node port. You then proceed with the terminal loopback test. If you successfully complete a terminal loopback on the node, this node is excluded from possible sources of circuit trouble.

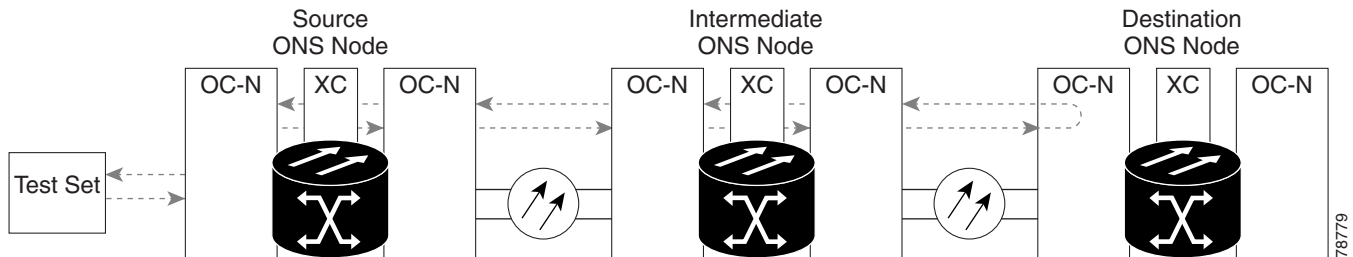
Figure 1-28 Facility Loopback Path to a Destination-Node OC-N Port

You perform a facility loopback test at the destination port to determine whether this local port is the source of circuit trouble. The example in [Figure 1-28](#) shows a facility loopback being performed on a destination-node OC-N port.

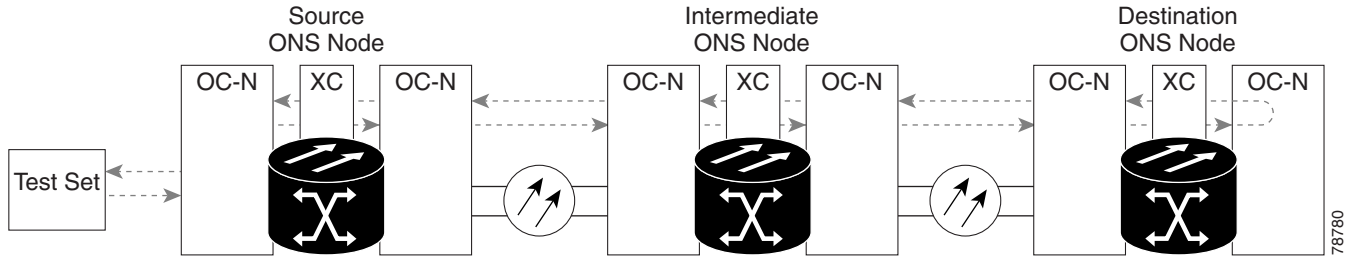
Figure 1-29 Terminal Loopback Path to a Destination-Node OC-N Port

The terminal loopback at the destination-node port is the final local hardware error elimination in the circuit troubleshooting process. If this test is completed successfully, you have verified that the circuit is good up to the destination port. The example in [Figure 1-29](#) shows a terminal loopback on an intermediate-node destination OC-N port.

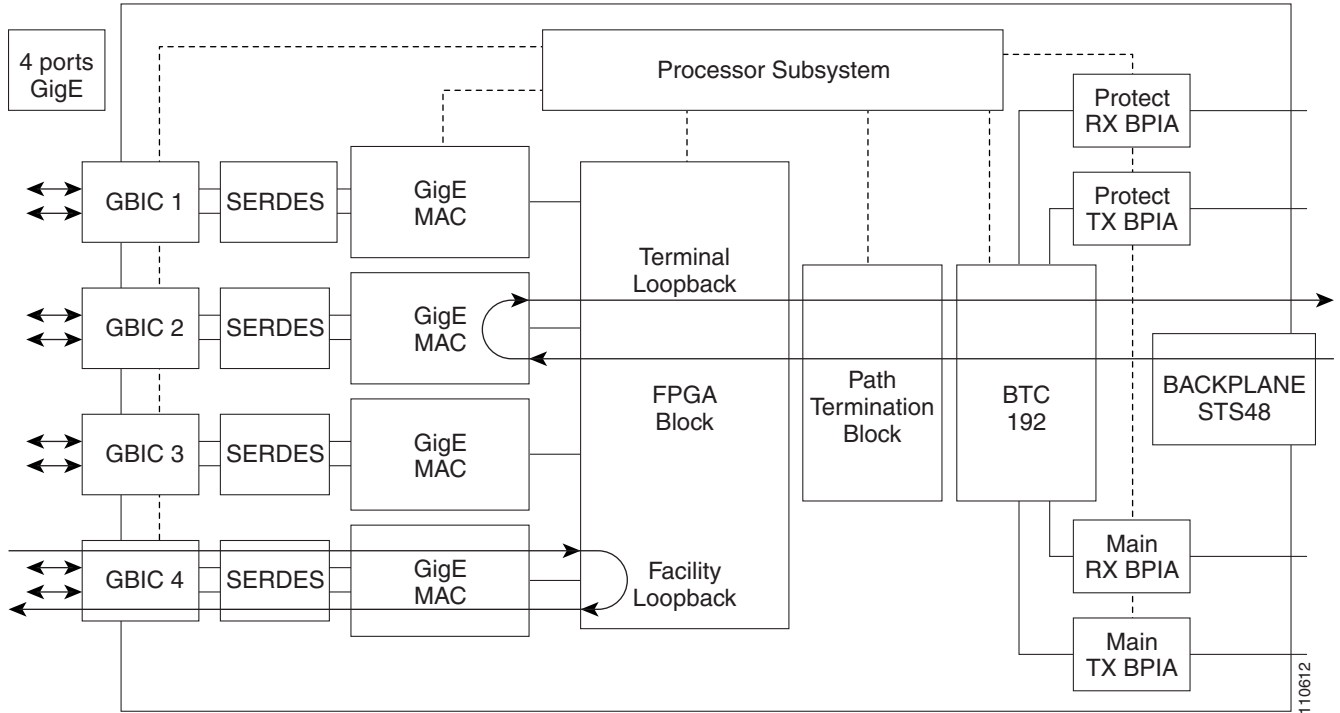
Figure 1-31 Terminal Loopback on a G-Series Port

The terminal loopback test is performed on the node source Ethernet port. For the circuit in this example, it is the source G-Series port in the source node. You first create a bidirectional circuit that starts on the node destination G-Series port and loops back on the node source G-Series port. You then proceed with the terminal loopback test. Completing a successful terminal loopback to a node source port verifies that the circuit is good to the source port. [Figure 1-31](#) shows terminal loopback on a G-Series port.

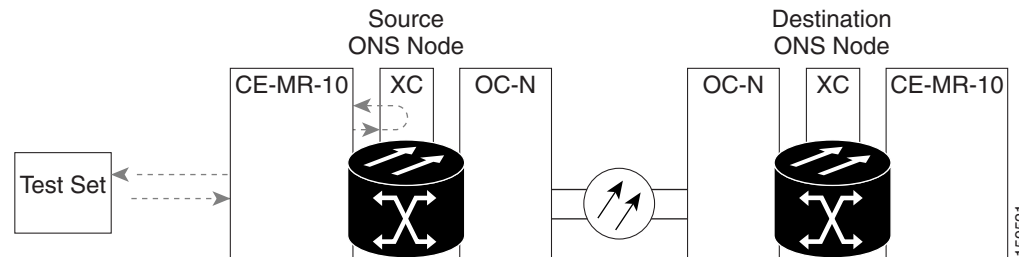
Figure 1-32 Hairpin on a Source-Node Ethernet Port

The hairpin test is performed on the cross-connect card in the network circuit. A hairpin circuit uses the same port for both source and destination. Completing a successful hairpin through the port isolates the possibility that the cross-connect card is the cause of the faulty circuit. [Figure 1-32](#) shows an example of a hairpin loopback on a source-node port.

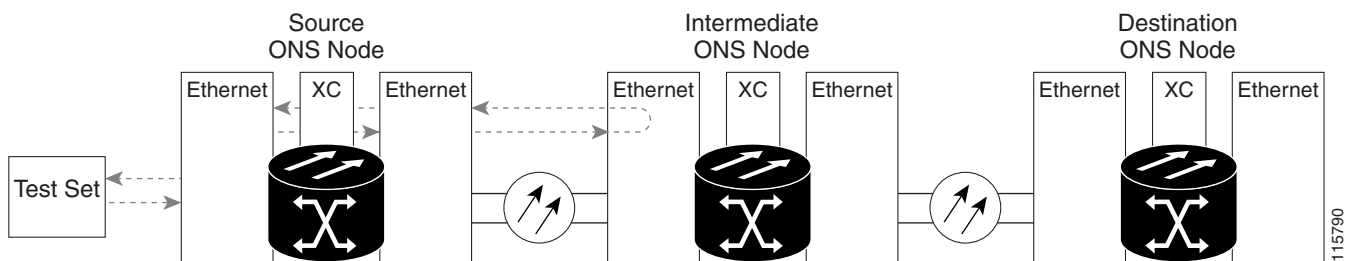
Figure 1-33 Facility Loopback on an Intermediate-Node Ethernet Port

Performing the facility loopback test on an intermediate port isolates whether this node is causing circuit failure. It is shown in [Figure 1-33](#).

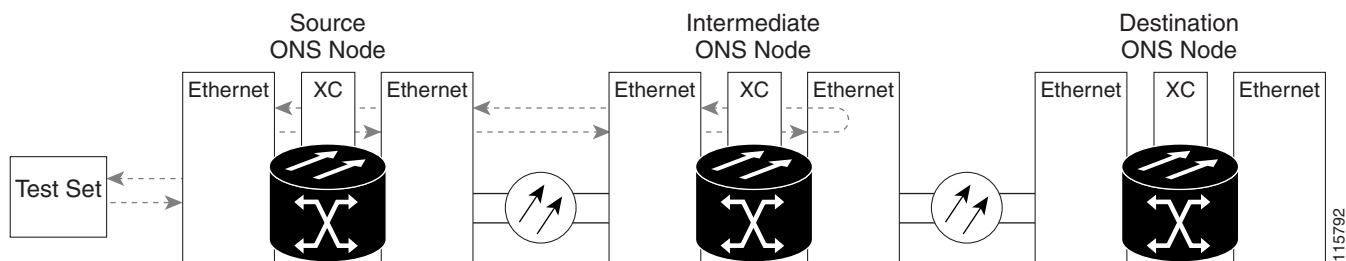
Figure 1-34 Terminal Loopback on an Intermediate-Node Ethernet Port

In the next troubleshooting test, you perform a terminal loopback on the intermediate-node port to isolate whether the destination port is causing circuit trouble. In the example situation in [Figure 1-34](#), the terminal loopback is performed on an intermediate Ethernet port in the circuit. You first create a bidirectional circuit that originates on the source-node Ethernet port and loops back on the intermediate-node port. You then proceed with the terminal loopback test. If you successfully complete a terminal loopback on the node, this node is excluded from possible sources of circuit trouble.

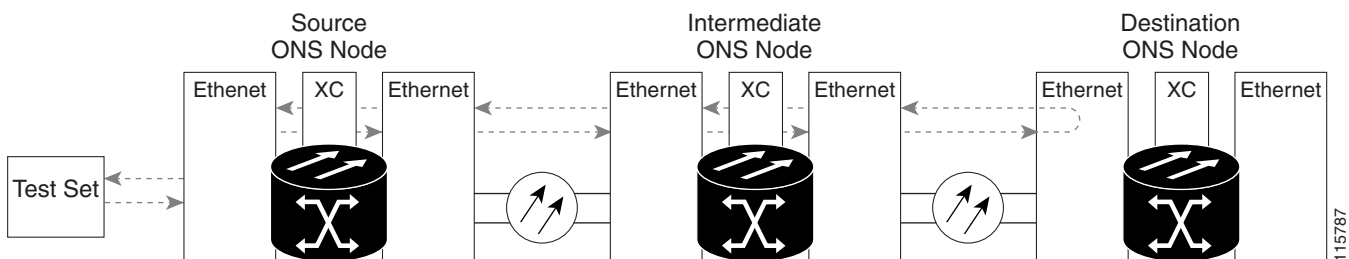
Figure 1-35 Facility Loopback on a Destination-Node Ethernet Port

You perform a facility loopback test at the destination port to determine whether this local port is the source of circuit trouble. The example in [Figure 1-35](#) shows a facility loopback being performed on an Ethernet port.

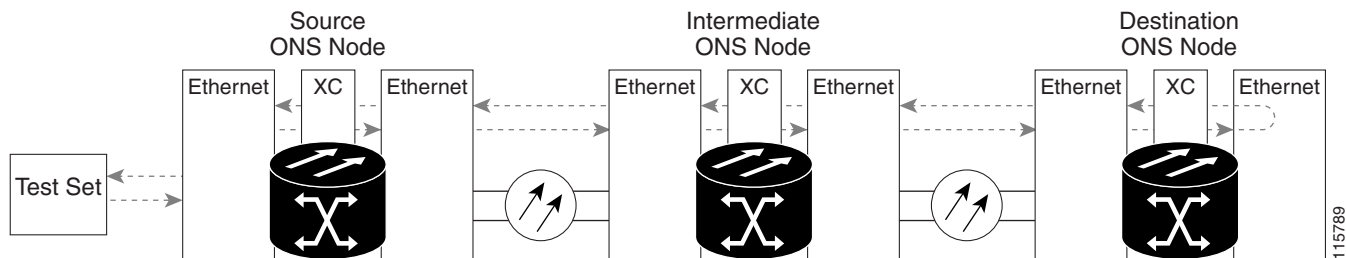
Figure 1-36 Terminal Loopback on a Destination-Node Ethernet Port

The terminal loopback at the destination-node port is the final local hardware error elimination in the circuit troubleshooting process. If this test is completed successfully, you have verified that the circuit is good up to the destination port. The example in [Figure 1-29](#) shows a terminal loopback on an intermediate-node destination Ethernet port.

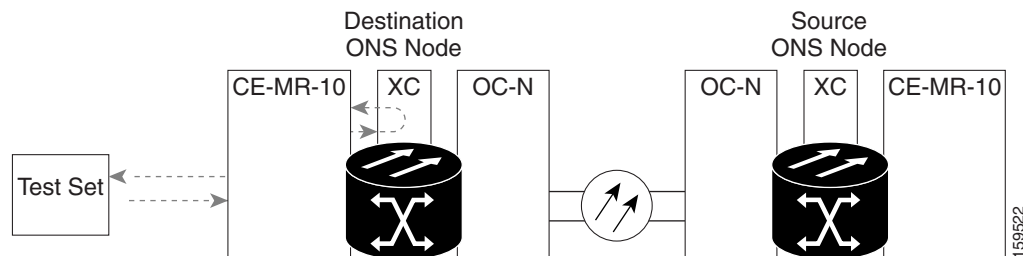
Figure 1-37 Hairpin on a Destination-Node Ethernet Port

The hairpin test is performed on the cross-connect card in the network circuit. A hairpin circuit uses the same port as source as well as destination. Completing a successful hairpin through the card isolates the possibility that the cross-connect card is the cause of the faulty circuit. [Figure 1-37](#) shows an example of a hairpin loopback on a destination-node port.

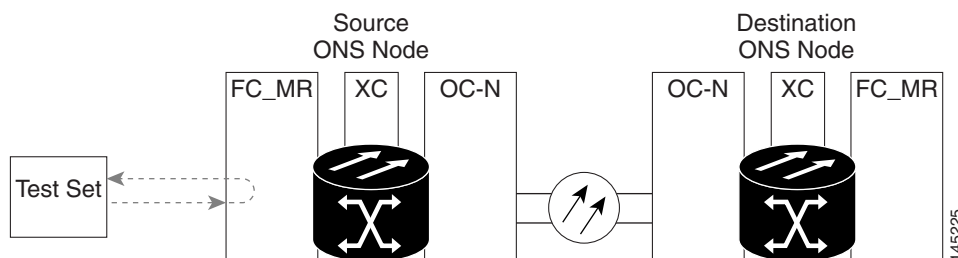
Figure 1-38 Facility Loopback on a Circuit Source FC_MR Port

[Figure 1-38](#) shows an example of a facility loopback on a circuit source FC_MR port.

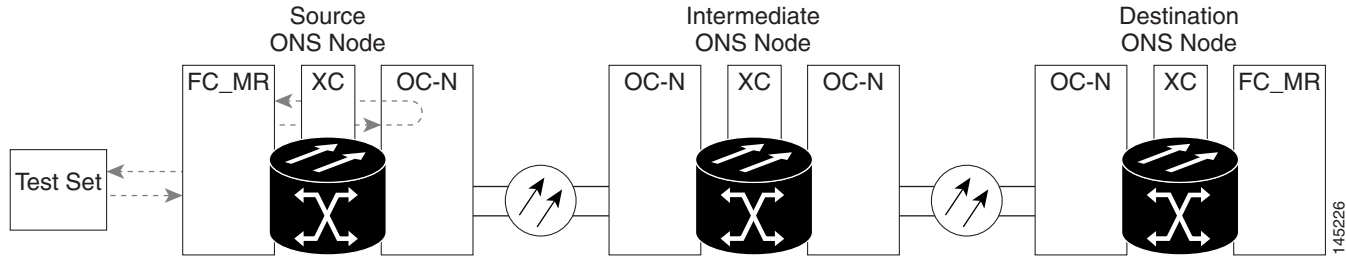
Figure 1-39 Terminal Loopback on a Source-Node FC_MR Port

The terminal loopback test is performed on the node source FC_MR muxponder or transponder port. For the circuit in this example, the test port is the source FC_MR port in the source node. Completing a successful terminal loopback to a node source port verifies that the circuit is good to the source port. [Figure 1-39](#) shows an example of a terminal loopback on a source FC_MR port.

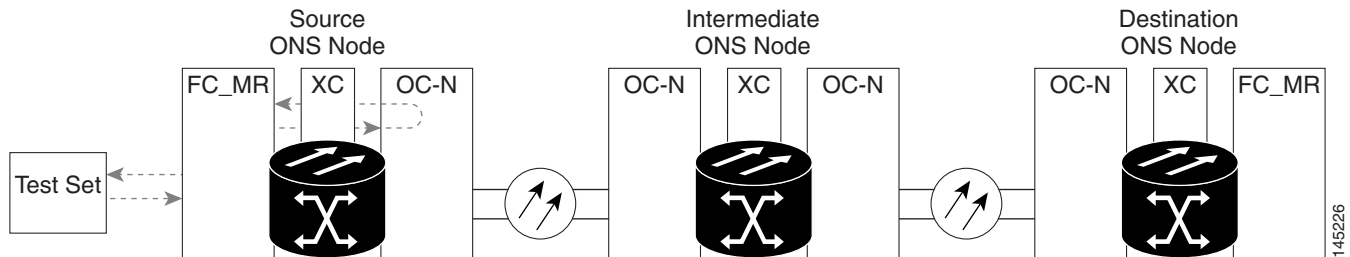
Figure 1-40 Facility Loopback on an Intermediate-Node FC_MR Port

Performing the facility loopback test on an intermediate port determines whether this node is causing circuit failure. In the example shown in [Figure 1-40](#), the test is being performed on an intermediate FC_MR port.

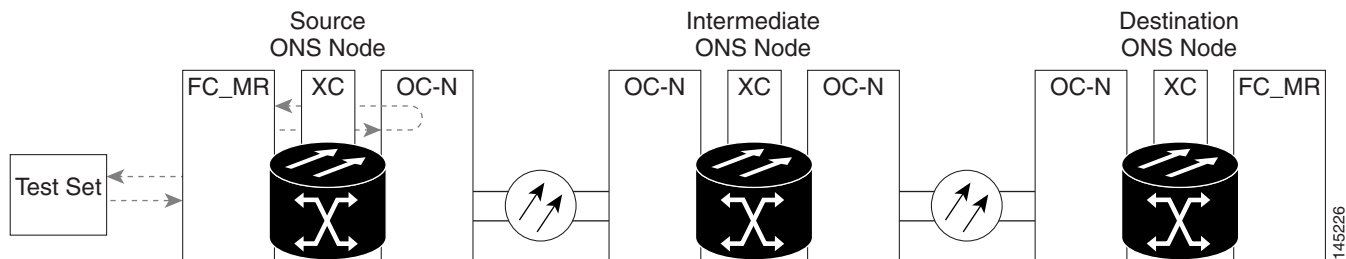
Figure 1-41 Terminal Loopback on an Intermediate-Node FC_MR Port

In the next troubleshooting test, you perform a terminal loopback on the intermediate-node port to isolate whether the destination port is causing circuit trouble. In the example situation in [Figure 1-41](#), the terminal loopback is performed on an intermediate FC_MR port in the circuit. If you successfully complete a terminal loopback on the node, this node is excluded from possible sources of circuit trouble.

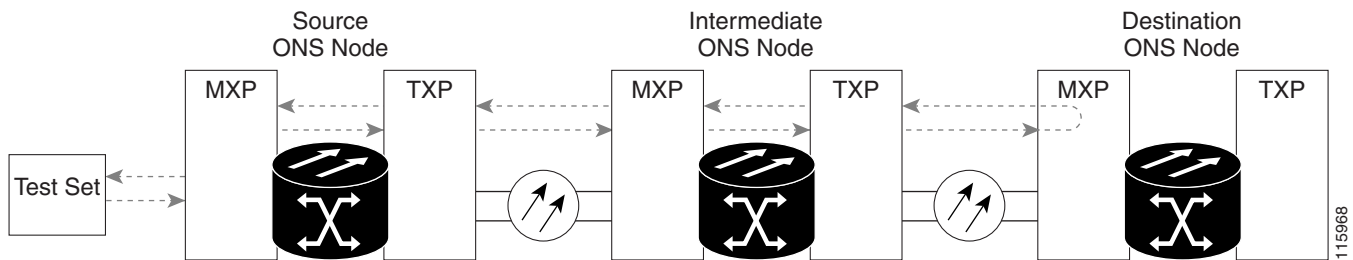
Figure 1-42 Facility Loopback on a Destination-Node FC_MR Port

You perform a facility loopback test at the destination port to determine whether this local port is the source of circuit trouble. The example in [Figure 1-42](#) shows a facility loopback being performed on an FC_MR port.

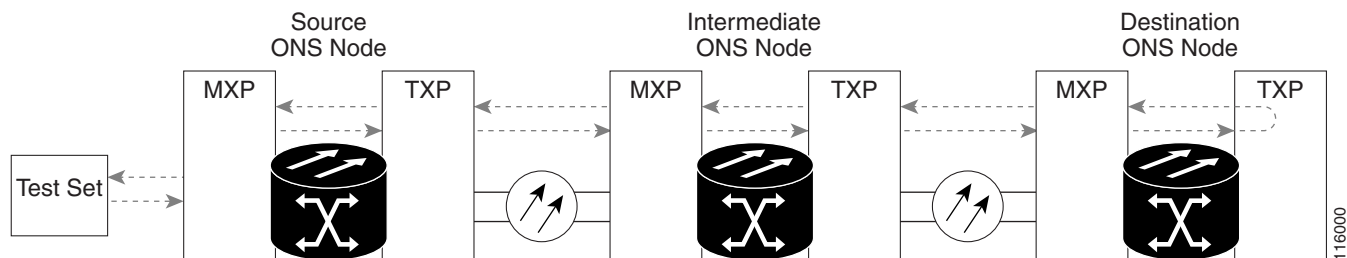
Figure 1-43 Terminal Loopback on a Destination-Node FC_MR Port

The terminal loopback at the destination-node port is the final local hardware error elimination in the circuit troubleshooting process. If this test is completed successfully, you have verified that the circuit is good up to the destination port. The example in [Figure 1-43](#) shows a terminal loopback on an intermediate-node destination FC_MR port.

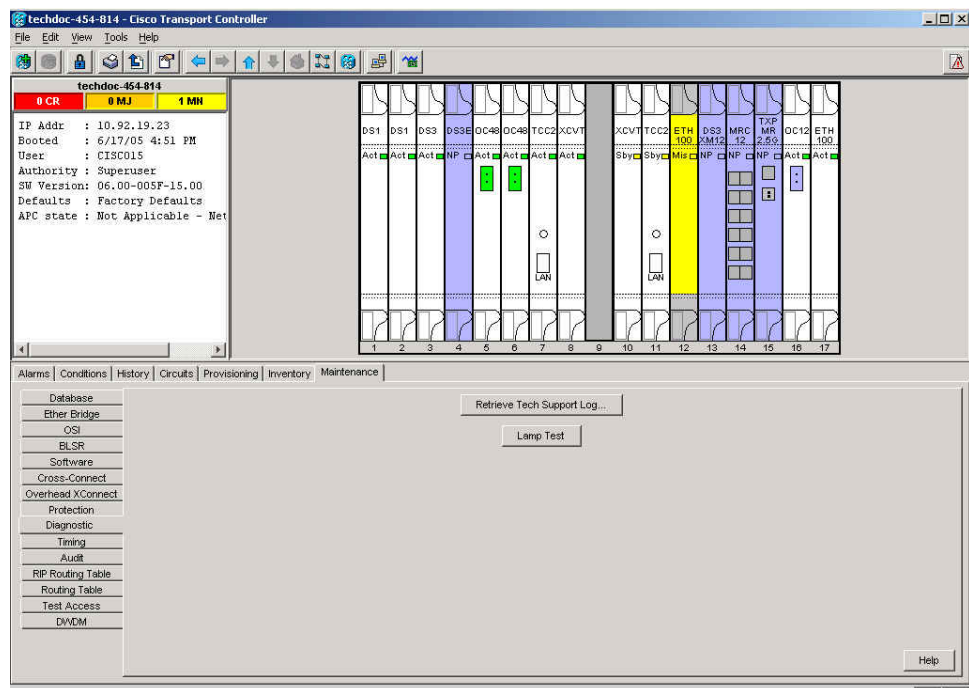
Figure 1-44 CTC Node View Diagnostic Window

Step 1 In node view, click the **Maintenance > Diagnostic** tabs (Figure 1-44).

- Step 1** In the node view, click the **Maintenance > Diagnostic** tabs (Figure 1-44).
- Step 2** Click **Retrieve Tech Support Log**.
- Step 3** In the Saving Diagnostic File dialog box, navigate to the directory (local or network) where you want to save the file.
- Step 4** Enter a name in the File Name field.
- You do not have to give the archive file a particular extension. It is a compressed file (gzip) that can be unzipped and read by Cisco Technical Support.
- Step 5** Click **Save**.
- The Get Diagnostics status window shows a progress bar indicating the percentage of the file being saved, then shows “Get Diagnostics Complete.”
- Step 6** Click **OK**.
-

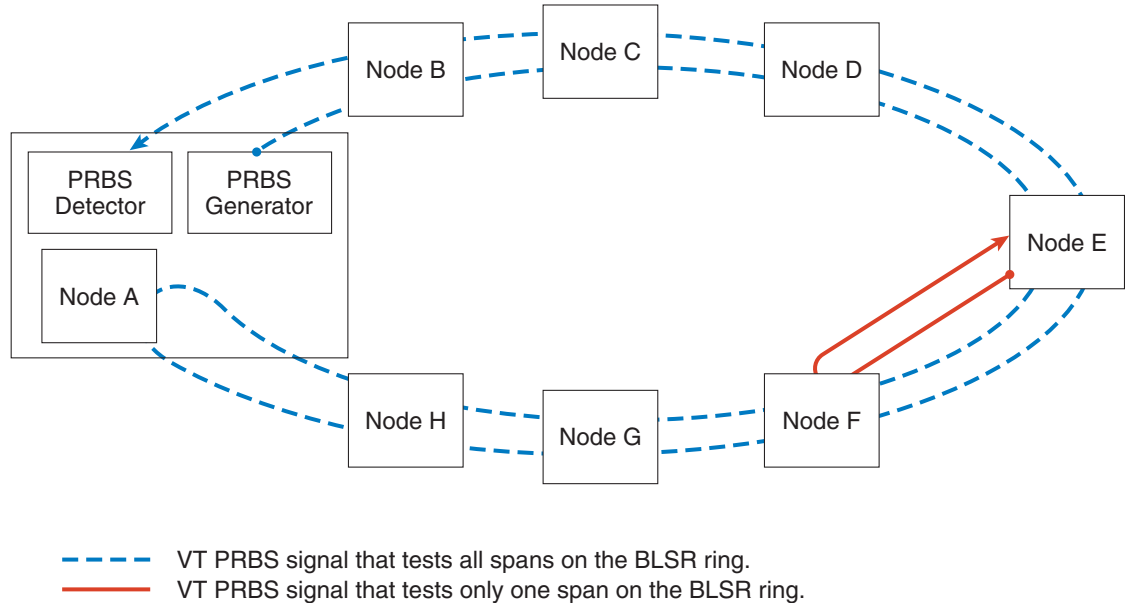
Figure 1-45 CTC Node View Diagnostic Window

The diagnostic circuit can be configured for an end-to-end or multiple-node path layout, traversing the transmit and receive standby paths as shown in Figure 1-45.

NOTE: The end without the arrow is where the PRBS pattern is generated. The end with the arrow is the end where the PRBS pattern is detected.

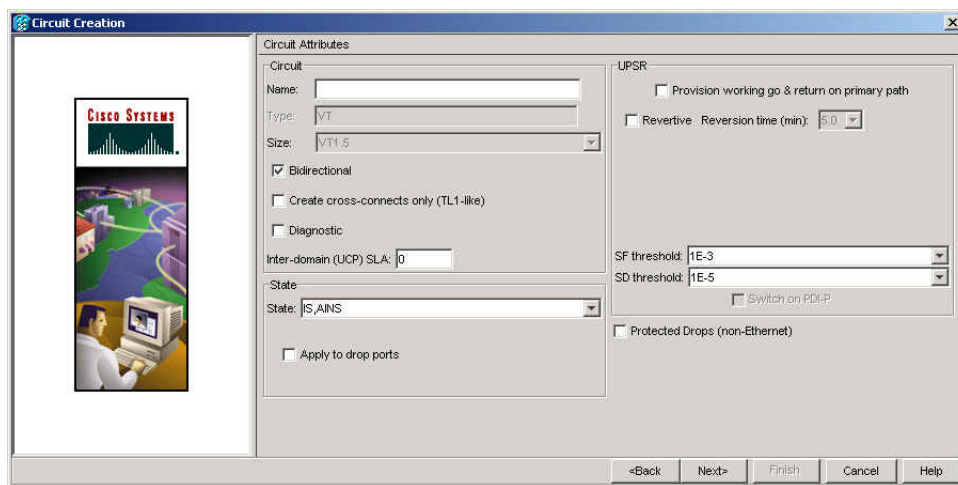
Figure 1-46 Network View Circuit Creation Dialog Box

- Step 6** Click **Next**.
- Step 7** Define the circuit attributes in the Circuit Creation Dialog Box ([Figure 1-46](#)) using the following parameters:

- Name—Assign a name to the circuit. The name can be alphanumeric and up to 48 characters, (including spaces). Circuit names should be 44 characters or less if you want the ability to create monitor circuits. If you leave the field blank, CTC assigns a default name to the circuit.
- Size—VT1.5 is the default. You cannot change it.

- Bidirectional—This is the default value. Leave it checked for this circuit.
- State—This option is not available when you check the Diagnostic option.
- Diagnostic—Check this box to create a diagnostic circuit.
- Apply to drop ports—Leave this box unchecked.
- Create cross-connects only (TL1-like)—Not applicable to diagnostic circuits.
- Inter-domain (UCP) SLA—Not applicable to diagnostic circuits.
- Protected Drops—Not applicable to diagnostic circuits.

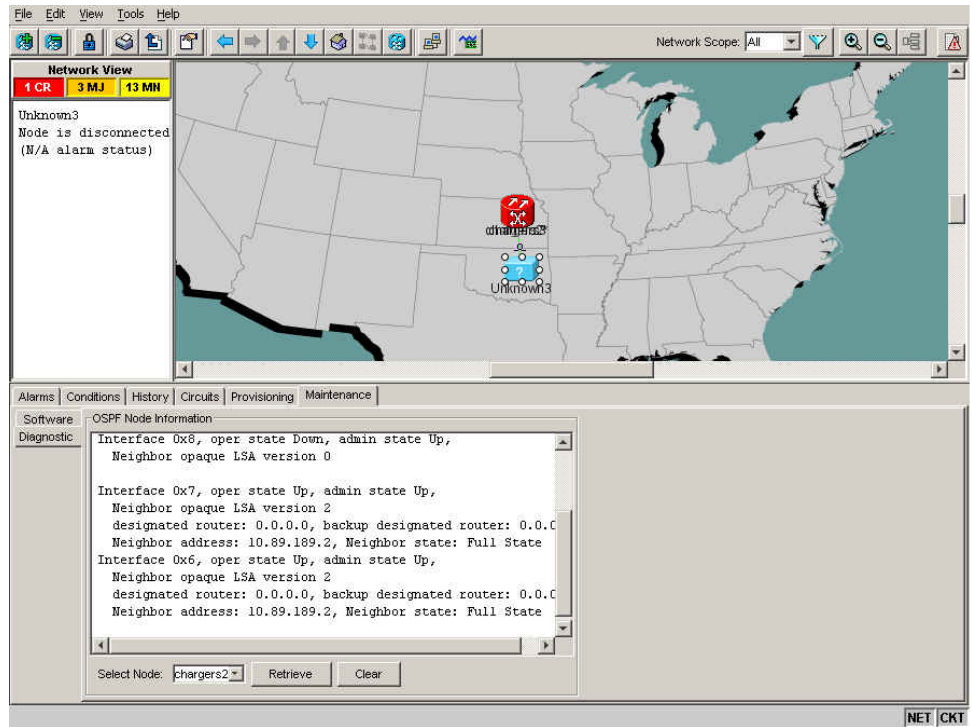
Figure 1-47 DCN Tools OSPF Dump

CTC contains a data communications network (DCN) tool that assists with network troubleshooting for Open Shortest Path First (OSPF) networks. This tool, located in network view, is shown in [Figure 1-47](#). It executes an internal dump command to retrieve information about all nodes accessible from the entry point.

The dump, which provides the same information as a dump executed by special networking commands, is available at the network view in the Maintenance > Diagnostic tabs. You can select the access point node in the Select Node drop-down list. To create the dump, click Retrieve. (To clear the dump, click Clear.)

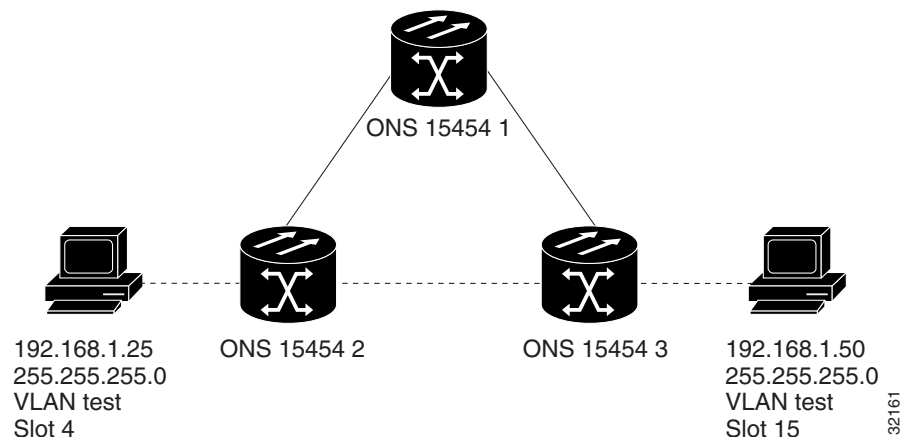
**Figure 1-49 Ethernet Connectivity Reference**

**Recommended Action** You can fix most connectivity problems in an Ethernet network by following a few guidelines. See [Figure 1-49](#) when using the steps in the “Verify Ethernet Connections” procedure on page 1-131.

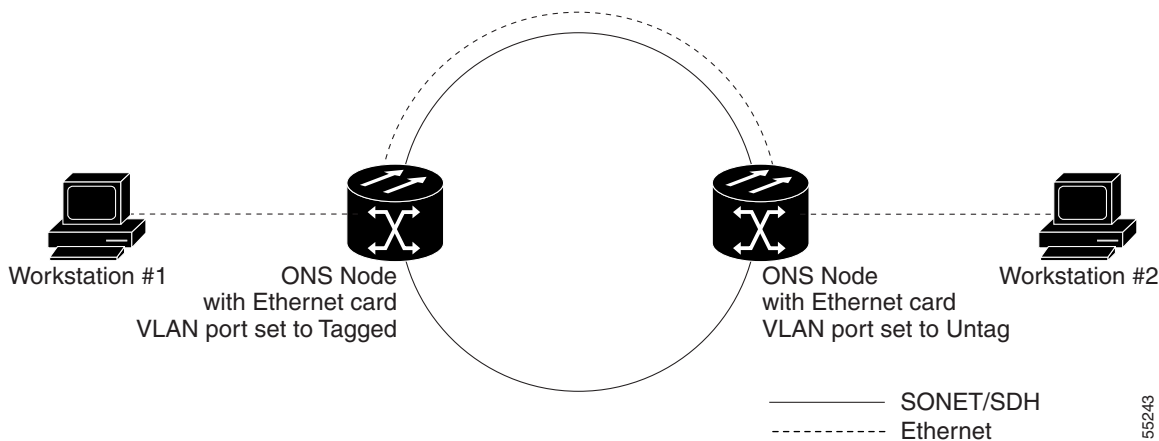
**Figure 1-50** VLAN with Ethernet Ports at Tagged and Untag

**Symptom** Networks that have a VLAN with one ONS 15454 Ethernet card port set to Tagged and one ONS 15454 Ethernet card set to Untag might have difficulty implementing Address Resolution Protocol (ARP) for a network device attached to the Untag port ([Figure 1-50](#)). They might also see a higher than

**Recommended Action** The solution is to set both ports in the VLAN to Tagged to stop the stripping of the 4 bytes from the data packet and prevent the NIC card in the network access device from recognizing the packet as a runt and dropping it. Network devices with IEEE 802.1Q-compliant NIC cards accept the tagged packets. Network devices with non-IEEE 802.1Q compliant NIC cards still drop these tagged packets. The solution might require upgrading network devices with non-IEEE 802.1Q compliant NIC cards to IEEE 802.1Q compliant NIC cards. You can also set both ports in the VLAN to Untag, but you will lose IEEE 802.1Q compliance.

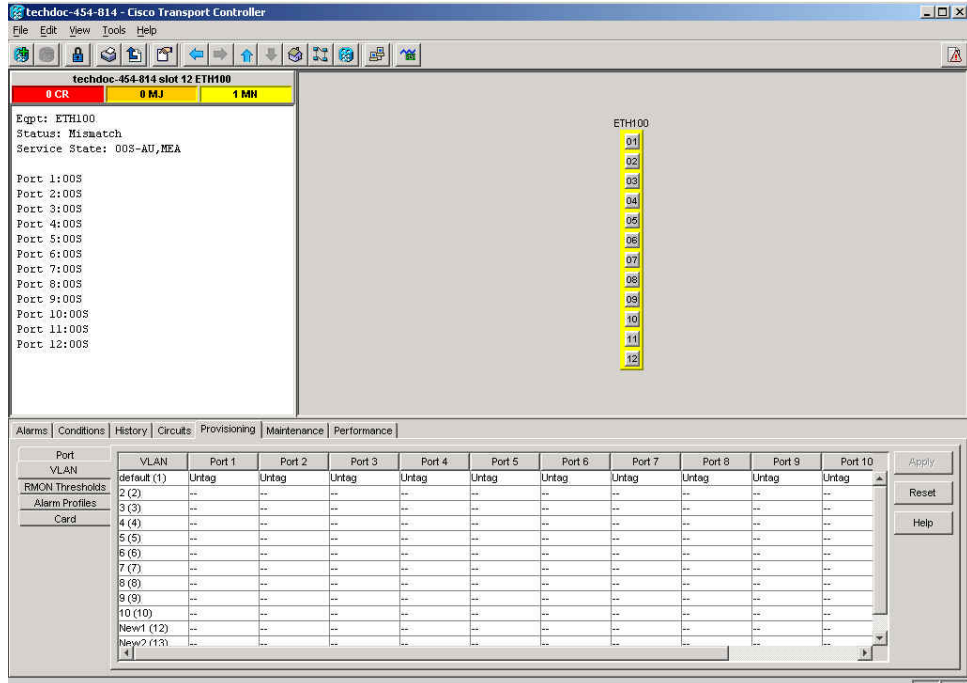
Figure 1-51 Configuring VLAN Membership for Individual Ethernet Ports

- Step 1** Open the CTC card view for the Ethernet card involved in the problem VLAN.
- Step 2** Click the **Provisioning > Ether VLAN** tabs (Figure 1-51).

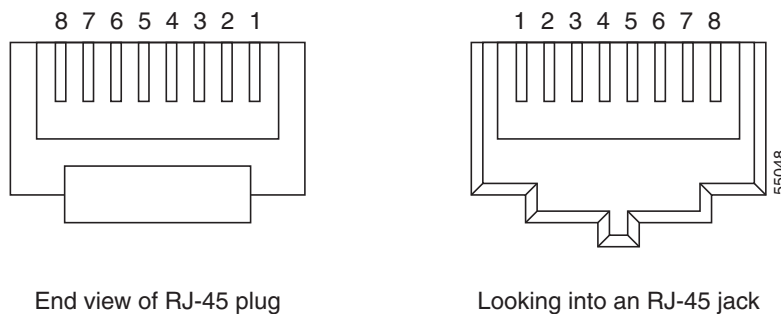
**Figure 1-52 RJ-45 Pin Numbers**

You can crimp your own LAN cables for use with the ONS 15454. Use a cross-over cable when connecting an ONS 15454 to a hub, LAN modem, or switch, and use a LAN cable when connecting an ONS 15454 to a router or workstation. Use Category-5 cable RJ-45 T-568B, Color Code (100 Mbps), and a crimping tool. [Figure 1-52](#) shows the wiring of an RJ-45 connector. [Figure 1-53](#) shows a LAN cable layout, and [Table 1-4](#) shows the cable pinouts. [Figure 1-54](#) shows a cross-over cable layout, and [Table 1-5](#) shows the cross-over pinouts.

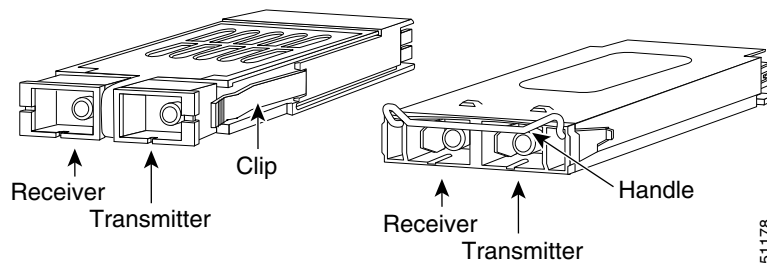
**Figure 1-55** GBICs

GBICs are available in two different models. One GBIC model has two clips (one on each side of the GBIC) that secure the GBIC in the slot on the E1000-2-G, G-Series, or G1K-4 card. The other model has a locking handle. Both models are shown in [Figure 1-55](#).

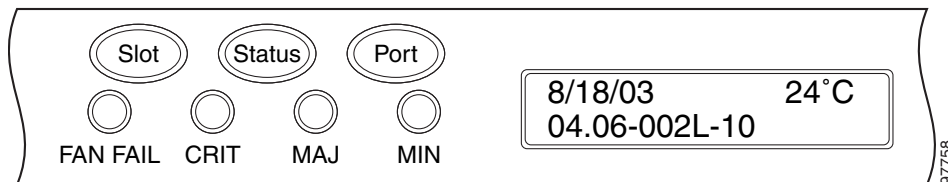
**Figure 2-1 Shelf LCD Panel**

- Step 1** View the temperature displayed on the ONS 15454 LCD front panel ([Figure 2-1](#)).

- Step 2** If the temperature of the shelf exceeds 194 degrees F (90 degrees C), the alarm should clear if you solve the ONS 15454 temperature problem. Complete the [“Clear the HITEMP Alarm” procedure on page 2-125](#).
- Step 3** If the temperature of the shelf is under 194 degrees F (90 degrees C), the HITEMP alarm is not the cause of the AUTOLSROFF alarm. Complete the [“Physically Replace a Traffic Card” procedure on page 2-274](#) for the OC-192 card.
- Step 4** If card replacement does not clear the alarm, call Cisco TAC 1 800 553-2447 to discuss the case and if necessary open a returned materials authorization (RMA) on the original OC-192 card.

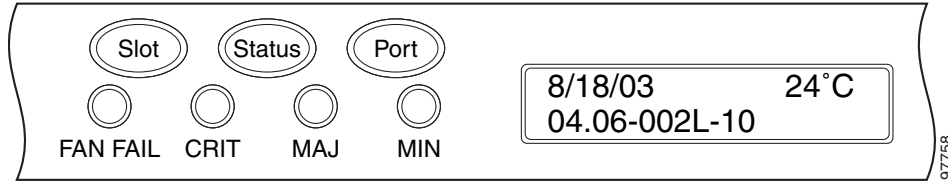
Figure 2-2 Shelf LCD Panel

-
- Step 1** View the temperature displayed on the ONS 15454 LCD front panel ([Figure 2-2](#)).

- Step 1** Check for any outstanding alarms that were raised against the active and standby TCC2/TCC2P and resolve them.
- Step 2** If the alarm does not clear, determine whether the LCD display on the fan tray ([Figure 2-2 on page 2-126](#)) is blank or if the text is garbled. If so, proceed to [Step 8](#). If not, continue with [Step 3](#).
- Step 3** At the earliest maintenance window, reset the standby TCC2/TCC2P:
