Cisco ONS 15454 Troubleshooting Guide

Product and Documentation Release 8.5
September 2010

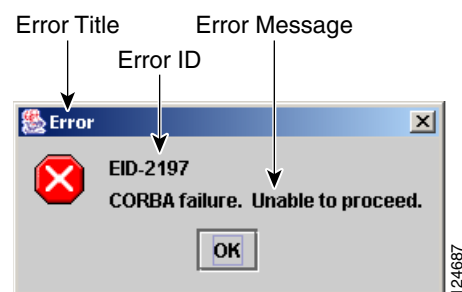
**Figure 4-1** Error Dialog Box

This chapter lists the Cisco ONS 15454, Cisco 15454 SDH, Cisco ONS 15600, Cisco 15600 SDH, Cisco ONS 15310-CL, and Cisco ONS 15310-MA error messages. The error dialog box in [Figure 4-1](#) consists of three parts: the error title, error ID, and error message. The table lists two types of messages: error messages (EID-*nnnn*) and warning messages (WID-*nnnn*). Error messages are alerts that an unexpected or undesirable operation has occurred which either indicates the risk of loss of traffic or an inability to properly manage devices in the network. Warnings are alerts that the requested operation could lead to an error. Warnings are sometimes used to convey important information.
