Cisco ONS 15454 DWDM Troubleshooting Guide, Release 9.2

Text Part Number: 78-19394-02

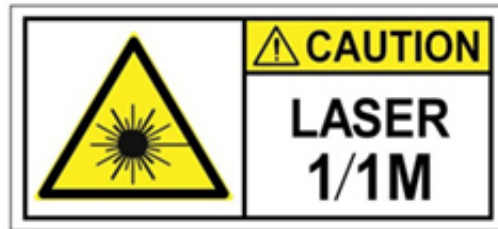
Cisco NCS 2000 Series cards are classified as Laser Class 1 or 1M as per IEC 60825-1 and Hazard Level 1M as per IEC 60825-2.
