## **Troubleshooting Guide for Cisco NCS 1010, IOS XR Releases 7.9.x**

**First Published:** 2023-02-03

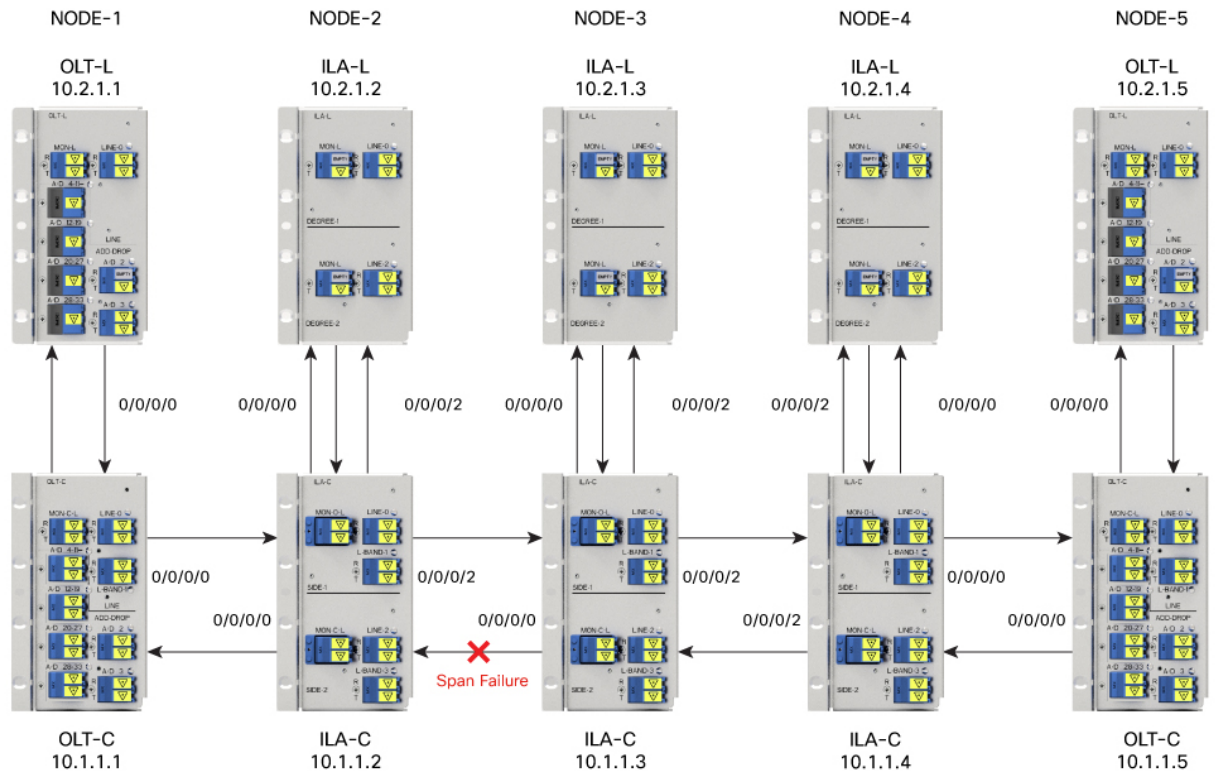
Figure 3: Example of Span Failure

To troubleshoot span failure on a C+L band network, start by running the following commands on the manager nodes in the same order:

**Step 1** Run the `show olc band-status` command on node 10.1.1.1.

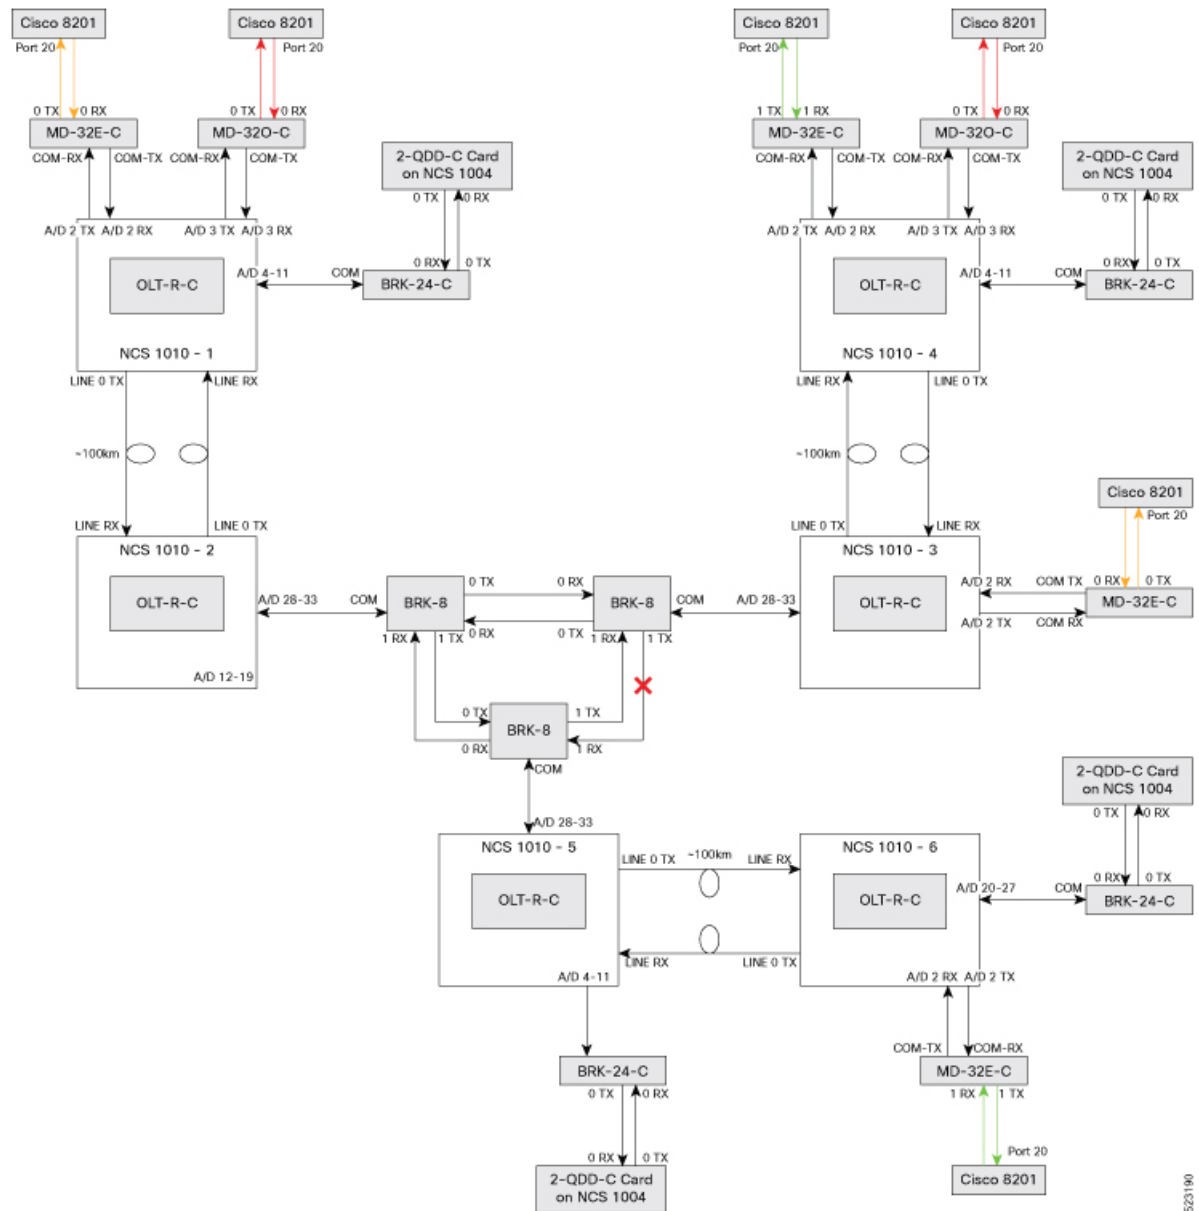
**Figure 7: Fiber Cut Between Two Passive Devices**

The following figure displays the fiber cut between two passive devices:

The following example shows how to determine the fiber cut between two passive devices:
