Troubleshooting Guide for Cisco NCS 1020, IOS XR Release 24.3.x

First Published: 2024-09-04

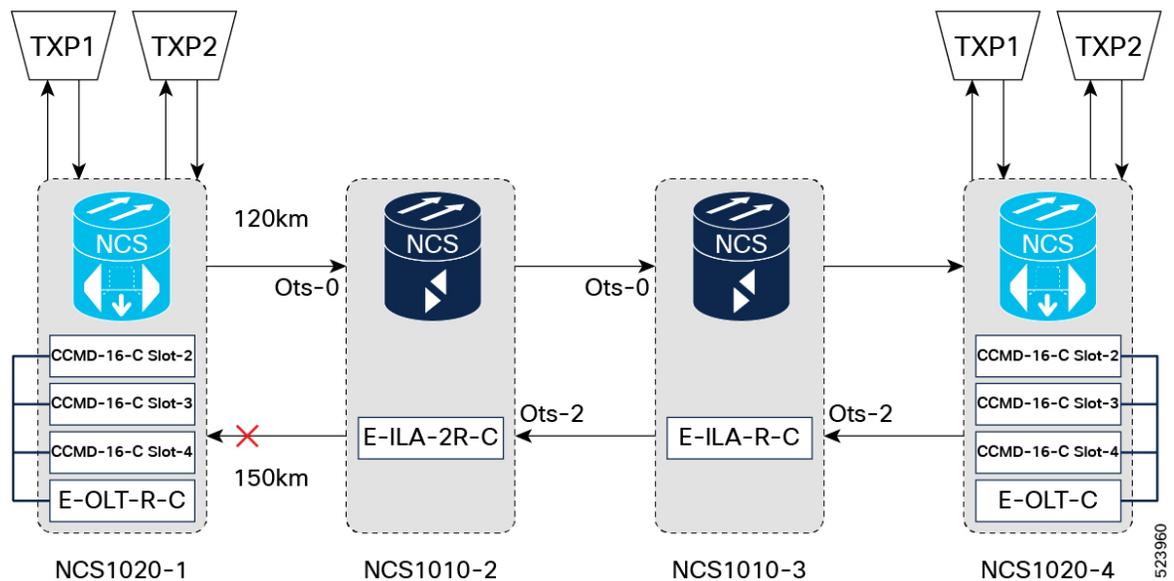
The following figure shows loss of fiber connection continuity at the Line port:

Figure 2: Fiber Cut at the Line OTS Controller

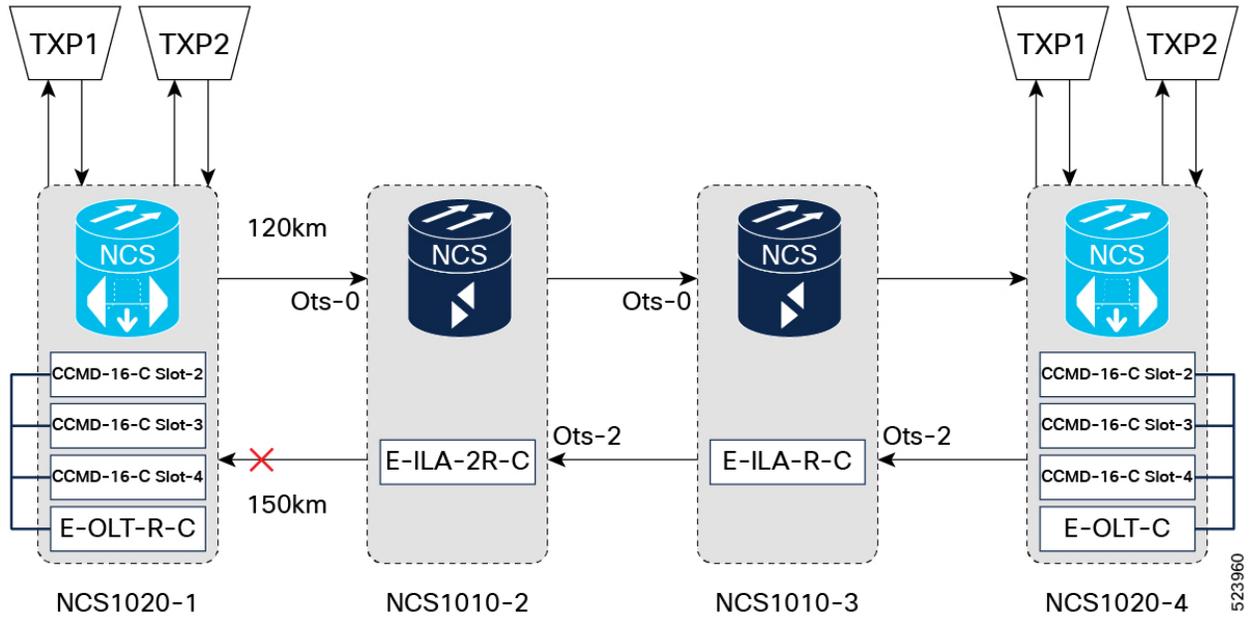
The following figure displays line unidirectional fiber cut on a NCS 1020:

Figure 3: Unidirectional Fiber Cut on Line

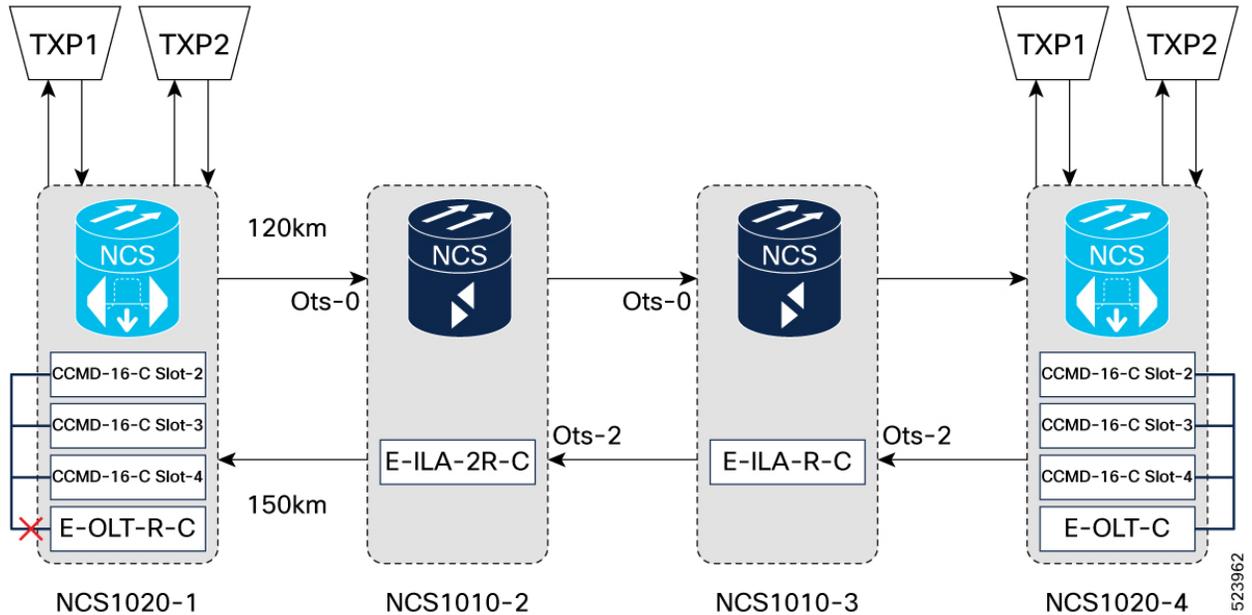
The following figure displays fiber cut between CCMD and OLT:

Figure 5: Fiber Cut Between CCMD and OLT

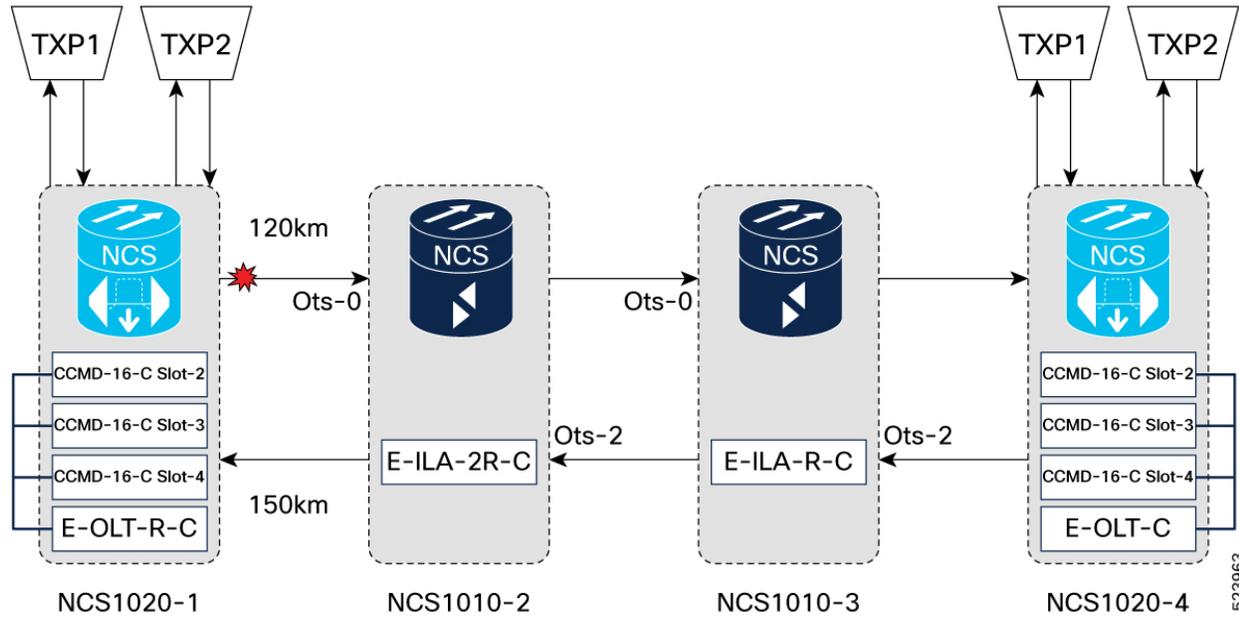
The following figure displays high back reflection condition on the line Tx port:

Figure 6: High Back Reflection Condition on the Line Tx port

High Back Reflection Condition on Line Tx Port 80

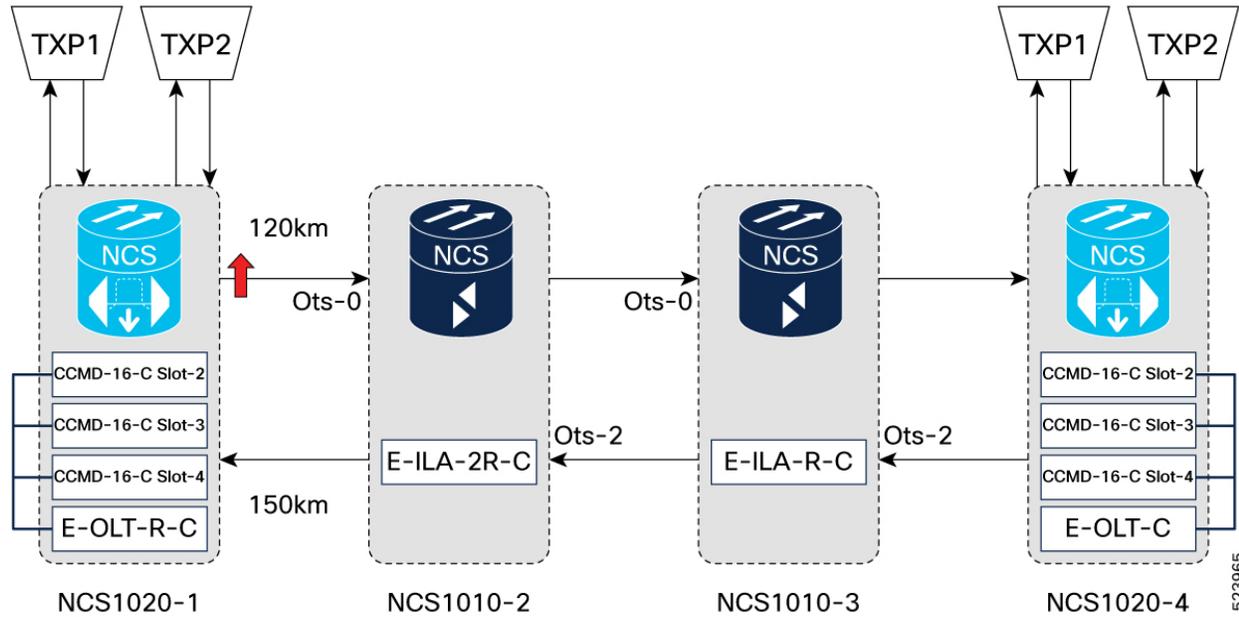
The following figure displays high span loss on line Tx port:

Figure 8: High span loss on Line Tx Port

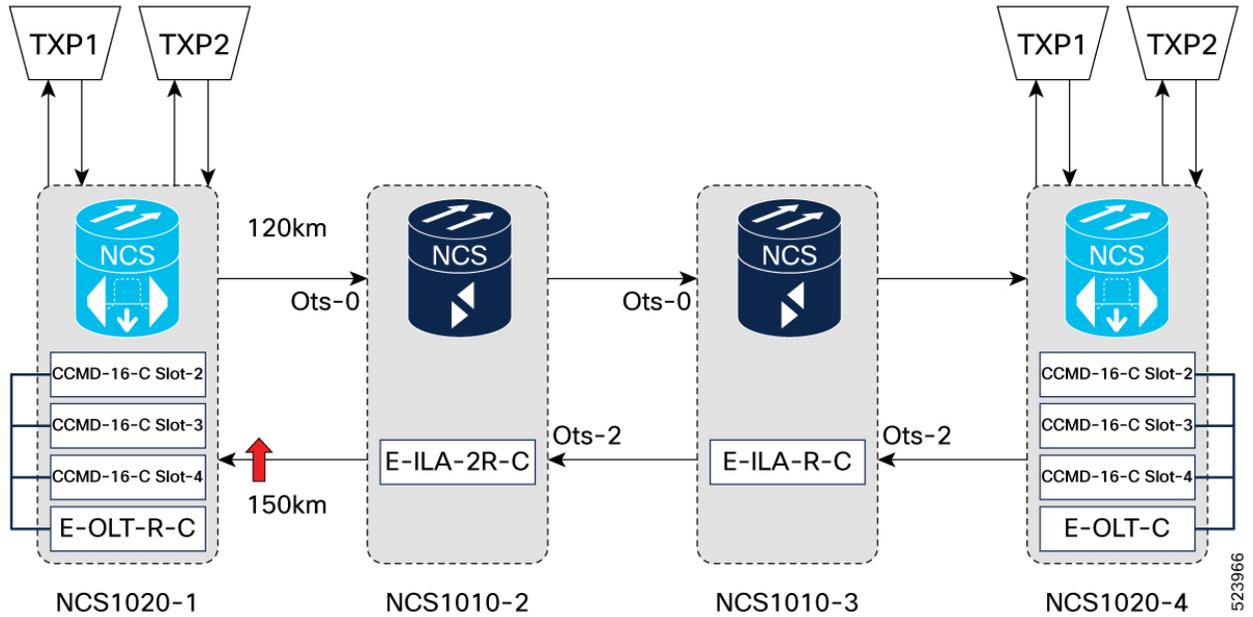
The following figure displays high span loss on the line Rx port:

Figure 9: High span loss on Line Rx port

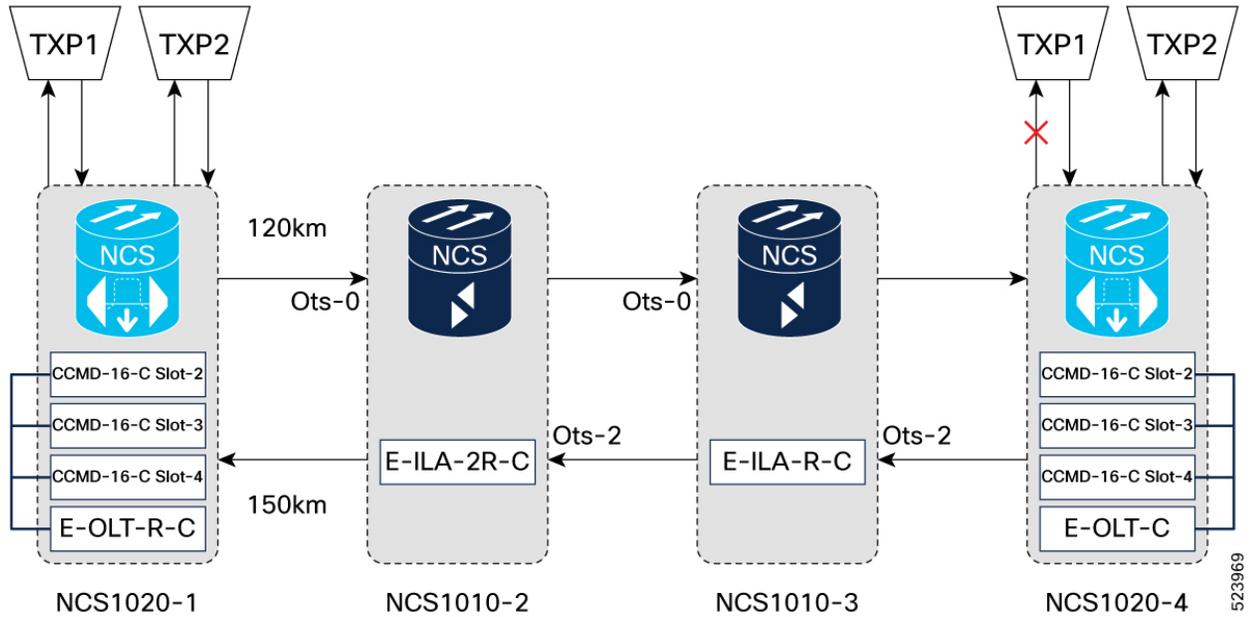
The following figure displays single channel failure due to unidirectional fiber cut at TXP-Tx:

Figure 11: Single Channel Failure due to Unidirectional Fiber Cut at TXP-Tx

Single Channel Failure due to Unidirectional Fiber Cut at TXP-Tx 85
