# Release Notes for the Catalyst 4500 Series Switch, Cisco IOS Release 12.1(20)EW3

**12.1(20)EW3—May 11, 2005**

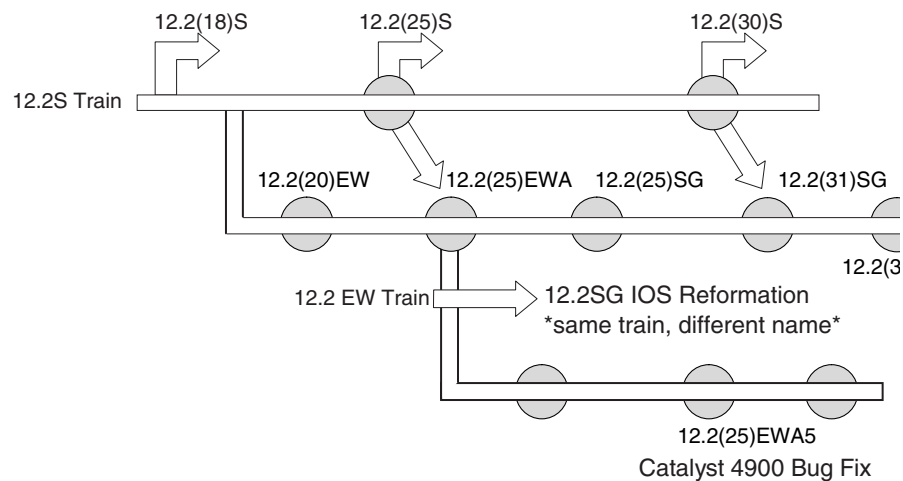
**Figure 1 Software Release Strategy**

[Figure 1](#) shows the Catalyst 4500 series switch Cisco IOS software release strategy.

Starting with Release 12.2(18)EW, additional software features and hardware support are introduced in the 12.2 EW release train of Cisco IOS software for the Catalyst 4500 series switch. Software features such as sticky port security, 802.1X accounting, SmartPort macros, as well as support for the Catalyst 4510R chassis, the the IEEE Power over Ethernet (PoE) line cards are contained in the 12.2 EW release train. The Catalyst 4500 series switch Cisco IOS software in the 12.2 EW release train will continue to offer the latest hardware and software features. The 12.2 S mainline releases will be offered in the future to Catalyst 4500 series switch customers for feature consistency across the Catalyst platforms.
