Release Notes for the Catalyst 4500 Series Switch, Cisco IOS Releases 12.2(37)SG to 12.2(25)SG

12.2(54)SG1—February 7, 2011

These release notes describe the features, modifications, and caveats for the Cisco IOS software on the Catalyst 4500 series switch. The most current software release is Cisco IOS Release 12.2(54)SG.

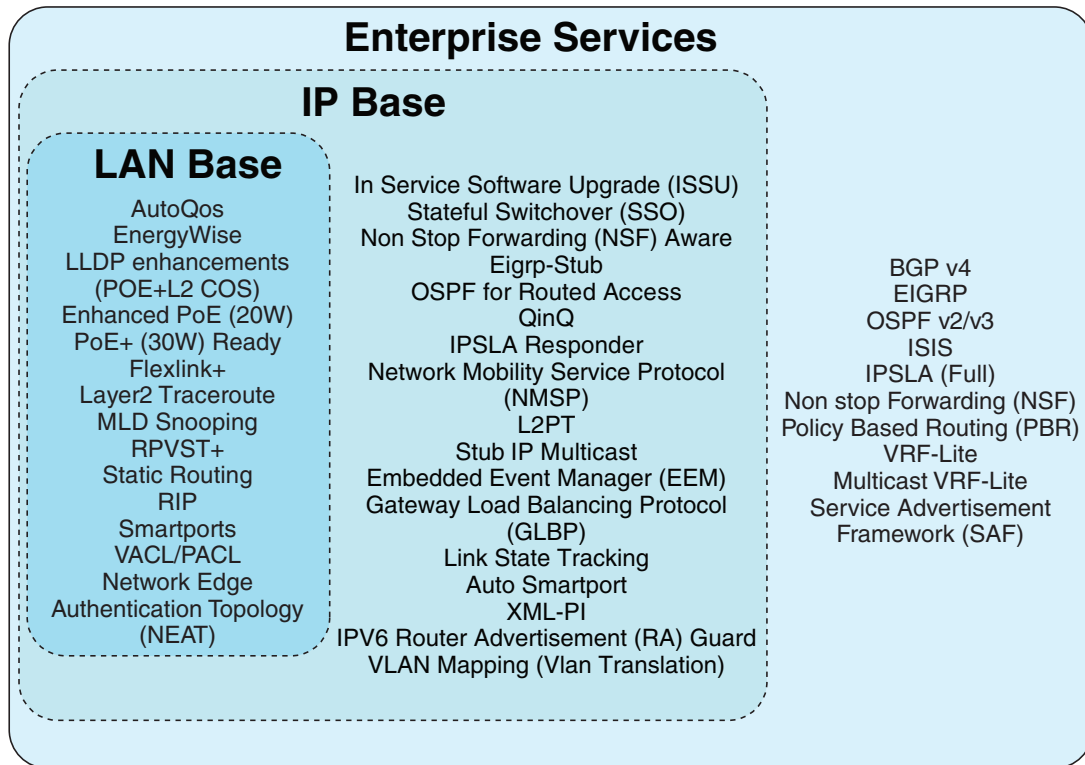
Figure 1 Feature Support by Packages

[Figure 1](#) illustrates feature support within the 3 packages: LAN Base, IP Base, and Enterprise Services. This is not a detailed list. Please visit Feature Navigator for full package details:
<http://tools.cisco.com/ITDIT/CFN/>
