# Release Notes for the Catalyst 4500 Series Switch, Cisco IOS Releases 15.1(1)SG

**Current Release**  
IOS 15.1(1)SG2—November 1, 2012

These release notes describe the features, modifications, and caveats for Cisco IOS Release 15.1(1)SG on the Catalyst 4500 series switch.

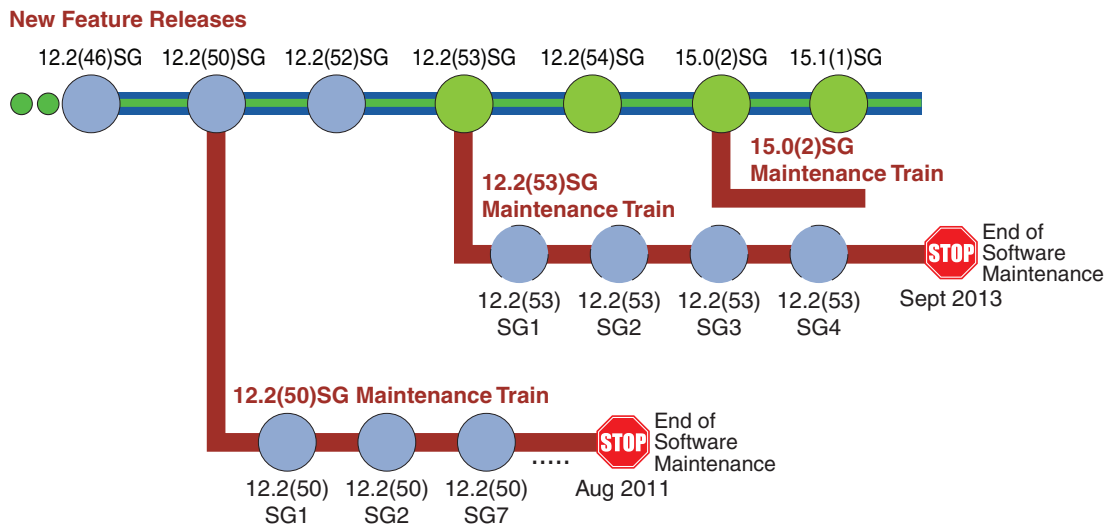
**Figure 1 Software Release Strategy for the Catalyst 4500 Series Switch**

Figure 1 displays the two active trains, 12.2(53)SG and 15.0(2)SG.

The Catalyst 4500 Series Switch has two maintenance trains. Cisco IOS Release 15.0(2)SG is the recommended release for customers who require a release with a maintenance train.
