Release Notes for the Catalyst 4500 Series Switch, Cisco IOS Releases 12.2(54)SGx and 12.2(53)SGx

Current Release
12.2(53)SG11—August 18, 2014

These release notes describe the features, modifications, and caveats for the Cisco IOS software on the Catalyst 4500 series switch. The most current software release is Cisco IOS Release 12.2(54)SG.

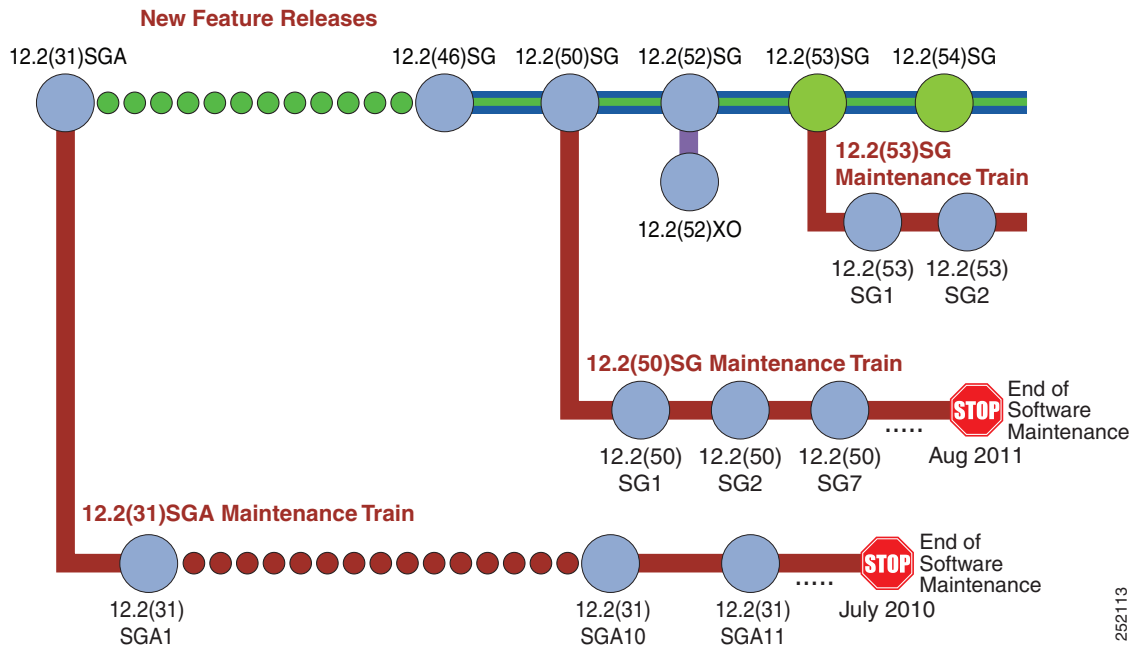
Figure 1 Software Release Strategy for the Catalyst 4500 Series Switch

Figure 1 displays the two active, 12.2(31)SGA and 12.2(50)SG, and newly introduced 12.2(53)SG extended maintenance trains.
