Release Notes for Cisco Aironet Access Points for Cisco IOS Release 15.3(3)JA4

Last Updated: September 28, 2016

This document describes features, enhancements, and caveats for autonomous mode access points using Cisco IOS Release 15.3(3)JBB5.

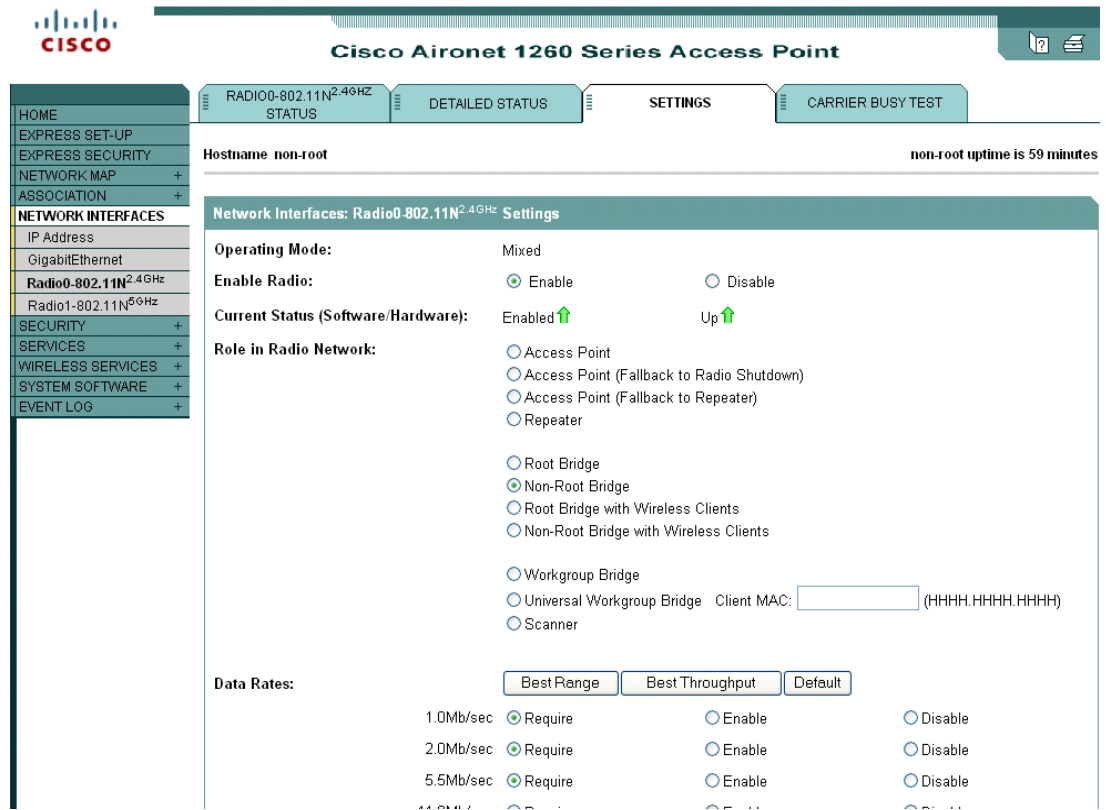
Figure 1 Network Interfaces: Radio Settings Page

- Step 1** Browse to the Network Interfaces: Radio Settings page. [Figure 1](#) shows the top portion of the Network Interfaces: Radio Settings page.

- Step 2 Choose **Disable** to disable the radio.
- Step 3 Click **Apply** at the bottom of the page.
- Step 4 If your access point has two radios, repeat these steps for the second radio.
