Guia de instalação do ISR-WAAS no roteador ISR 4000 Series

Este documento descreve o guia de instalação do Cisco ISR-WAAS no Cisco Integrated Services Router (ISR). É a implementação do Wide Area Application Services (vWAAS) virtual em um Cisco ISR.

O ISR-WAAS é implantado dentro de um contêiner IOS-XE. Um contêiner nesse contexto se refere ao hipervisor que executa aplicativos virtualizados em um roteador Cisco ISR 4000 Series.

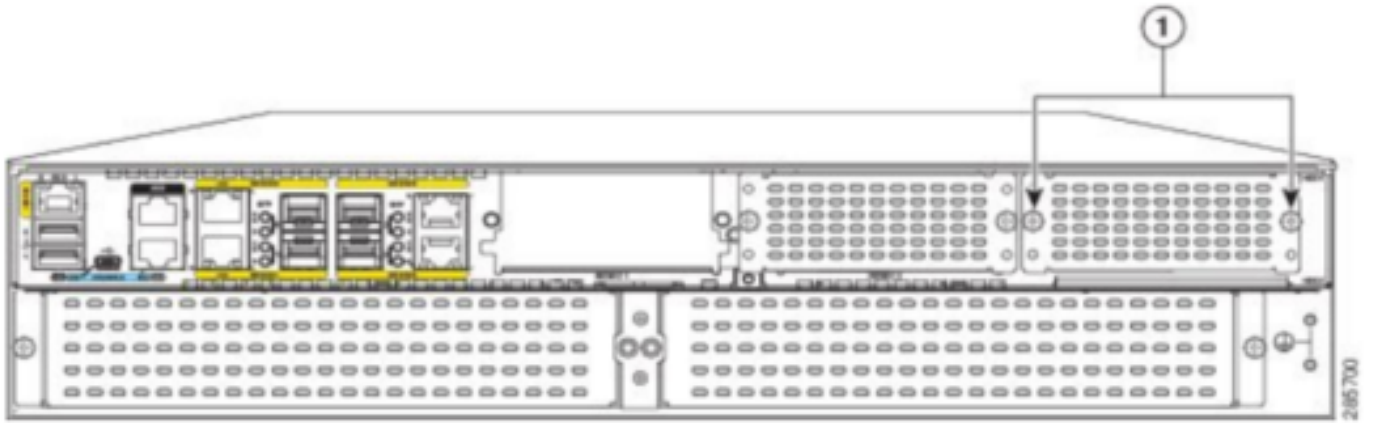
Etapa 1. Use uma chave de fenda Phillips para afrouxar os parafusos prisioneiros de ambos os lados, como mostrado nesta imagem:

1 Captive screws holding the NIM-SSD to the router

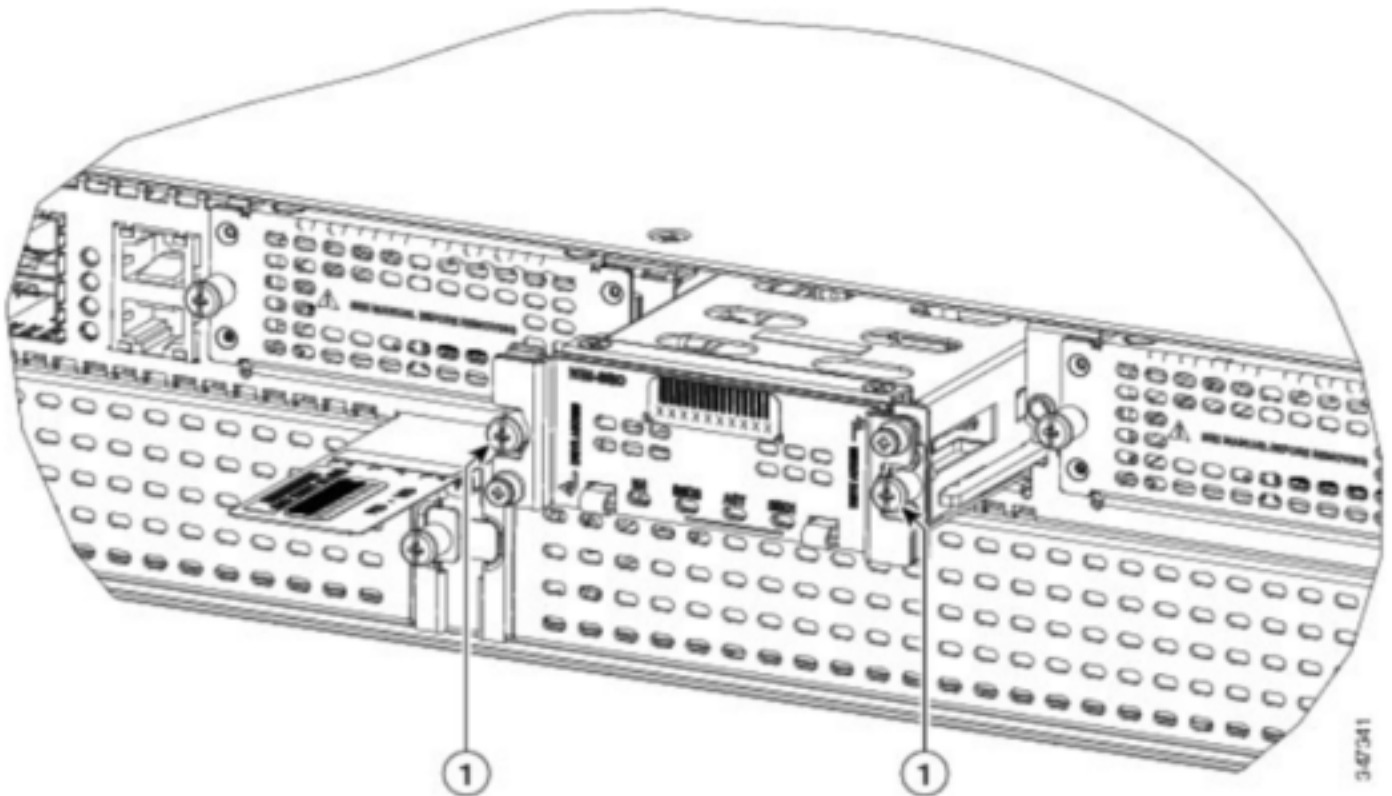
Etapa 2. Remova o NIM-SSD ou NIM-HDD da rota, como mostrado nesta imagem:

1 Captive screws holding the NIM-SSD to the router

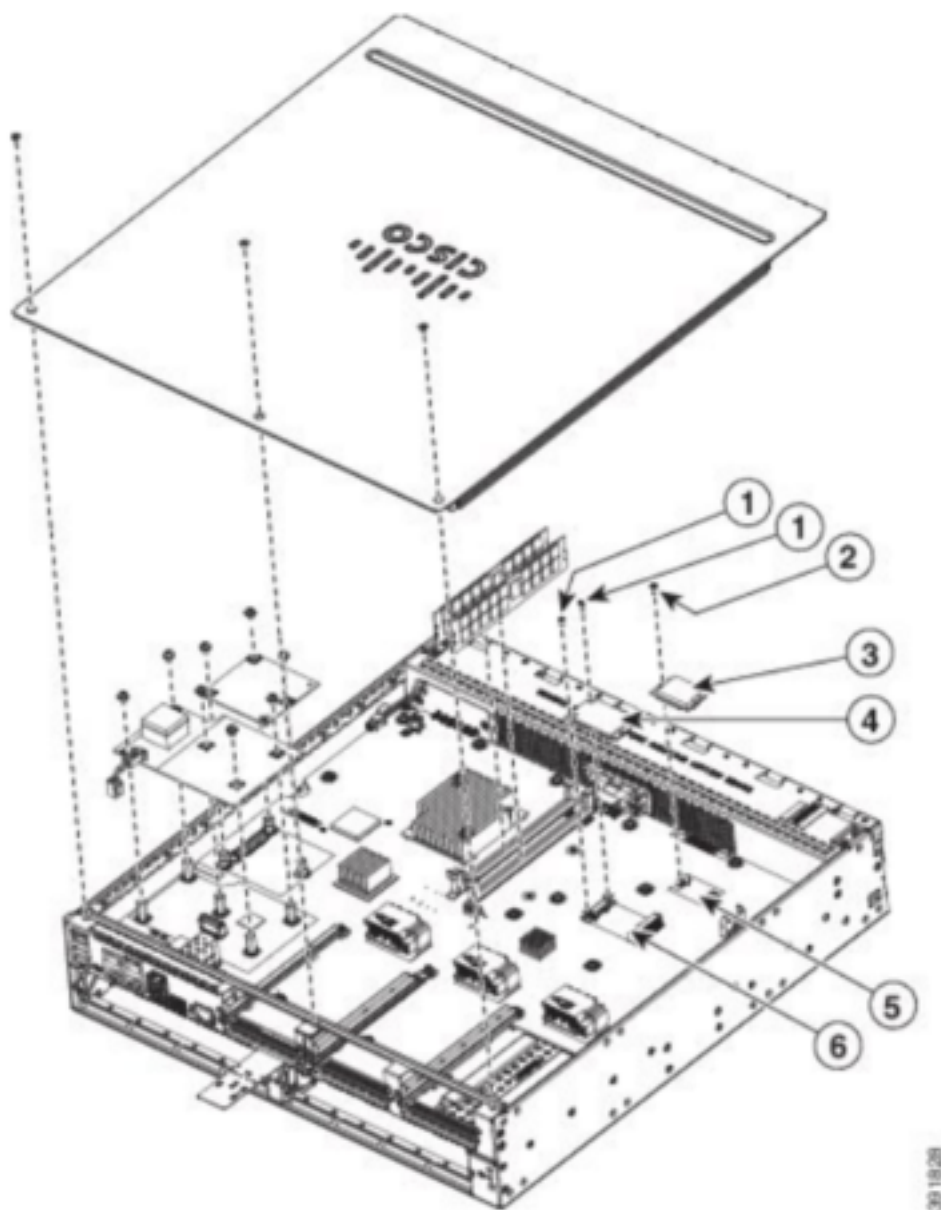
Esta imagem mostra a placa de memória flash e os locais dos dispositivos de armazenamento SSD mSATA :

1	Supplied screw	2	Supplied screw
3	Flash memory card	4	SSD mSATA storage device
5	Flash memory card connector	6	SSD mSATA connector
