排查开放最短路径优先路由数据库问题

本文档介绍如何在数据库中的路由不在路由信息库 (RIB) 或路由表中时修复 OSPF 问题。

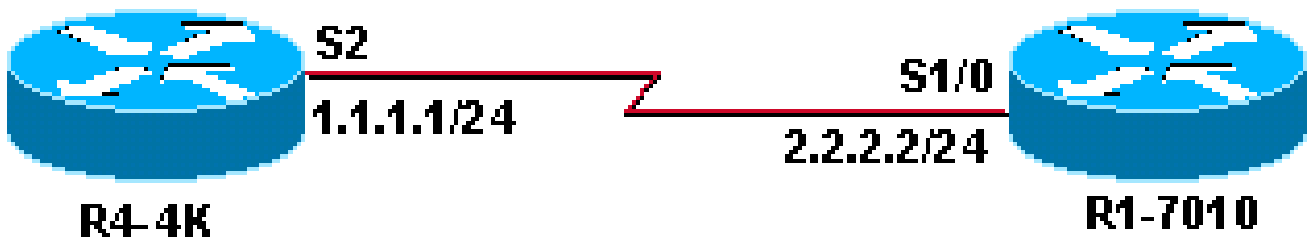
请以以下网络图为例：

此情况产生的行为与双串行链路设置中的[错误地址分配](#)完全相同。要解决此问题，请为两台路由器分配同一子网中的IP地址。

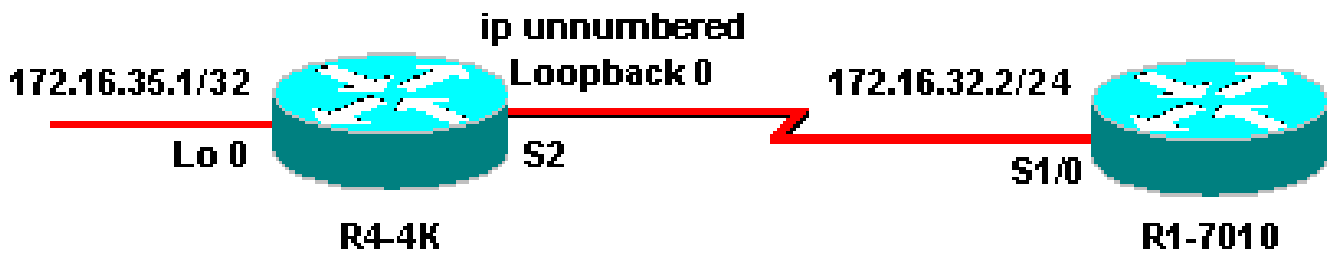
以下一个网络图为例：

R4-4K	R1-7010
<pre><#root> interface Loopback0 ip address 172.16.35.1 255.255.255.255 ! interface Serial2 ip unnumbered Loopback0 router ospf 20 network 172.16.0.0 0.0.255.255 area 0</pre>	<pre>interface Loopback0 ip address 172.16.30.1 255.255.255.255 ! interface Serial1/0 ip address 172.16.32.2 255.255.255.0 clockrate 64000 ! router ospf 20 network 172.16.0.0 0.0.255.255 area 0</pre>

前面的输出显示，R4-4K Serial 2接口未编号为Loopback0（使用Loopback0 172.16.35.1的地址），而R1-7010的Serial 1/0接口为编号接口。

如前所述，两种情况下的network-type都是点对点类型。问题在于一端未编号，而另一端未编号，这样会在数据库中产生差异，如下所示。

您可以看到，R1-7010使用包含其接口地址的Link Data字段为此点对点链路生成LSA，而R4-4K使用包含MIB-II IfIndex值的Link Data字段为同一链路生成LSA([RFC 2328](#))。这会在链路状态数据库中产生差异，这意味着路由表中未安装任何路由。

要解决此问题，请将两台路由器的串行接口配置为已编号或未编号。在本例中，我们对路由器R4-4K的串行2接口进行了编号。

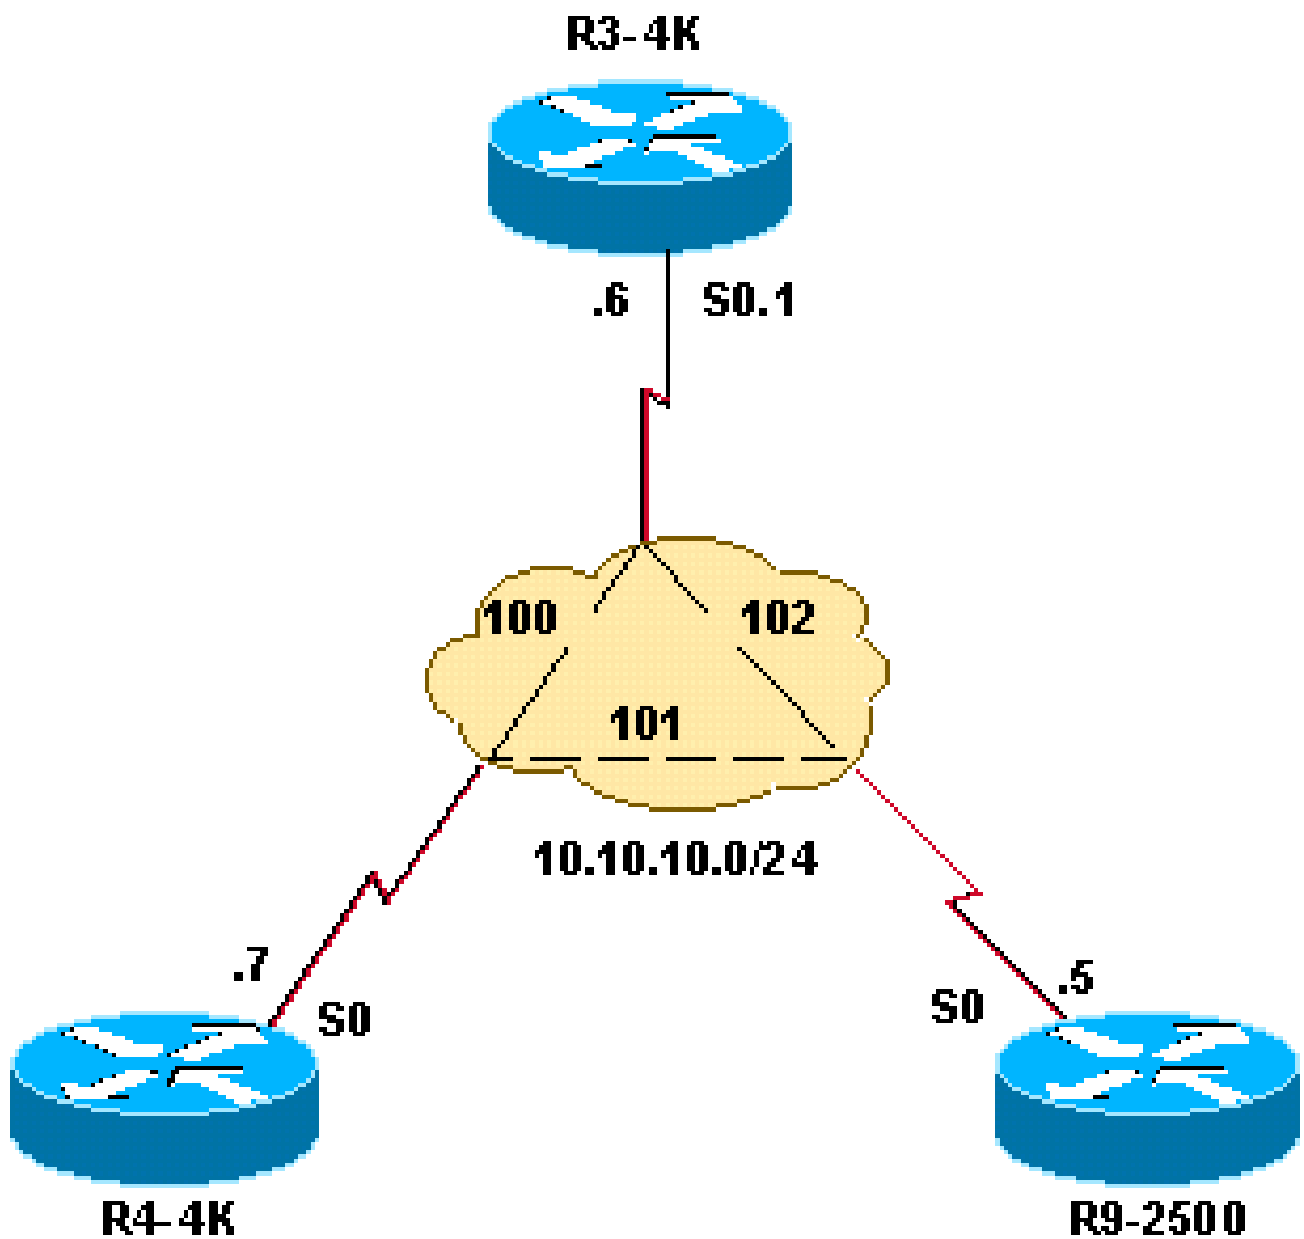
请以以下网络图为例：

```
interface Loopback0
ip address 10.50.50.50 255.255.255.255
!
interface Serial0
ip address 10.10.10.5 255.255.255.0
encapsulation frame-relay
ip ospf network broadcast
frame-relay map ip 10.10.10.6 102 broadcast
```

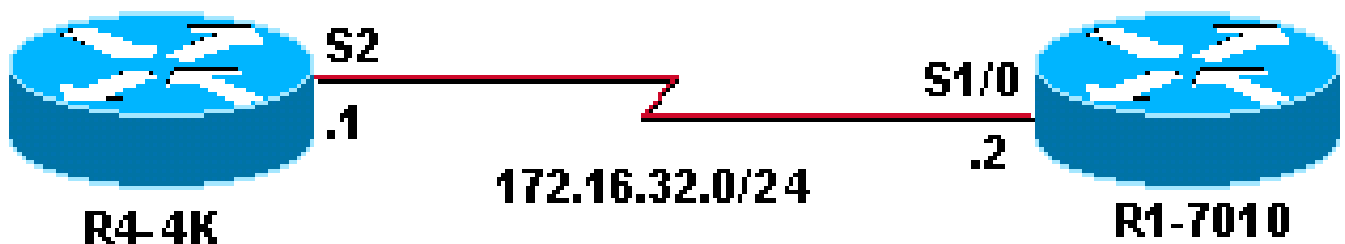
以下网络图用作示例：

R4-4K	R1-7010
<pre>interface Loopback0 ip address 172.16.33.1 255.255.255.255 ! interface Serial2 ip address 172.16.32.1 255.255.255.0 ! router ospf 20 network 172.16.0.0 0.0.255.255 area 0</pre>	<pre>interface Loopback0 ip address 172.16.30.1 255.255.255.255 ! interface Serial1/0 ip address 172.16.32.2 255.255.255.0 clockrate 64000 ! router ospf 20 network 172.16.0.0 0.0.255.255 area 0 distribute-list 1 in ! access-list 1 permit 172.16.32.0. 0.0.0.255</pre>

如前所述，R1-7010配置了distribute-list命令，它仅允许在路由表中安装172.16.32.0/24地址范围。在链路状态协议中，您实际上无法使用distribute-list命令过滤LSA。LSA仍存在于数据库中；但是LSA未安装在路由表中。
