檢驗基本NAT連線並排除故障

本文件說明如何在 NAT 環境中疑難排解 IP 連線問題。

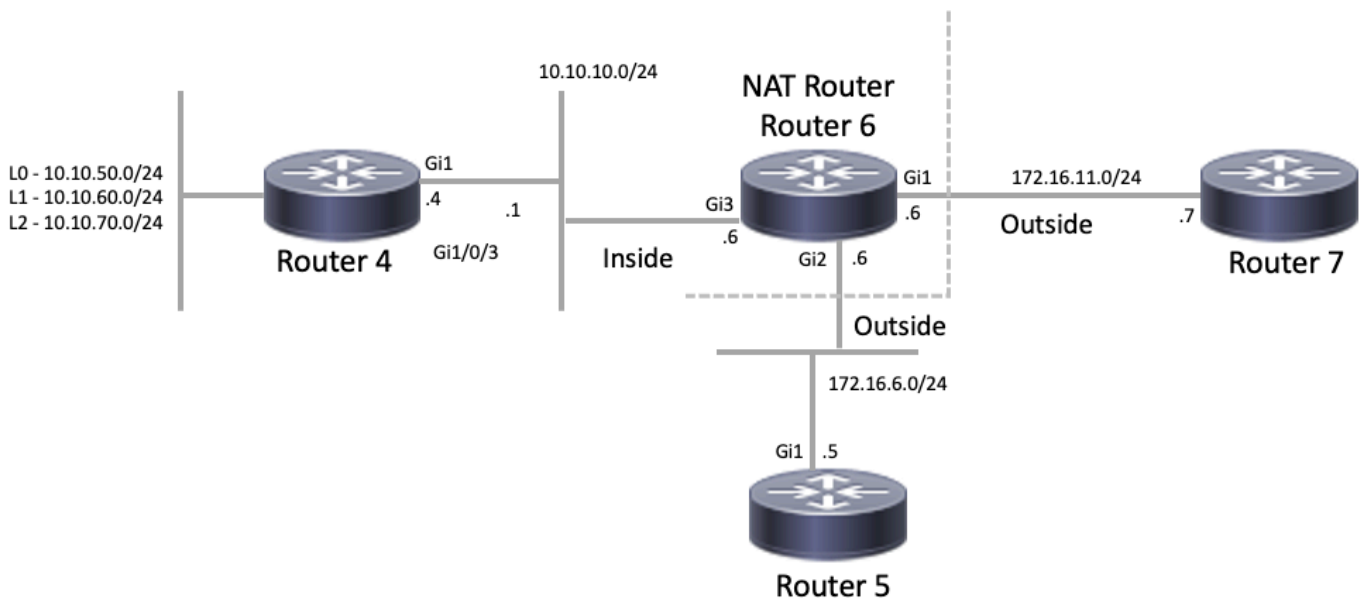
NAT拓撲

在第一種場景中，路由器4可以ping路由器5 (172.16.6.5)但不能ping通路由器7 (172.16.11.7)：

- 路由器上未配置動態路由協定，僅使用靜態路由。
- Router 4的預設網關是Router 6。
- 路由器6配置了NAT。
